# 2016

## 2016 PROJECT INSPECTION REPORT

The mission of the Clearwater River Watershed District is to promote, preserve, and protect water resources within the boundaries of the district in order to maintain property values and quality of life as authorized by MS 103D.

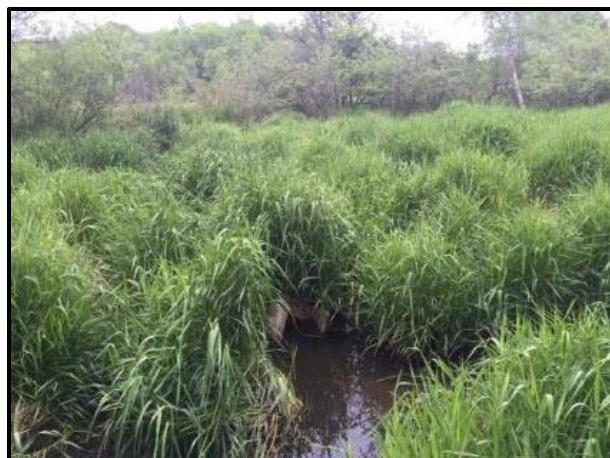
The CRWD Board of Managers has already authorized work be completed to repair the breach in the western channel and berm. However, this inspection has noted that a large amount of sedimentation has occurred in the channel, as well as several ports that are no longer functioning.

**Recommendation:** The effect of accumulated sediment on project effectiveness should be evaluated in order to determine if and where sediment cleanout is necessary.

**Recommendation:** A plan to repair the break in the berm should be developed to restrict water from flowing directly into the wetland. This plan could include the evaluation of potential options for project modification that would result in similar treatment as the original project.

**Recommendation:** If the break in the berm is fixed, a plan to repair the ports or provide other ways for water to flow back into the wetland should be developed in order to reduce the risk of future berm failures.

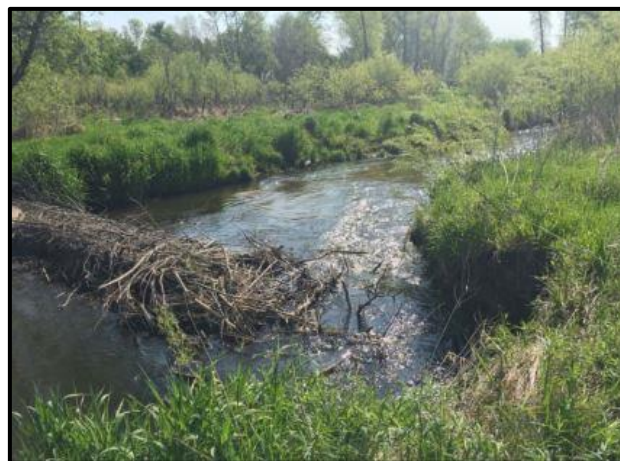
Inspection indicated the re-meandered low-flow channel was in good condition; its shape seems to be very stable, and vegetation is established. Two large beaver dams were discovered at the diversion of the river between the high and low-flow channels. Erosion around the dam has allowed flow into the low-flow channel; evidence indicates that a large amount of ponding had recently occurred (dead and dormant grasses above the dam). It is unclear whether beaver remain in the area.

**Recommendation:** The CRWD should contact both the MN DNR and Meeker County (ditch authority for this stretch of the river) to coordinate removal of the beaver dam (it is too large to be hand-removed) as well as to set up traps in the area to control beaver activity in the future. In addition, riprap (preferably granite) should be brought in to shore up the banks along the diversion area due to erosion that has occurred.

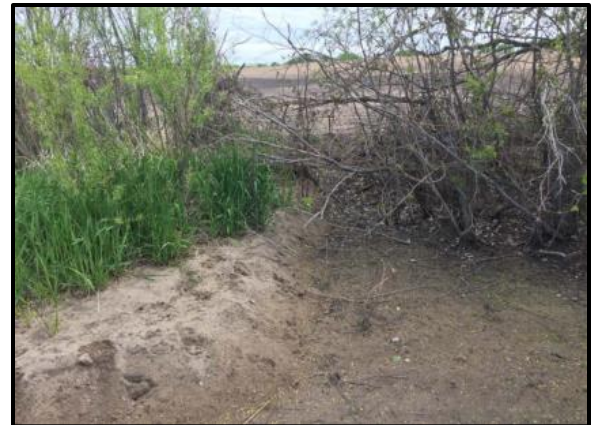
The CRWD has already authorized the cleaning of the southern diversion channel to as-built conditions; this was put on hold pending approval from permitting authorities. During inspection, staff noted several small areas of deposition as well as one area of large deposition near the previously-noted breach in the berm in the northern portion of the diversion channel. Most of this deposition seems to be coming from adjacent farm fields.

**Recommendation:** Accumulated sediment in the northern diversion channel is severely impeding flow in the channel downstream of the breach in the berm. A plan for removing the sediment should be developed in conjunction with the repair of the breach in the berm. Large sections of the channel will likely need to be cleaned to return the channel to as-built conditions.

**Recommendation:** The breach in the berm is allowing nearly all of the flow from the diversion channel upstream of the noted accumulated sediment above to flow directly into the wetland. The breach should be repaired.

**Recommendation:** Sediment accumulation in the channel seems to be driven in several locations from runoff from adjacent agricultural fields. Options to address these areas to prevent future sedimentation should be evaluated and implemented where possible.

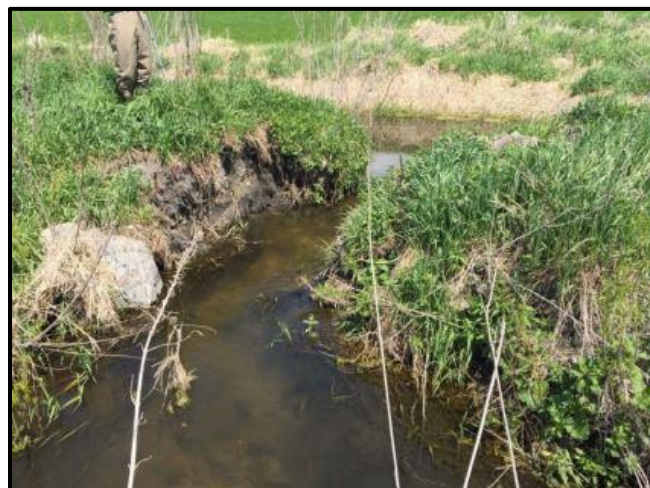
Channel A and corresponding diversion berm are in good condition, with few channel sections where sedimentation has occurred. Channel B has several sections where sedimentation has occurred. Flow seems to not be significantly restricted; however, capacity of the ditch is affected by this sedimentation.

**Recommendation:** Cleanout of channel sections where sedimentation has occurred is likely needed to return channel to design capacity and mitigation potential drainage concerns of upstream properties.

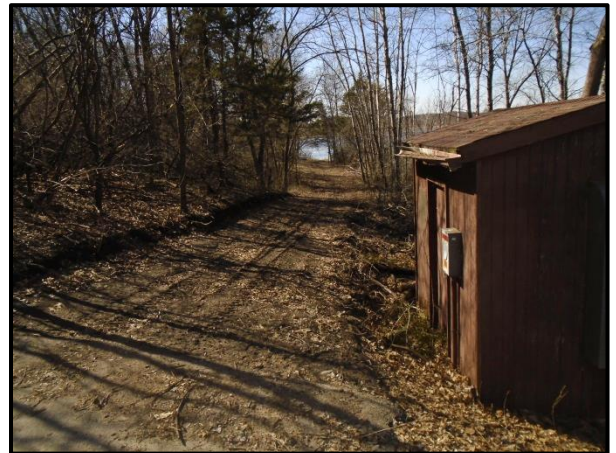
The Lake Marie aerator building is in good condition. The Lake Augusta aerator building is in need of a new coat of paint, as well as some work to its soffits, eaves, and potentially its foundation. In addition, recent work on the lake access road located adjacent to the building has resulted in a large amount of dirt and debris pushed against the lake Augusta aerator building.

**Recommendation:** The CRWD should consider whether this building should continue to be maintained or abandoned, considering the amount of time that has transpired since the aerators were active.

If the CRWD wishes to continue to maintain, the soffits and eaves of the Lake Augusta building should be repaired. A more in-depth review of this building's foundation should be conducted in the next year or so to determine whether it needs repair work.

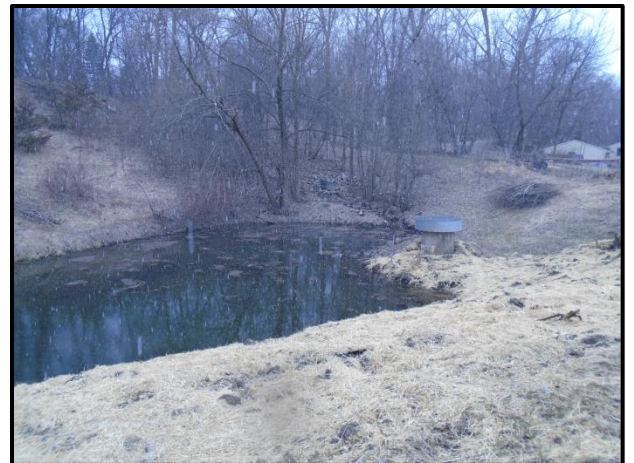
Portions of the fence around the basin are bent due to woody vegetation growth.

**Recommendation:** Clear woody vegetation from the fence in multiple locations. This is a lower priority than other noted work items.

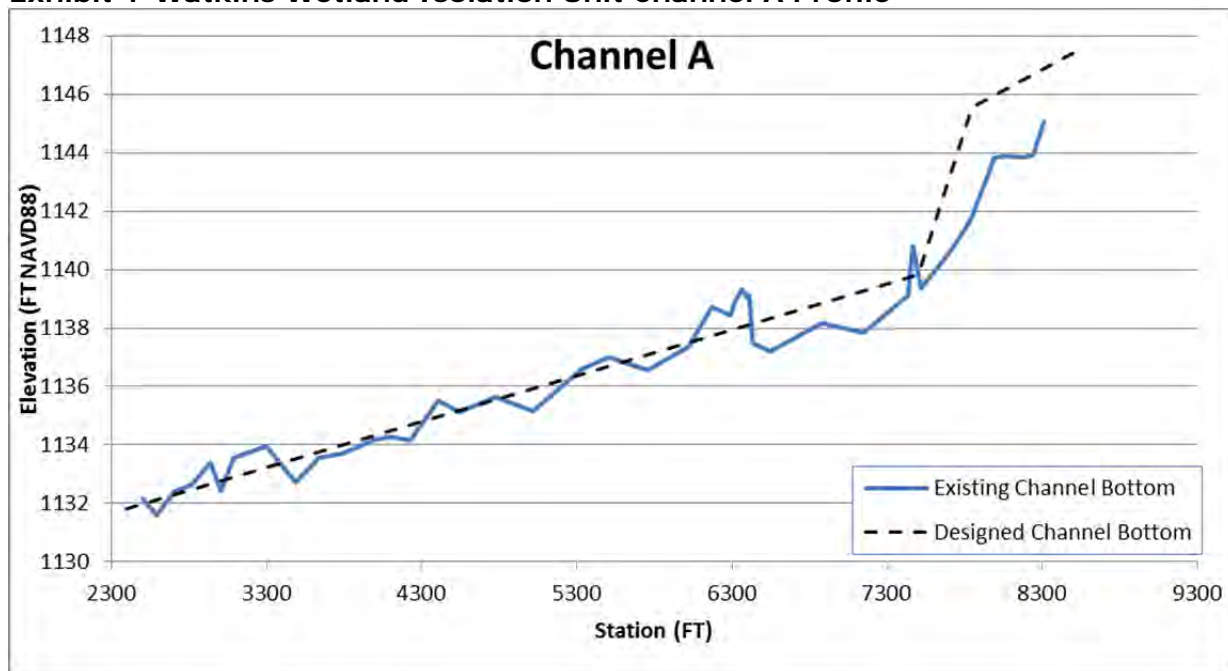
**Exhibit 1-Watkins Wetland Isolation Unit Channel A Profile**

While some sediment has accumulated in the western portion of Channel A (station point 2300 to 5200), the diversion channel has maintained flow through this section and is beginning to form a natural braided channel that is slightly different in shape than the original design channel as shown in Exhibit 2. Two areas of sediment runoff from adjacent agricultural fields were observed in the western channel near station points 2900 and 3300.

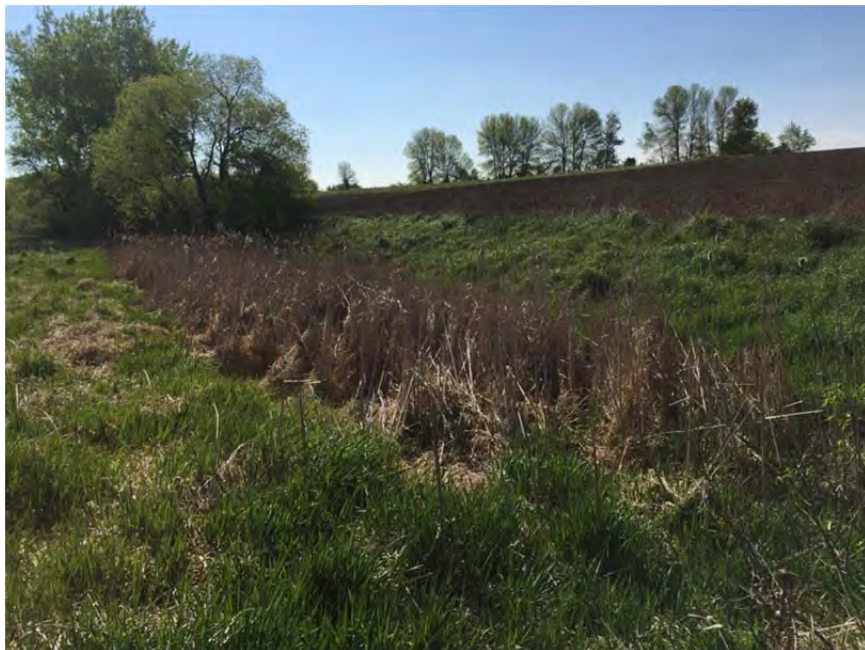
Cattails/Sediment blocking Channel B

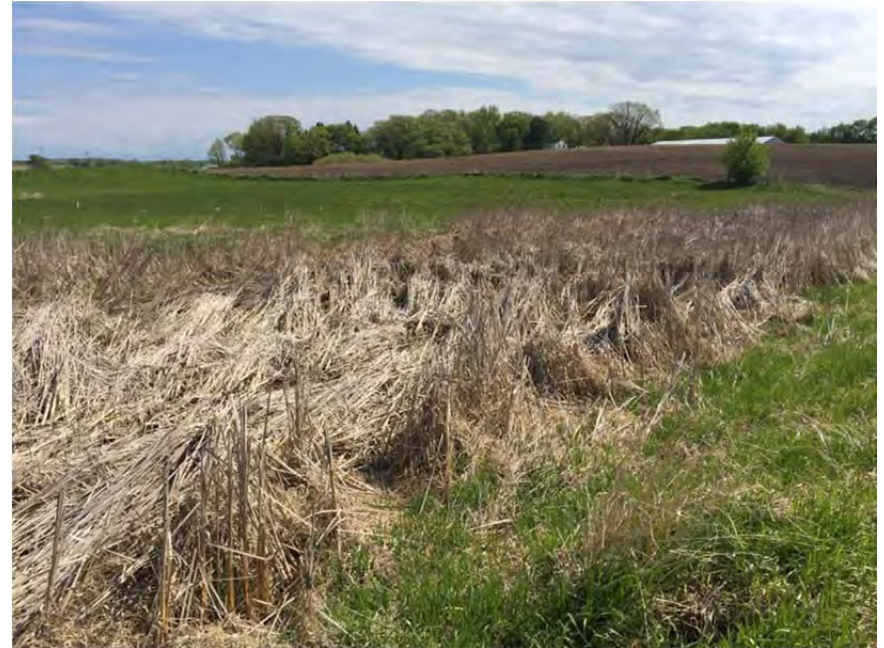
Blockage in Channel A (Station Point 5300)

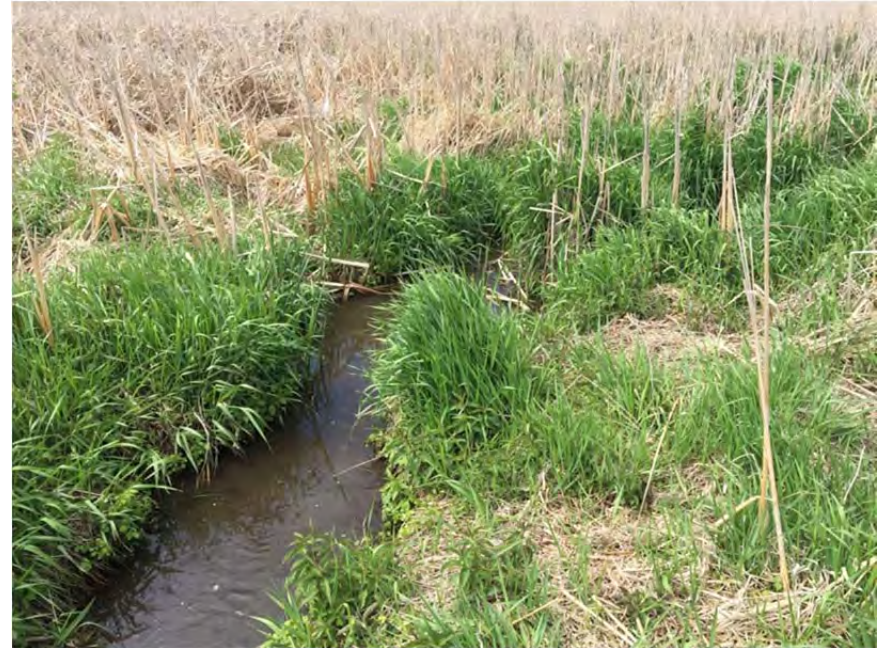
Break in Berm (Station Point 6300)

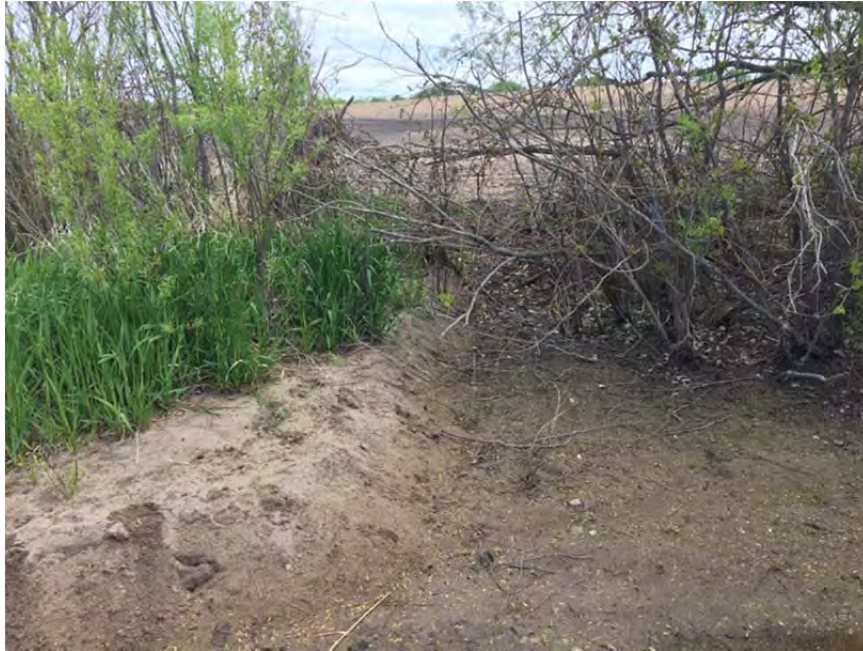
Sediment in Channel (Station Point 6400)

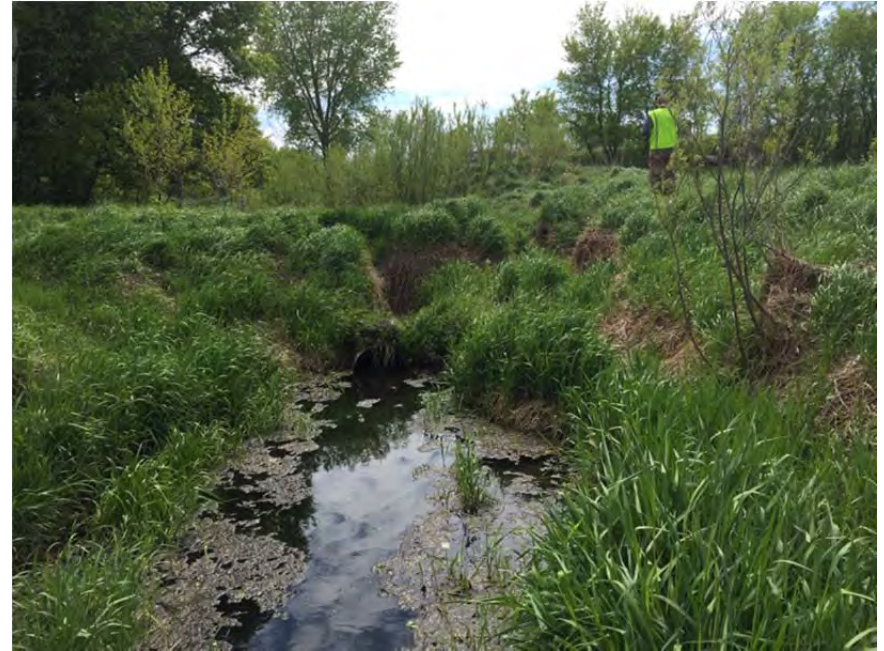
Pipe failure at channel crossing  
(Station Point 7500)

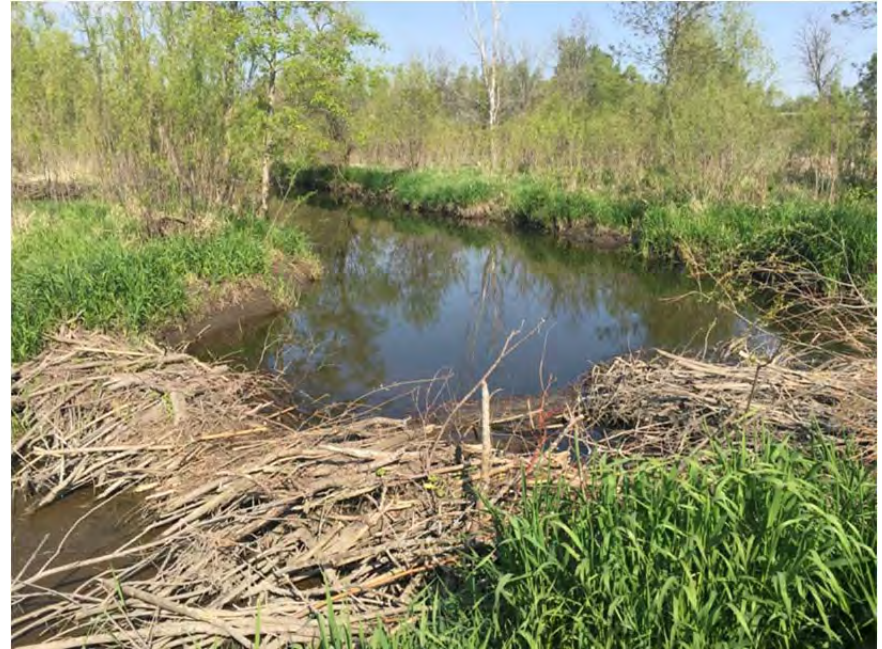
Beaver dam blocking sediment forebay channel

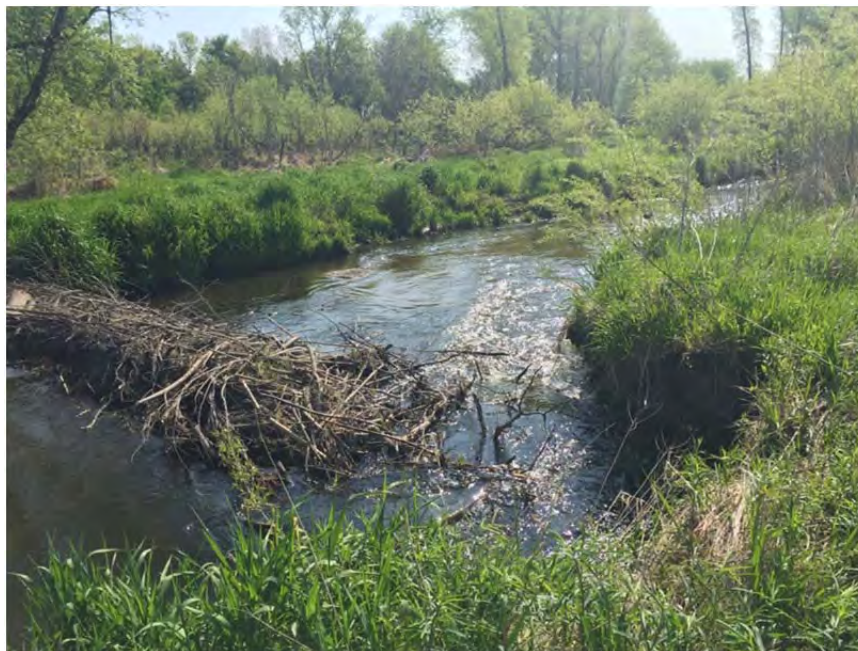
Beaver dam and eroded south bank of main channel

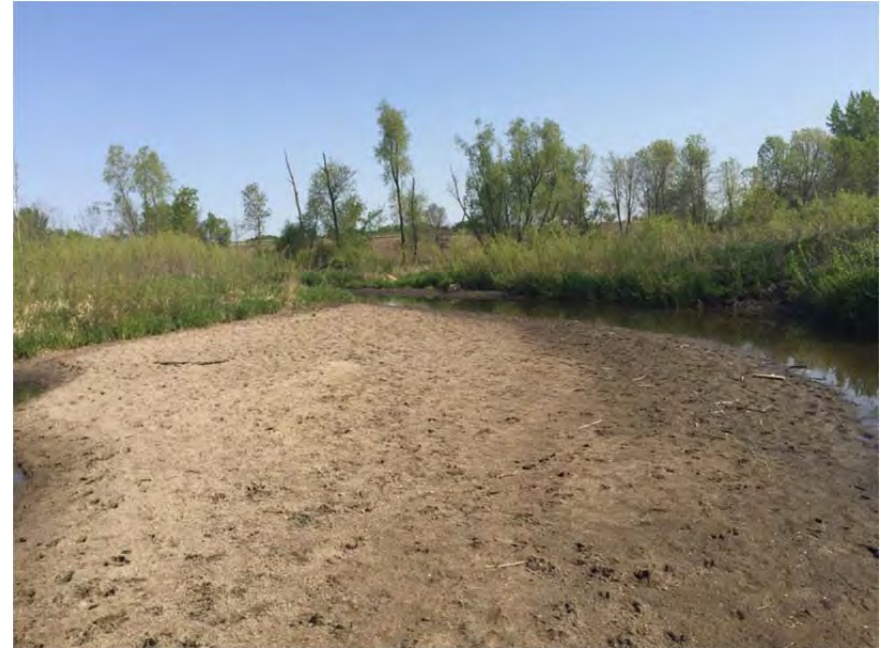
Sediment deposit in sedimentation basin

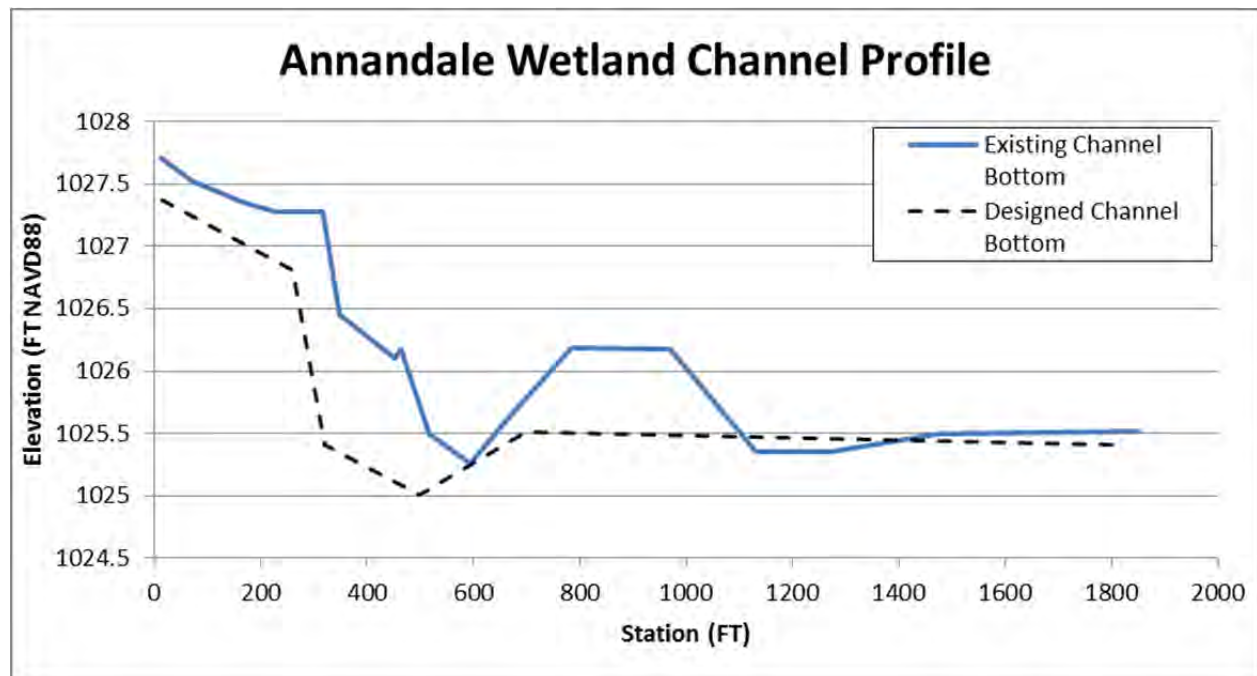
**Exhibit 5-Annandale Wetland Treatment System Channel Profile**

Significant sediment accumulation was observed in the beginning section of ditch channel (station point 0 to 600). An additional area of sediment accumulation was observed near station point 800. In these locations, sediment was observed to have nearly filled in the channel, except for a flow channel cutting through the sediment. Accumulated sediment depths of approximately 3 feet were observed in this portion of the channel. Trash and other debris were observed in the channel, indicating volumes of stormwater runoff from upstream.

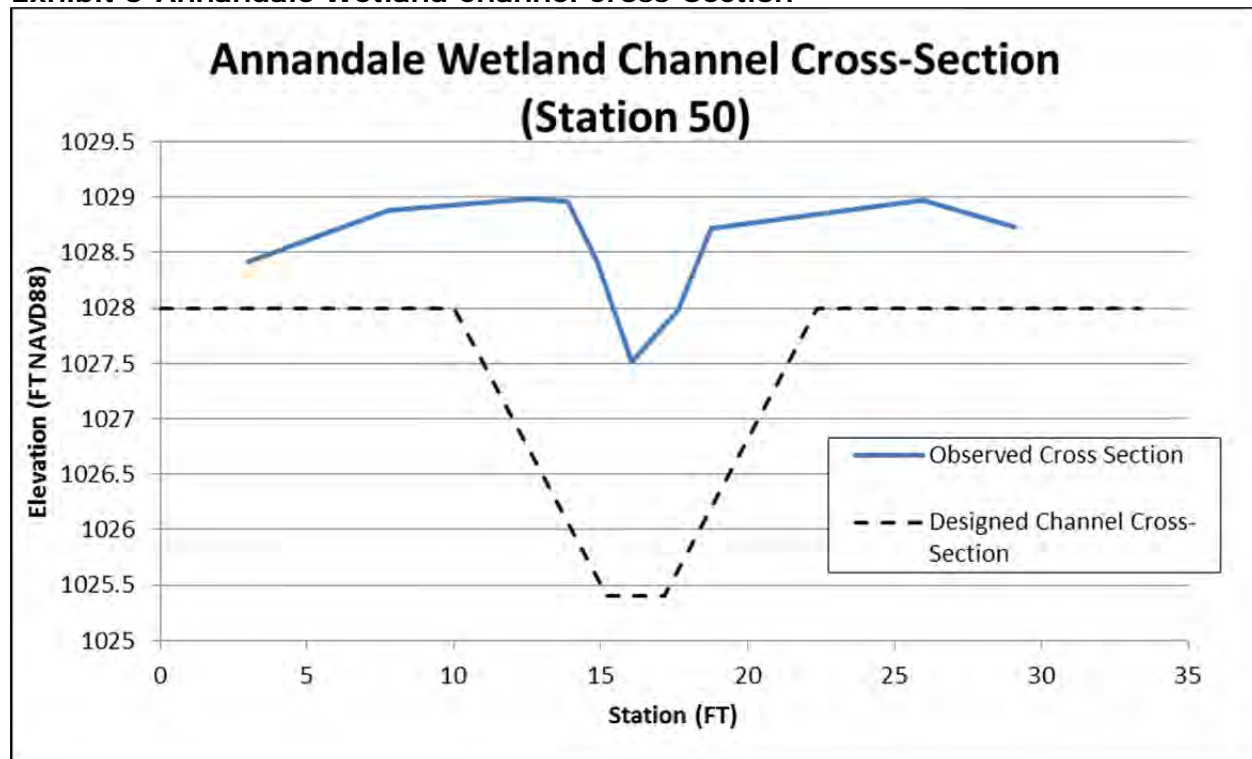
## Exhibit 6-Annandale Wetland Channel Cross-Section

Sediment accumulation was not as extensive in the portion of the channel north of station point 1100. In this portion of the channel, lowered water levels and minimal flows have resulted in the channel transitioning to a natural wetland condition, as stands of native emergent wetland species have become established.

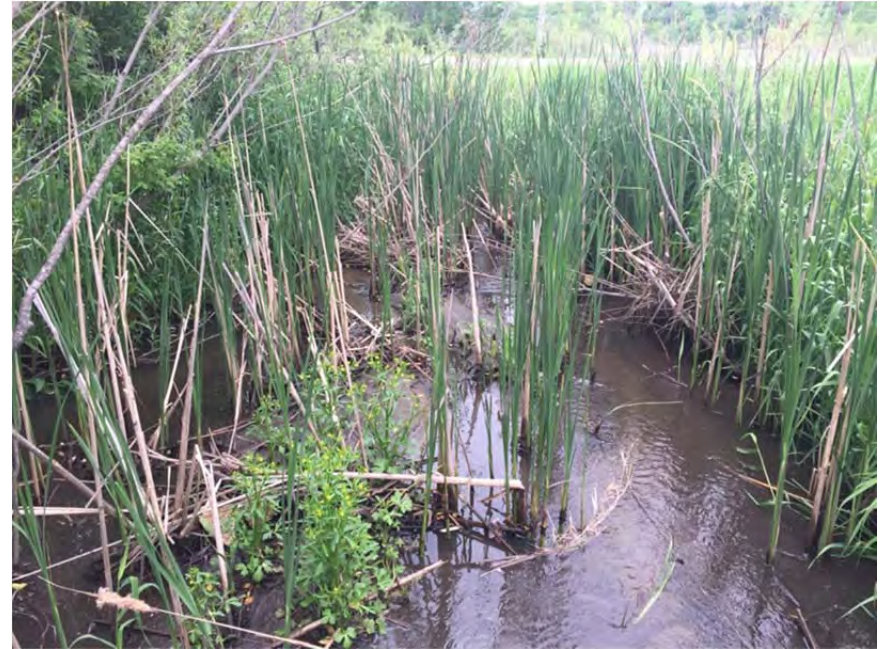
Sedimentation in Channel (Station Point 100)

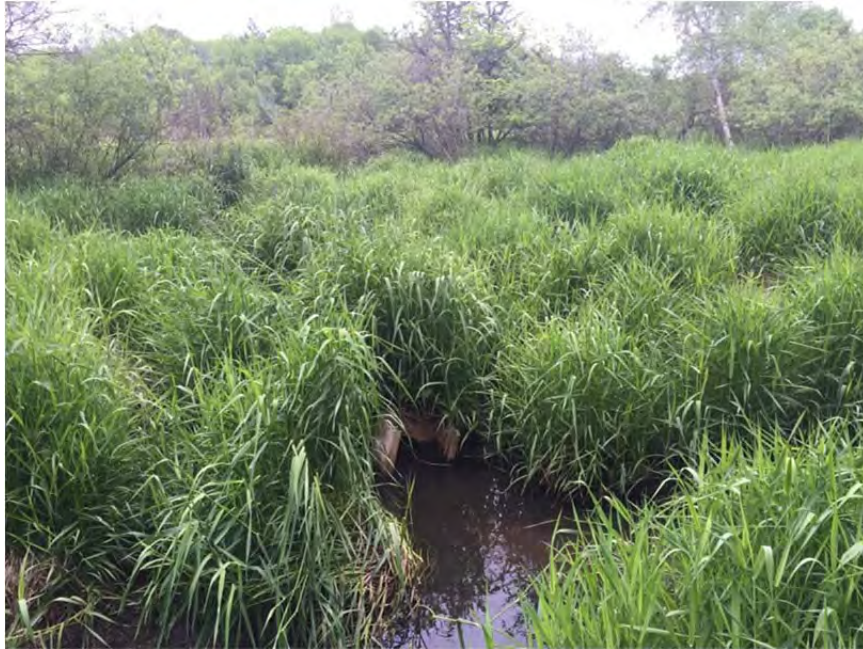
Breach in berm (Station Point 650)

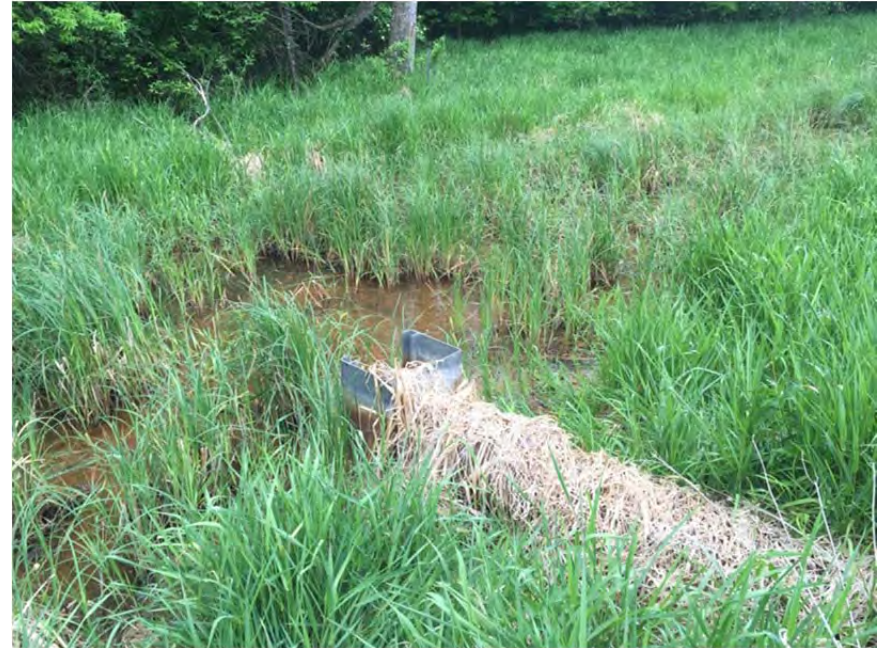
Damaged port inlet

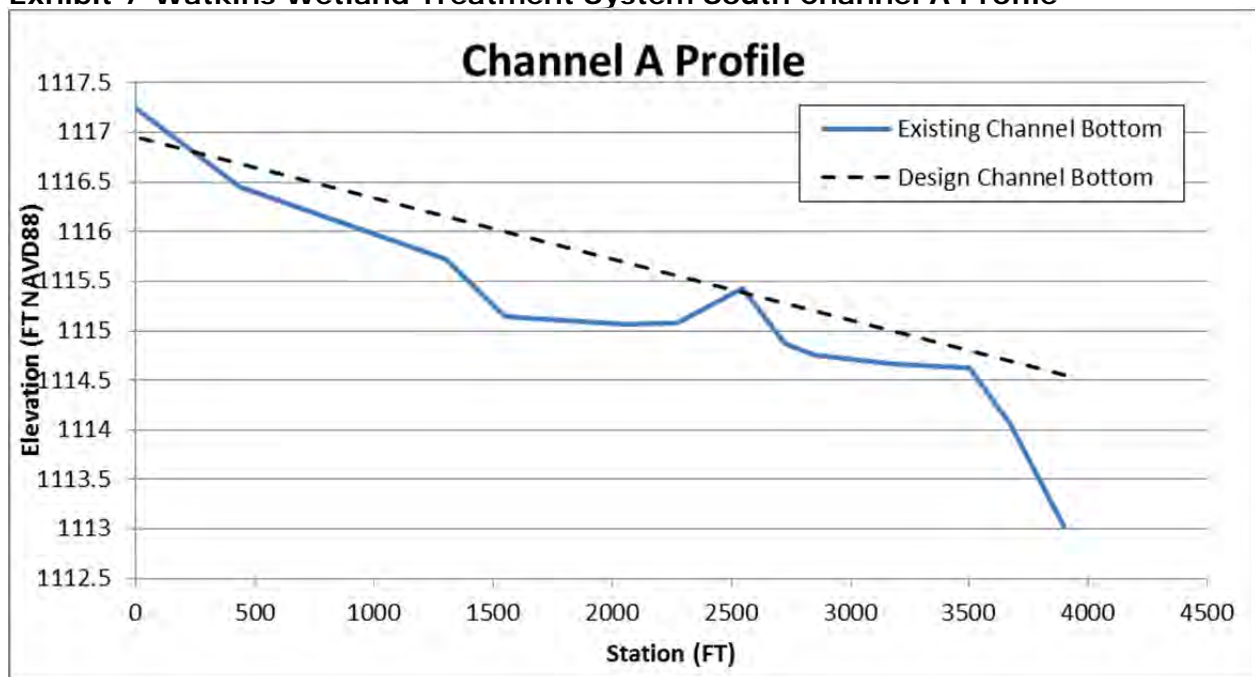
**Exhibit 7-Watkins Wetland Treatment System South Channel A Profile**

Investigation of Channel B demonstrates that some sedimentation has occurred that has limited capacity in the channel. This was especially apparent in the upper portions of the channel (station point 0 to 1000) but the sedimentation has not severely restricted flow in the channel. The profile shown in Exhibit 7 compares the design channel to the existing channel.

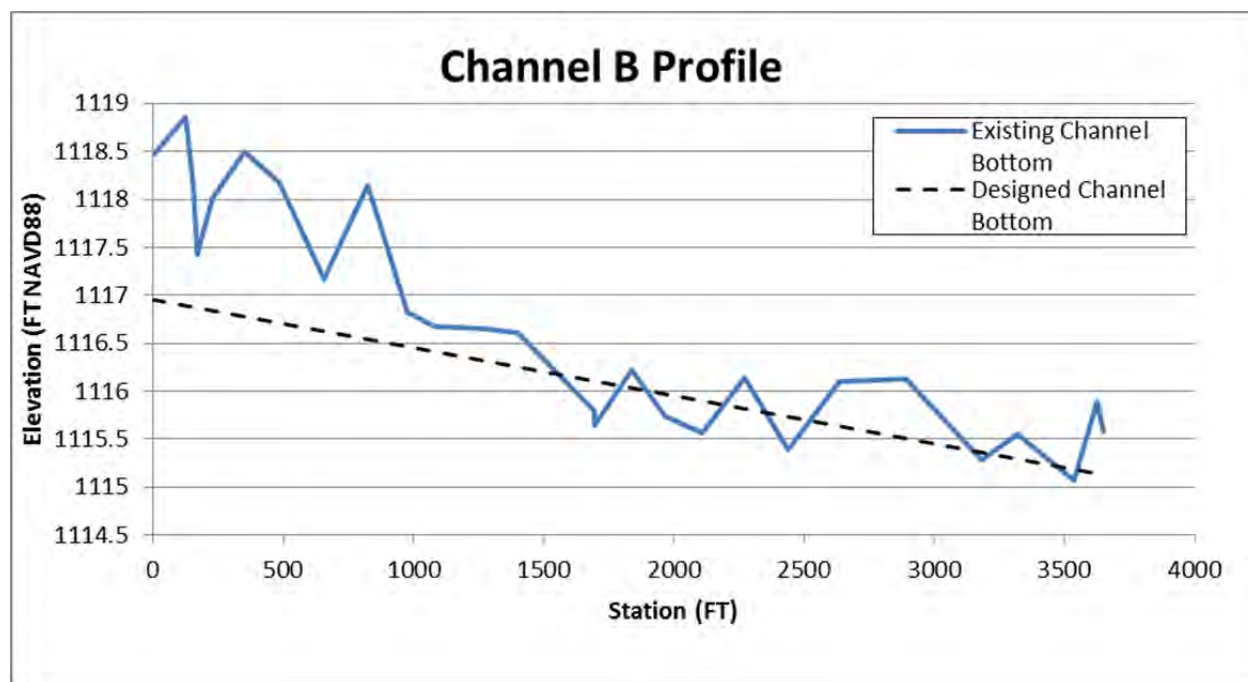
## Exhibit 8-Watkins Wetland Treatment System South Channel B Profile

A comparison of the design and existing cross section of Channel B (at station point 1000) in Exhibit 8 demonstrates the change in channel shape as a result of sedimentation. While it appears that the channel has lost capacity, since the channel shape has changed from a straight channel with uniform slopes to a braided channel over most of the reach of the channel, flow appears to be maintained through the channel as designed.

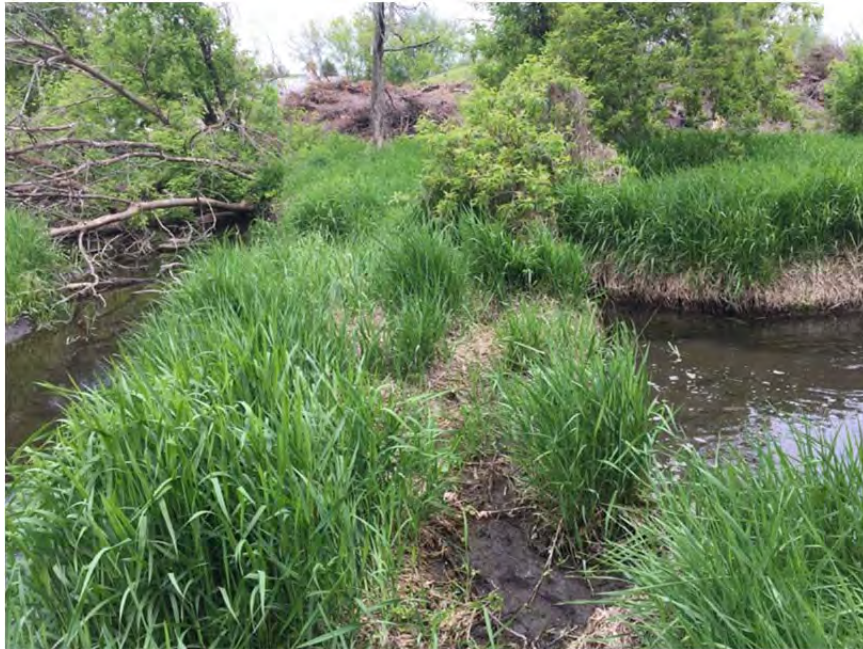
Accumulated Sediment at Diversion Structure

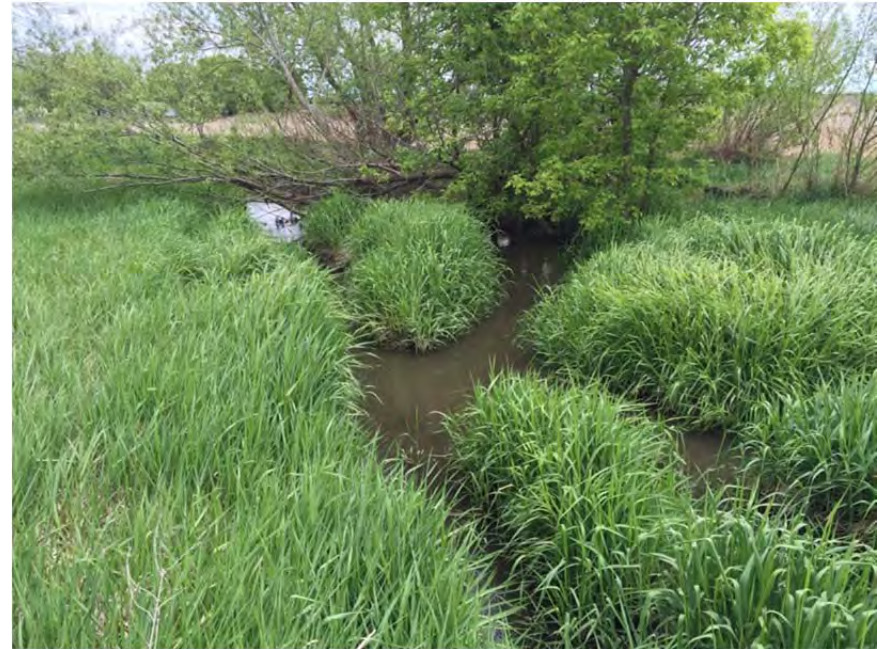
Sediment in Channel B (Station 500)

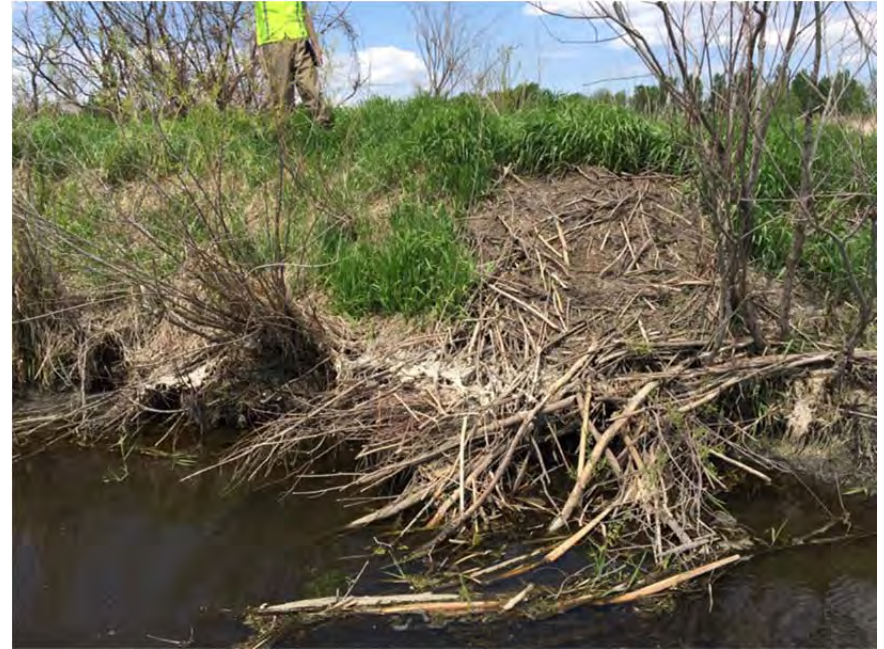
Beaver activity on banks (Station Point 3300)

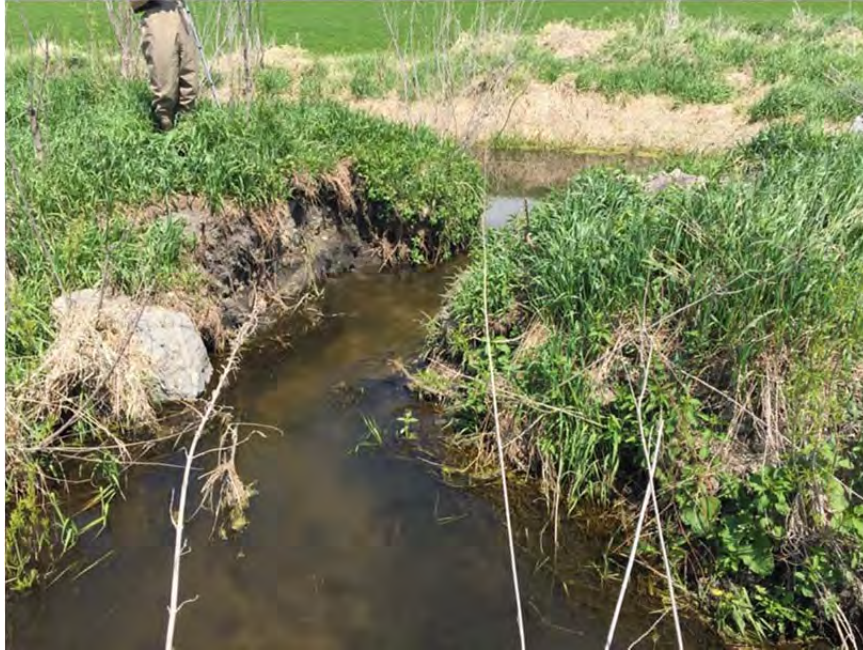
Cut in Berm (Station Point 3900)
