### **2019-2021 The Project Inspection and Maintenance Summary**

The mission of the Clearwater River Watershed District is to promote, preserve, and protect water and natural resources within the boundaries of the district in order to maintain property values and quality of life as authorized by MS 103D.

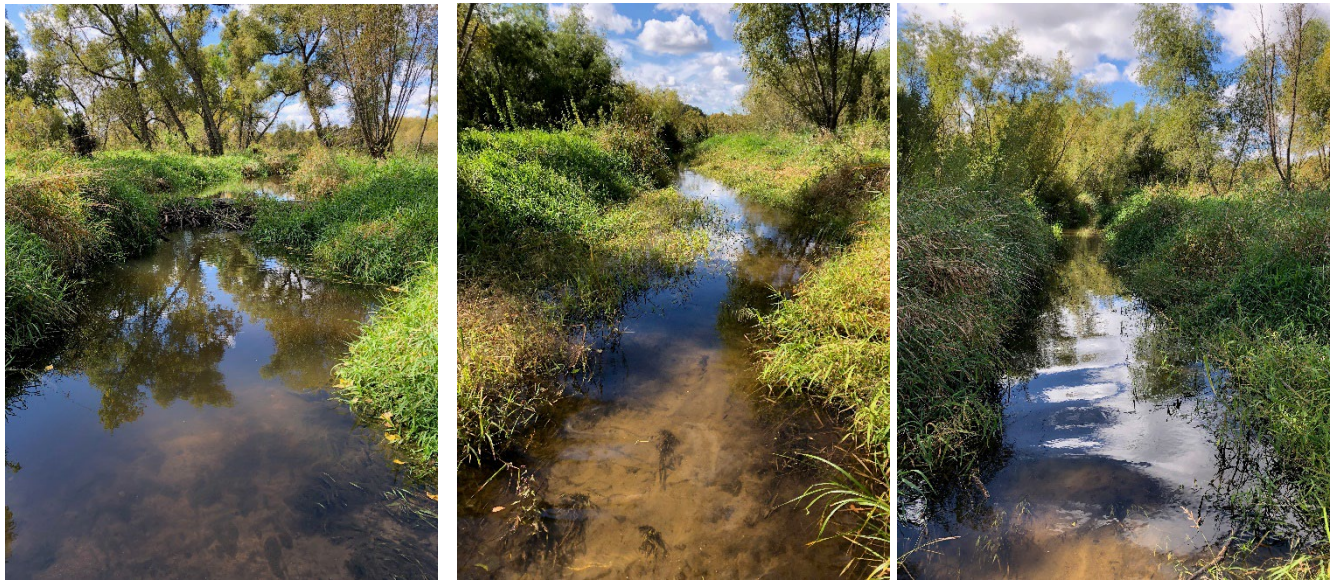
October 2021. R10 survey unit with canoe. Beaver dam at diversion structure with observed with head differential between upstream and downstream. Downstream of beaver dam water level was ~0.5 ft. Upstream water depth was ~2ft. Sediment basin requires cleanout. Channel in mostly good shape with well established vegetation. Reed canary grass buffer the stream banks dominant with some noticeable undercutting further upstream. Water was present along

*2021 survey photos*

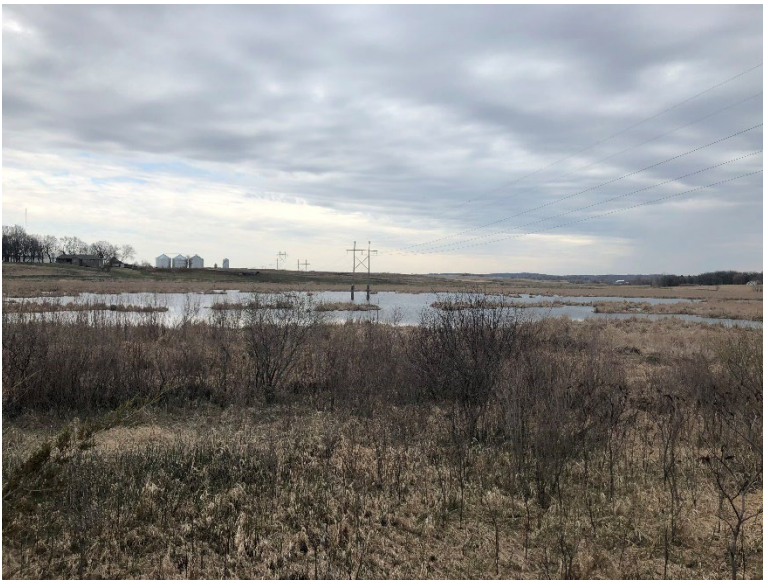
*2021 site photo. Whole site looking north*

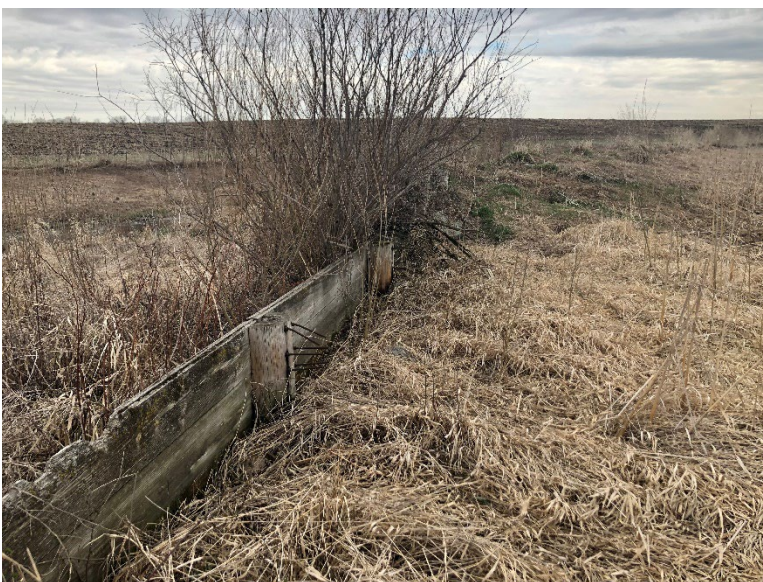
The wooden weir diversion structures are in good condition. The berm and outlet structure do have woody brush growing that should be removed, and evidence of rodent tunneling which can undermine berm function.

*2019 site photo. Outlet structure on berm, excess brush, structure holding*

- Conduct full survey in 2022 spring with drone and elevation.
- Survey the channel to determine if repair is needed.
- Flush cut brush on the berm and near the outlet structure.
- Investigate adding rat wire to areas of the berm/ outlet structure where rodents have burrowed and repair burrow damage.
- Consider repairing portions of broken fencing, or remove broken portions and replace with signage. The fencing work is a lower priority than other noted work items.
- Prior to any work, the District may wish to contact easement holders to inform them of work to be undertaken in order to avoid any potential confusion.

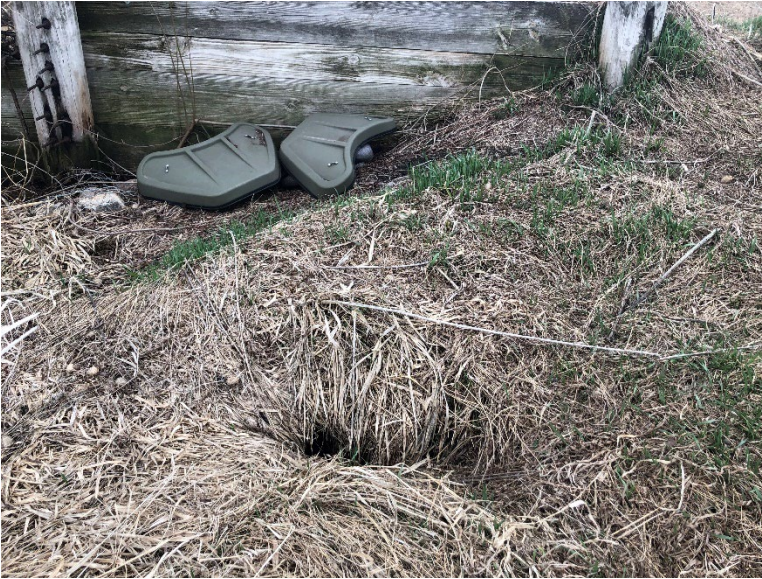
*2019 site photos. Outlet structure, rodent activity proximity*

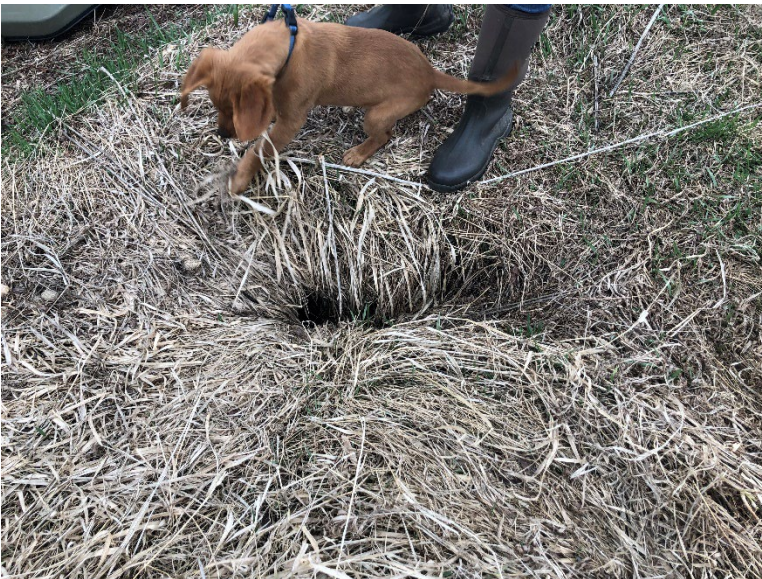
*2019 site photo. On outlet berm, characteristic rodent tunneling (puppy for scale)*

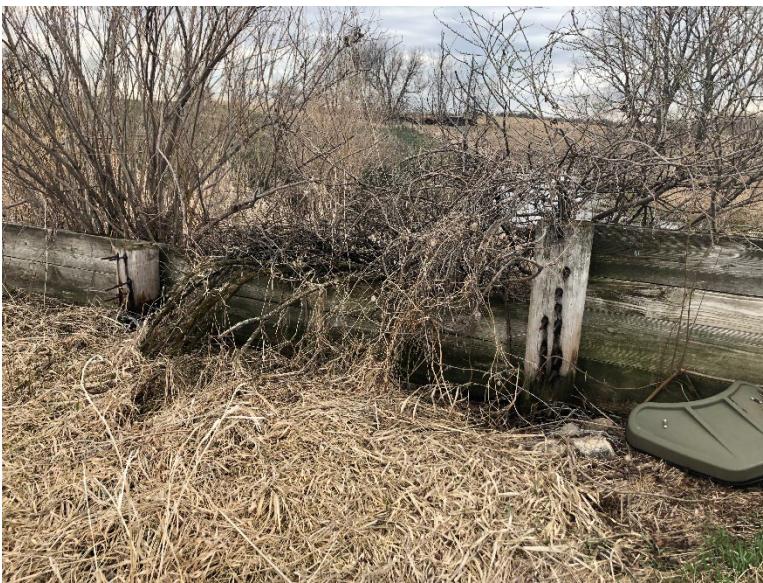
*2019 Site Photos. Baffle berm, some burrowing by animals, brush needs to be removed*

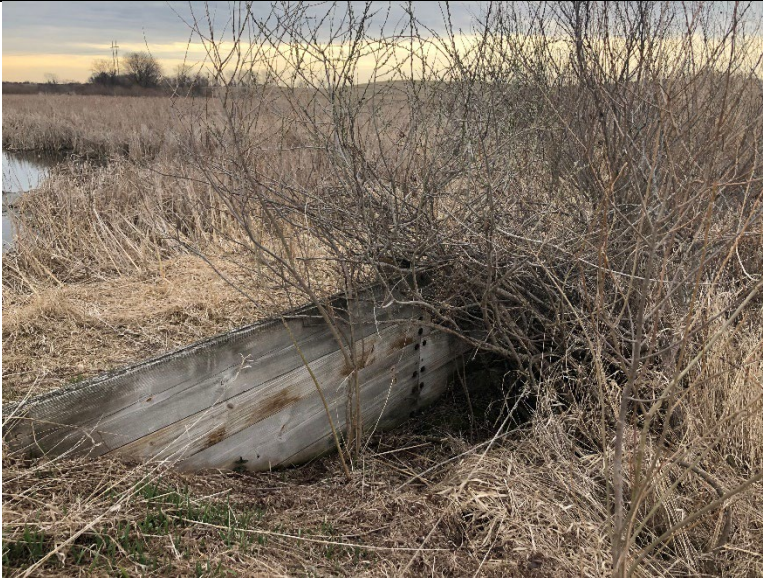
*2019 site photos. Outlet brush, remove.*

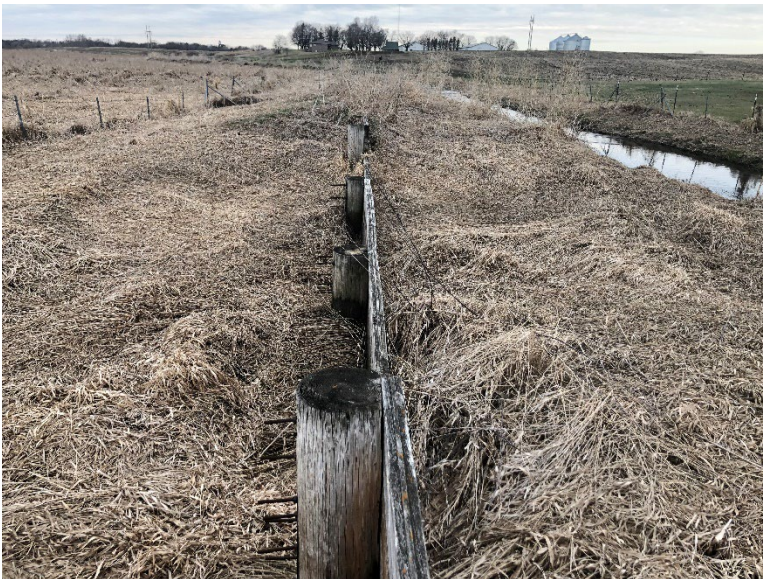
*2019 site photos. Outlet and diversion channel*

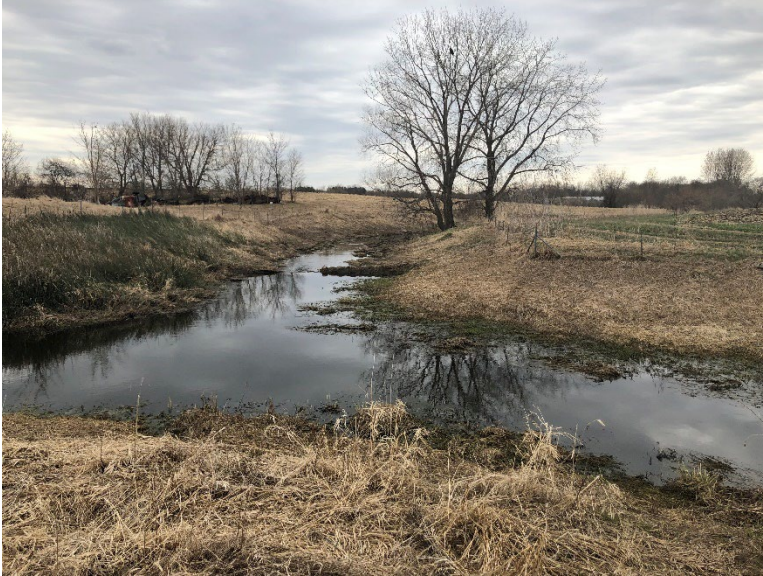
*2019 site photo. Diversion channels*

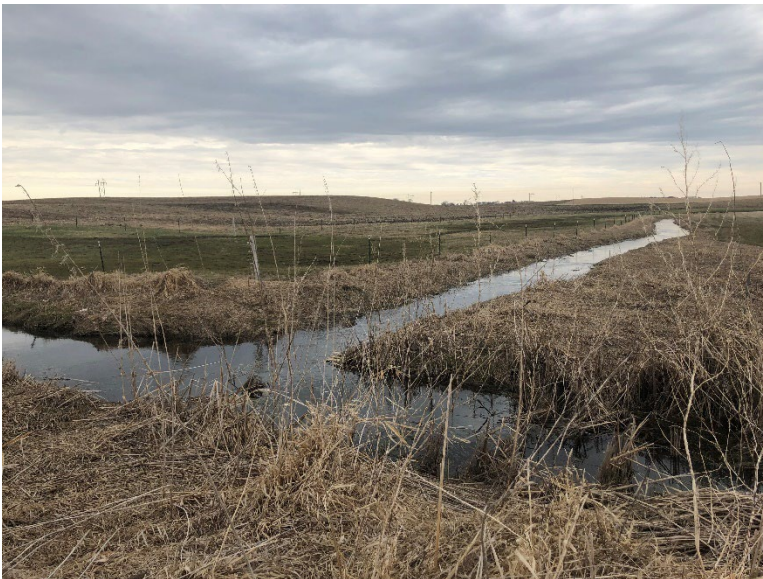
*2019 site photos. Diversion channels*

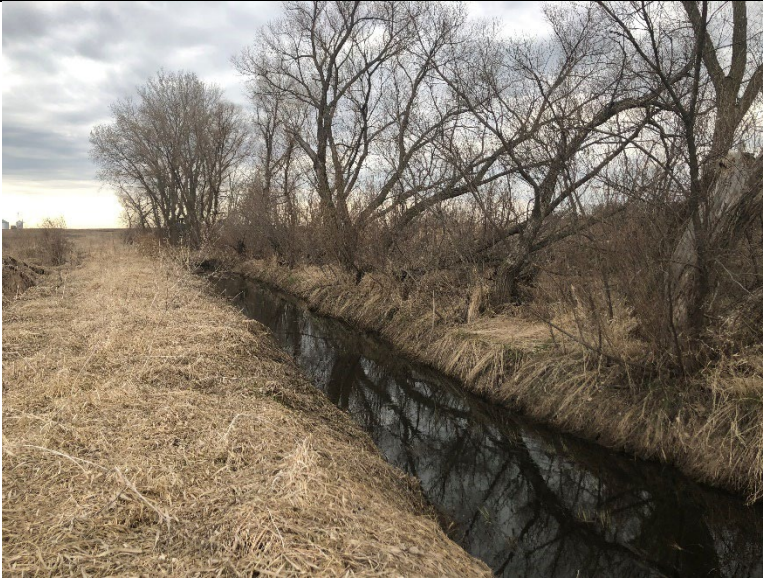
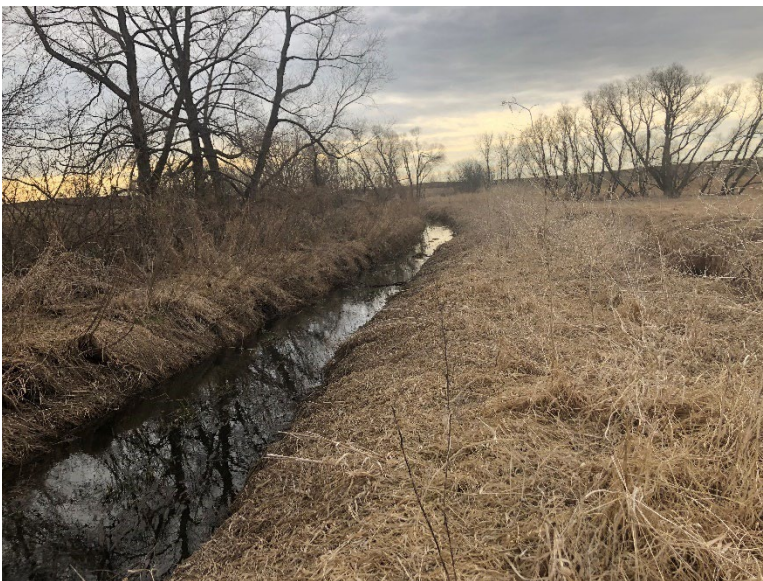
*2019 site photos. Channel w/ berm and trees.*

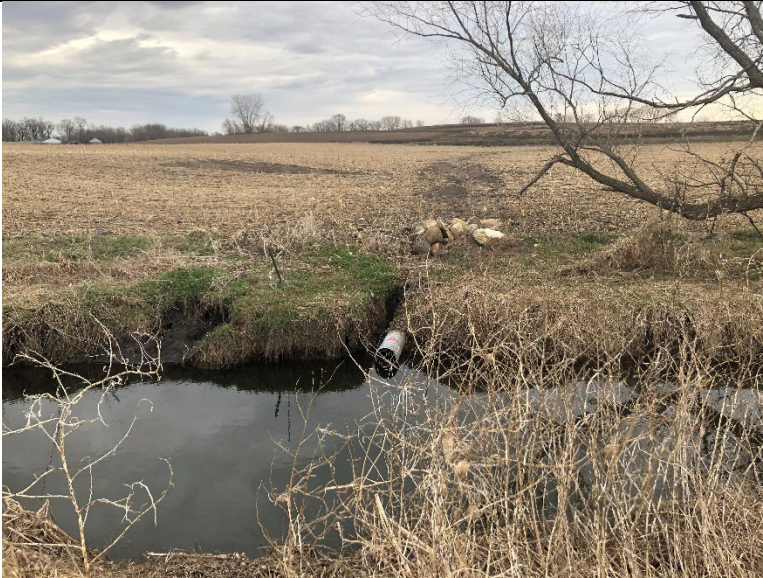
*2019 site photos. Field inlet*

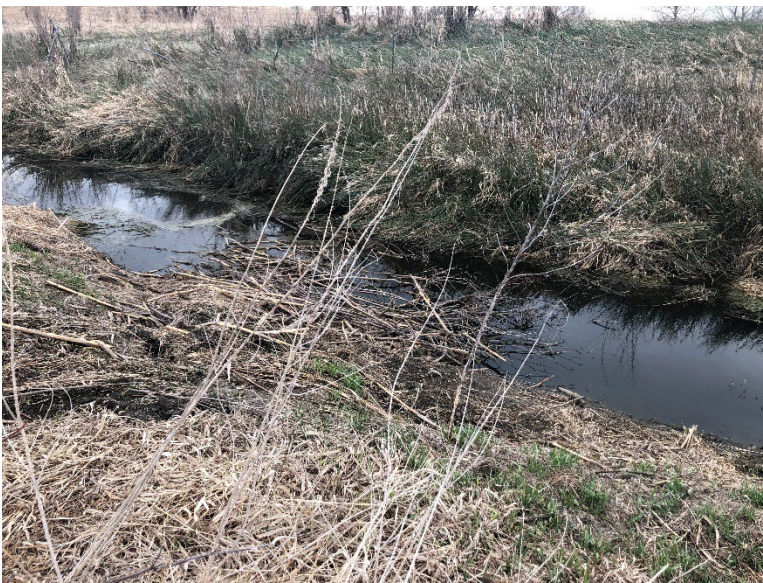
*2019 site photo. Brush in diversion channel, with additional buildup would require cleanout*

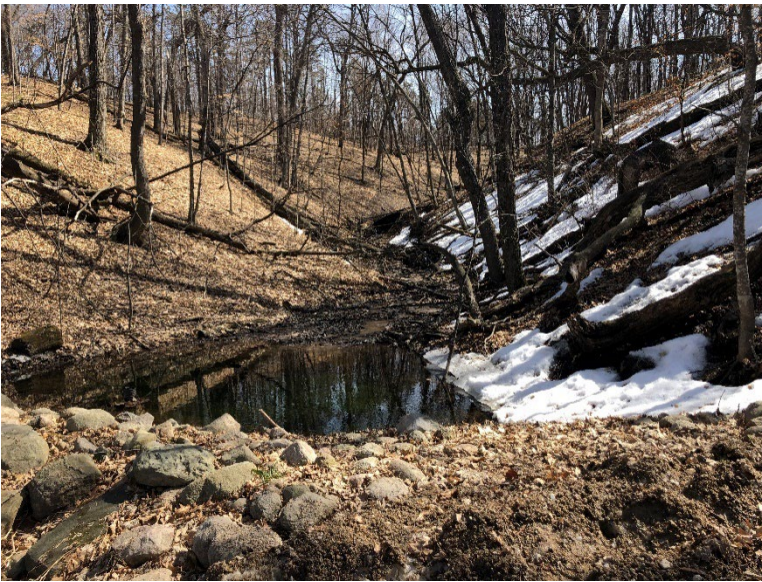
*2019 Site Inspection. Erosion control channel + drop structure rip rap.*

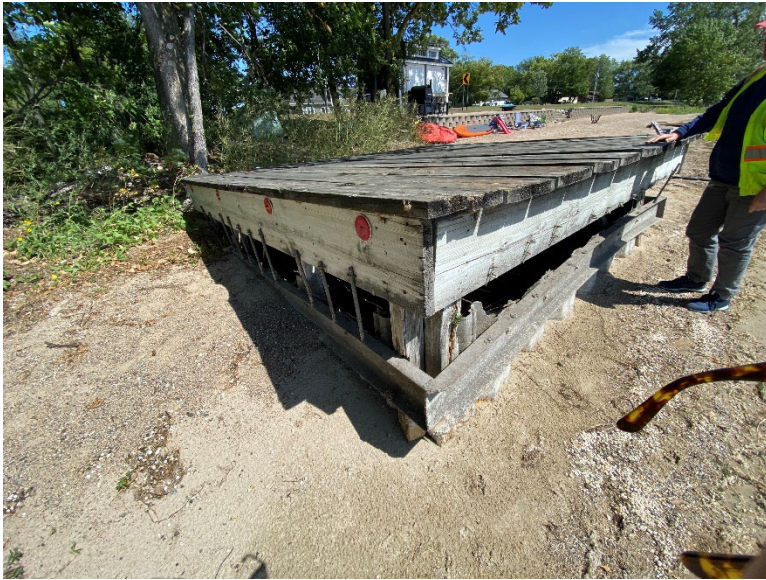
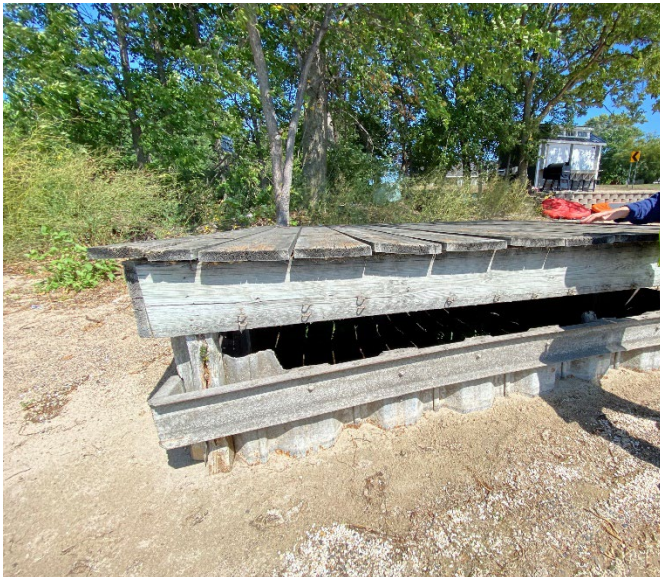
Overall, the outlet control structure is in fair condition. The rebar trash guards on the front of the structure are missing. One board on top of the structure is loose. One hinge on door access is broken, and the door is missing its lock. Last year it was noted the outlet guillotine valve does not completely close so as to make a watertight seal.

**Recommendations:** The Board of Managers approved at their August 2021 meeting to replace the wooden decking in kind. The rebar was gone on the entire front of the platform. The decking replacement is scheduled for February/ March 2022. In addition, the guillotine valve should be greased by maintenance personnel to promote ease of operation. Staff secured a maintenance contractor who will do this annually as well as operate the valve as indicated by the Grass Lake Dam elevations. Check with landowner to ensure replacement tree is added per DNR for repairing the outlet channel.

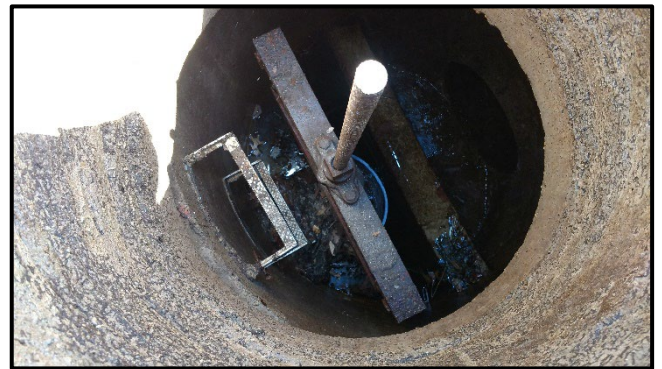
May 2, 2018. The lake outlet pipe has sand and debris in it that has caused a partial blockage to occur. It will need to be cleared to return the outlet to operational effectiveness. The ice barrier is damaged. Both issues will be address as part of outlet control reconstruction.

Figure 1: SedimentatFigure 2: Valve and weir in manhole

- The guillotine valve should be greased by maintenance personnel to promote ease of operation. Staff retained operation and maintenance contractor to do this and operate valve.
- Consider the installation of trash guards as part of ice barrier replacement for work on Theil Creek.
- Consider a legal survey to clearly delineate the easements for this project on a drawing and in current geospatial terms.

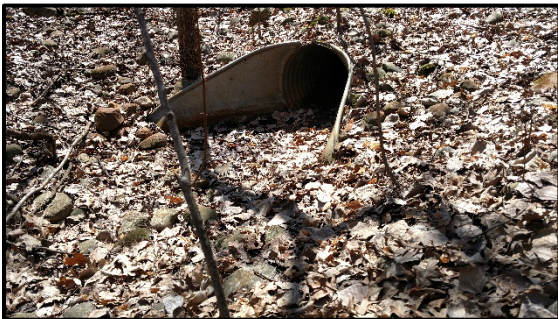
The remainder of the outlet systems seems to be in good operational order. Several of the culverts are missing trash guards.

Figure 3: Example of culvert w/o trash guard
