2006 Project Inspection Report

Prepared for
**Clearwater River
Watershed
District**

April 2006

Re: 2006 Project Inspection Report
Wenck File # 0002-84

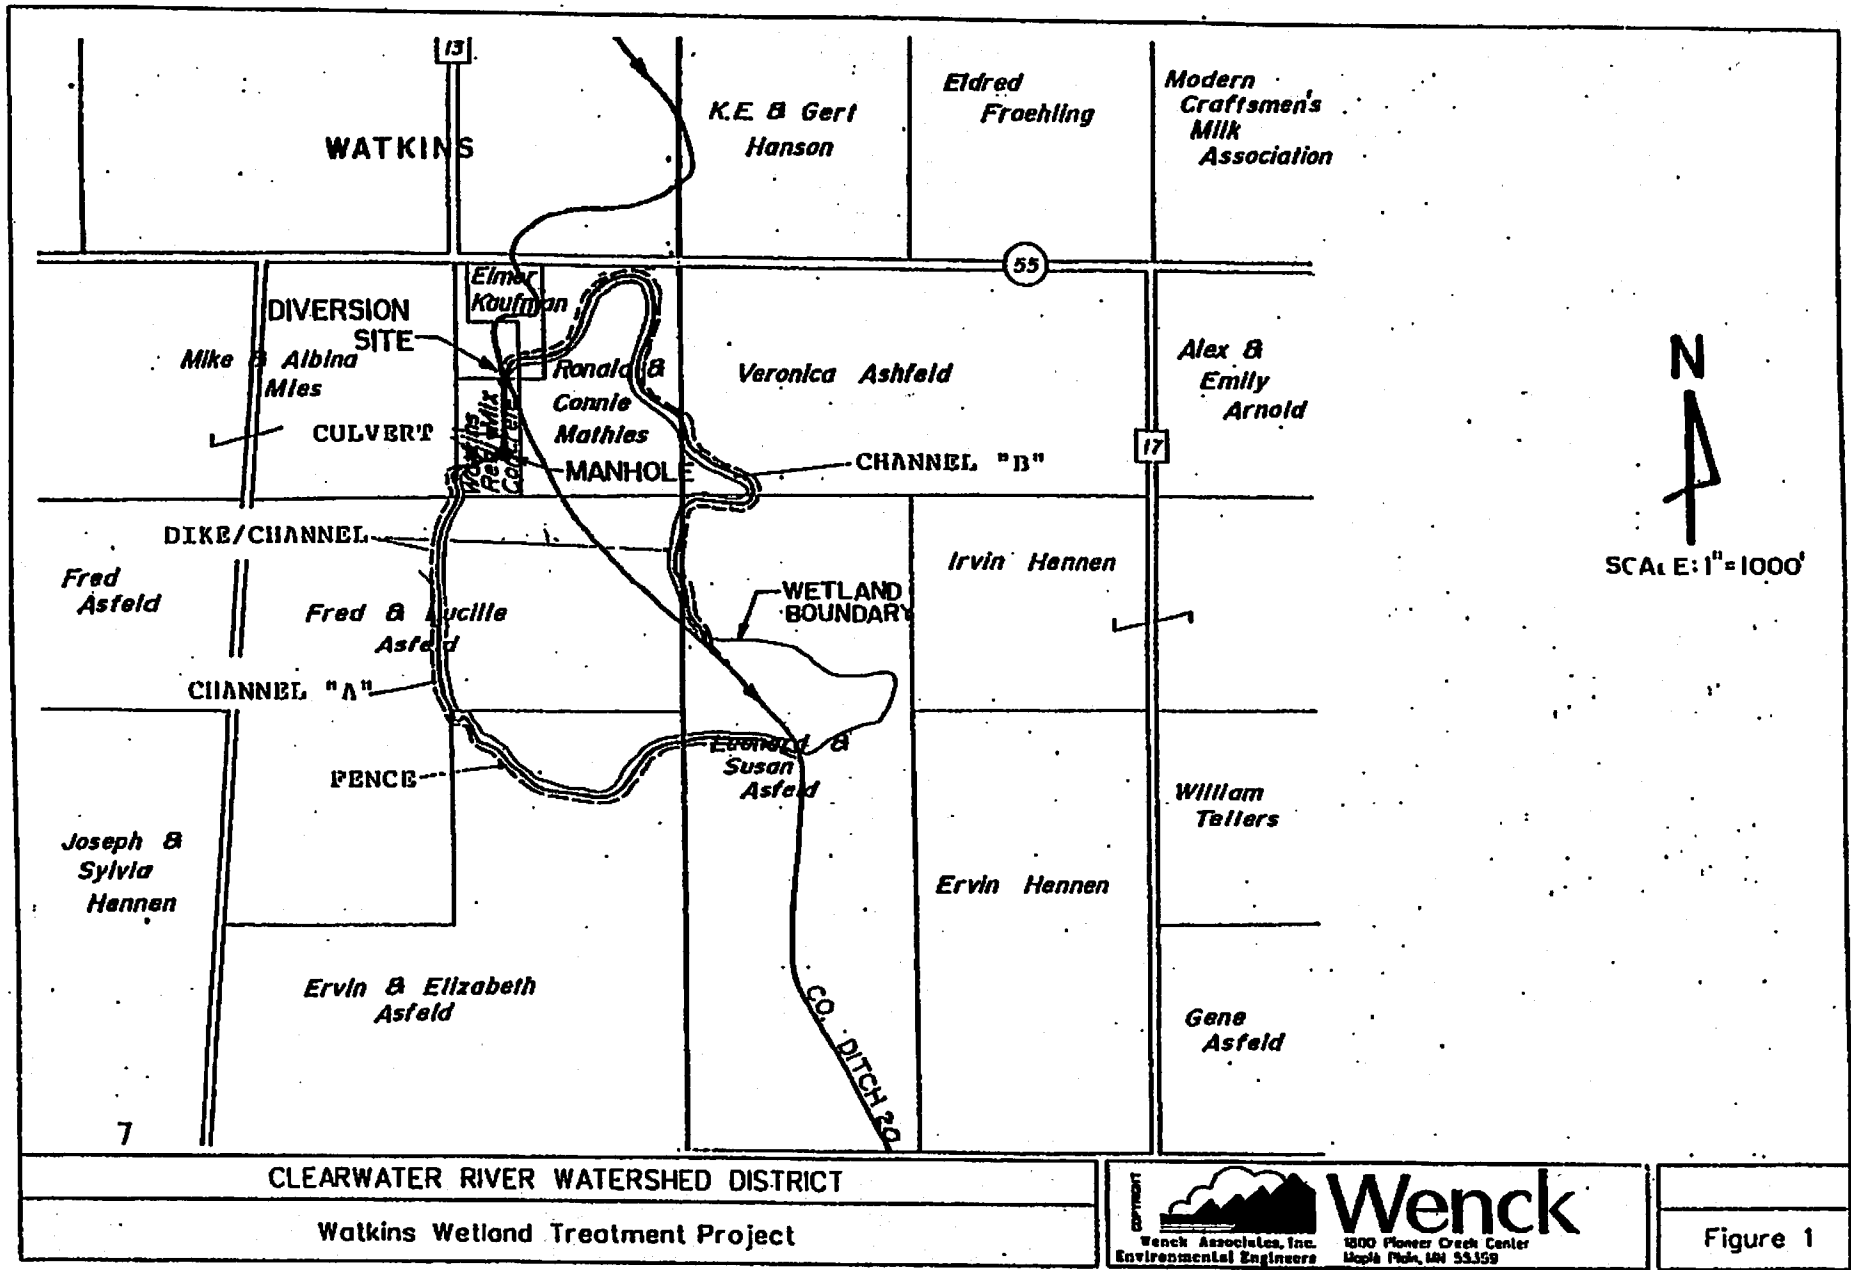
1. Excellent condition.			✓	
Watkins Wetland Treatment System (south) (See Figure 1 and Photos 3,4,5,6,7,8)				
1. Snag in need of removal.	✓			Kevin - 4 hrs

2. East side (Channel B) good condition.			✓	
3. Overflows vegetated.			✓	
4. Tile inlet and outlet in good condition.			✓	
5. Ports in good condition			✓	
Clear Lake (northeast) Wetland Outlet Structure (See Photo 9)

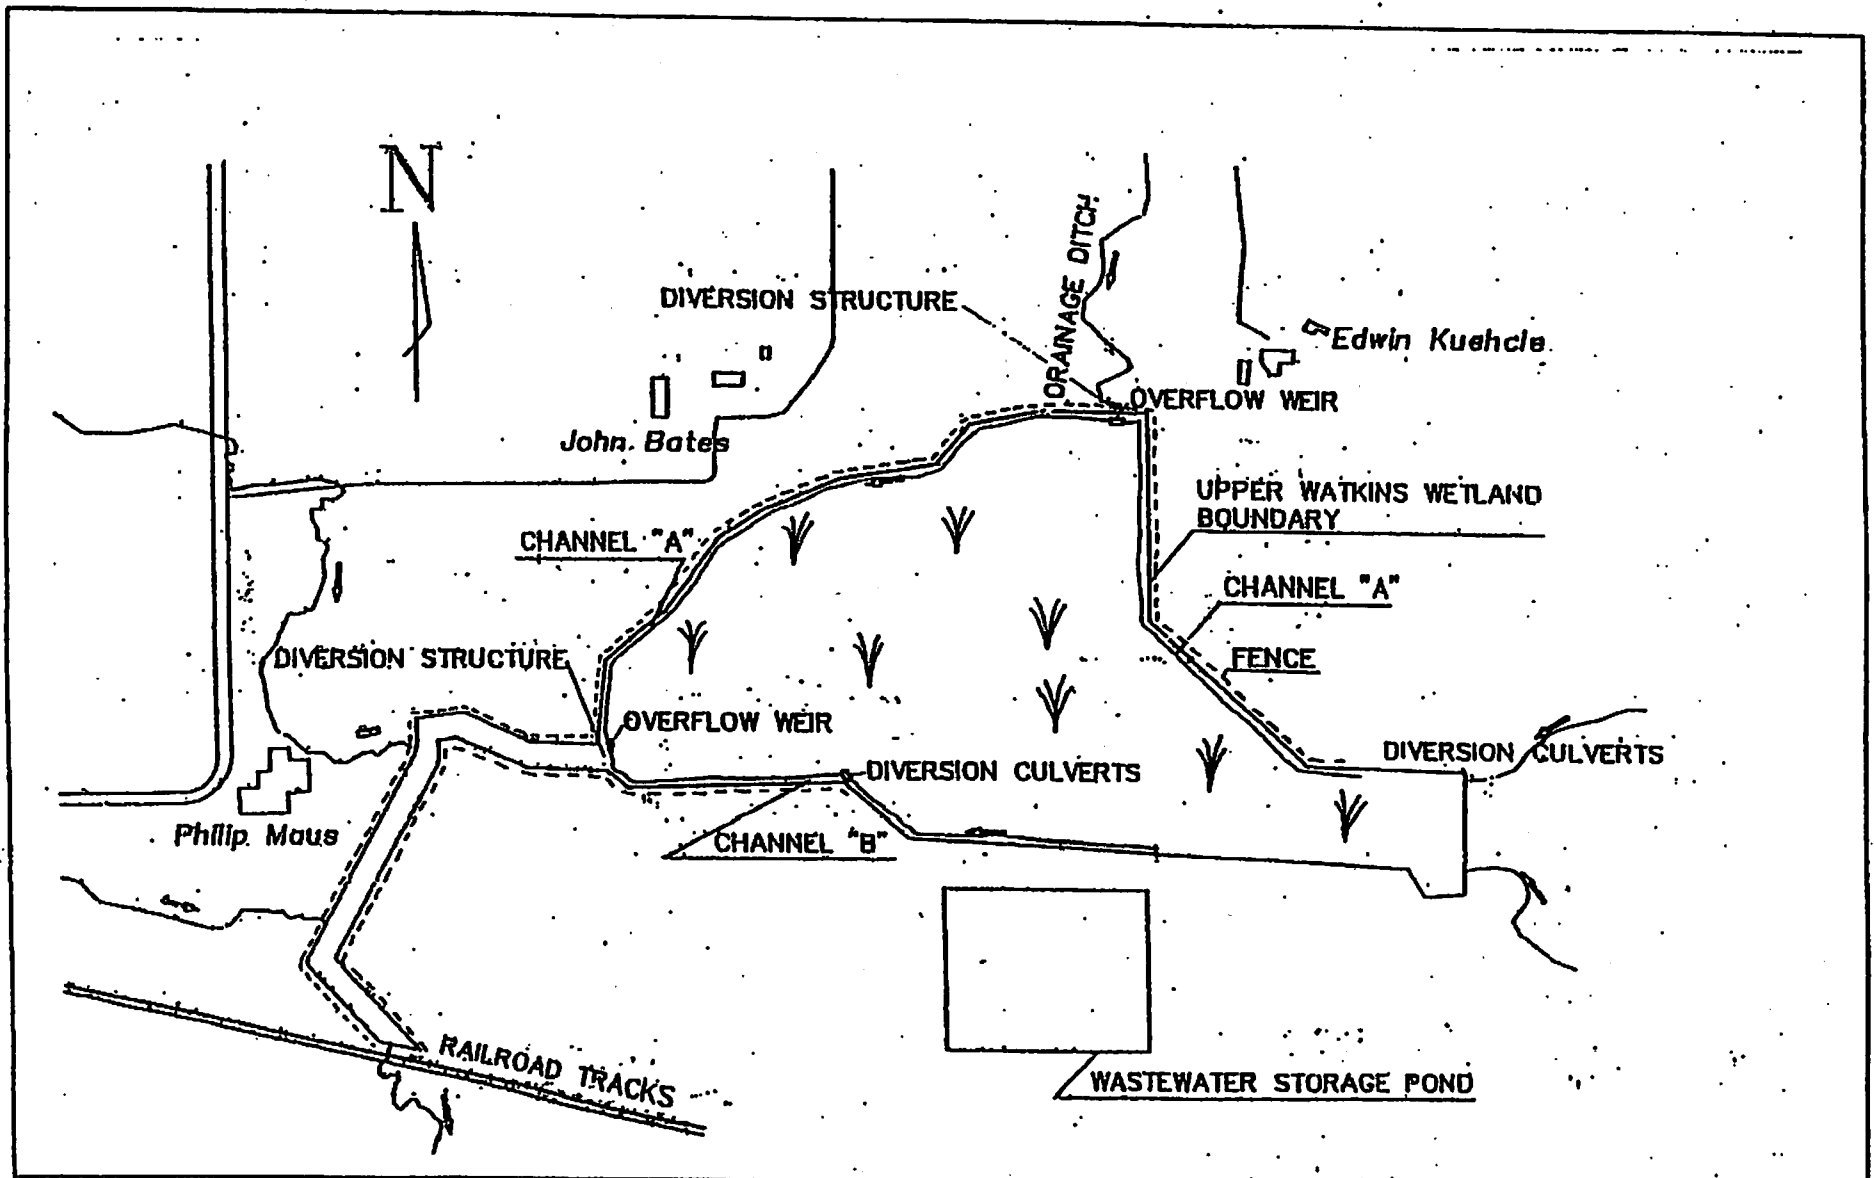
Project	Maintenance			Estimated Cost
	Required	Optional	No Action Now	
Upper Watkins Wetland Isolation Project (north) (See Figure 2 and Photos 1 and 2)

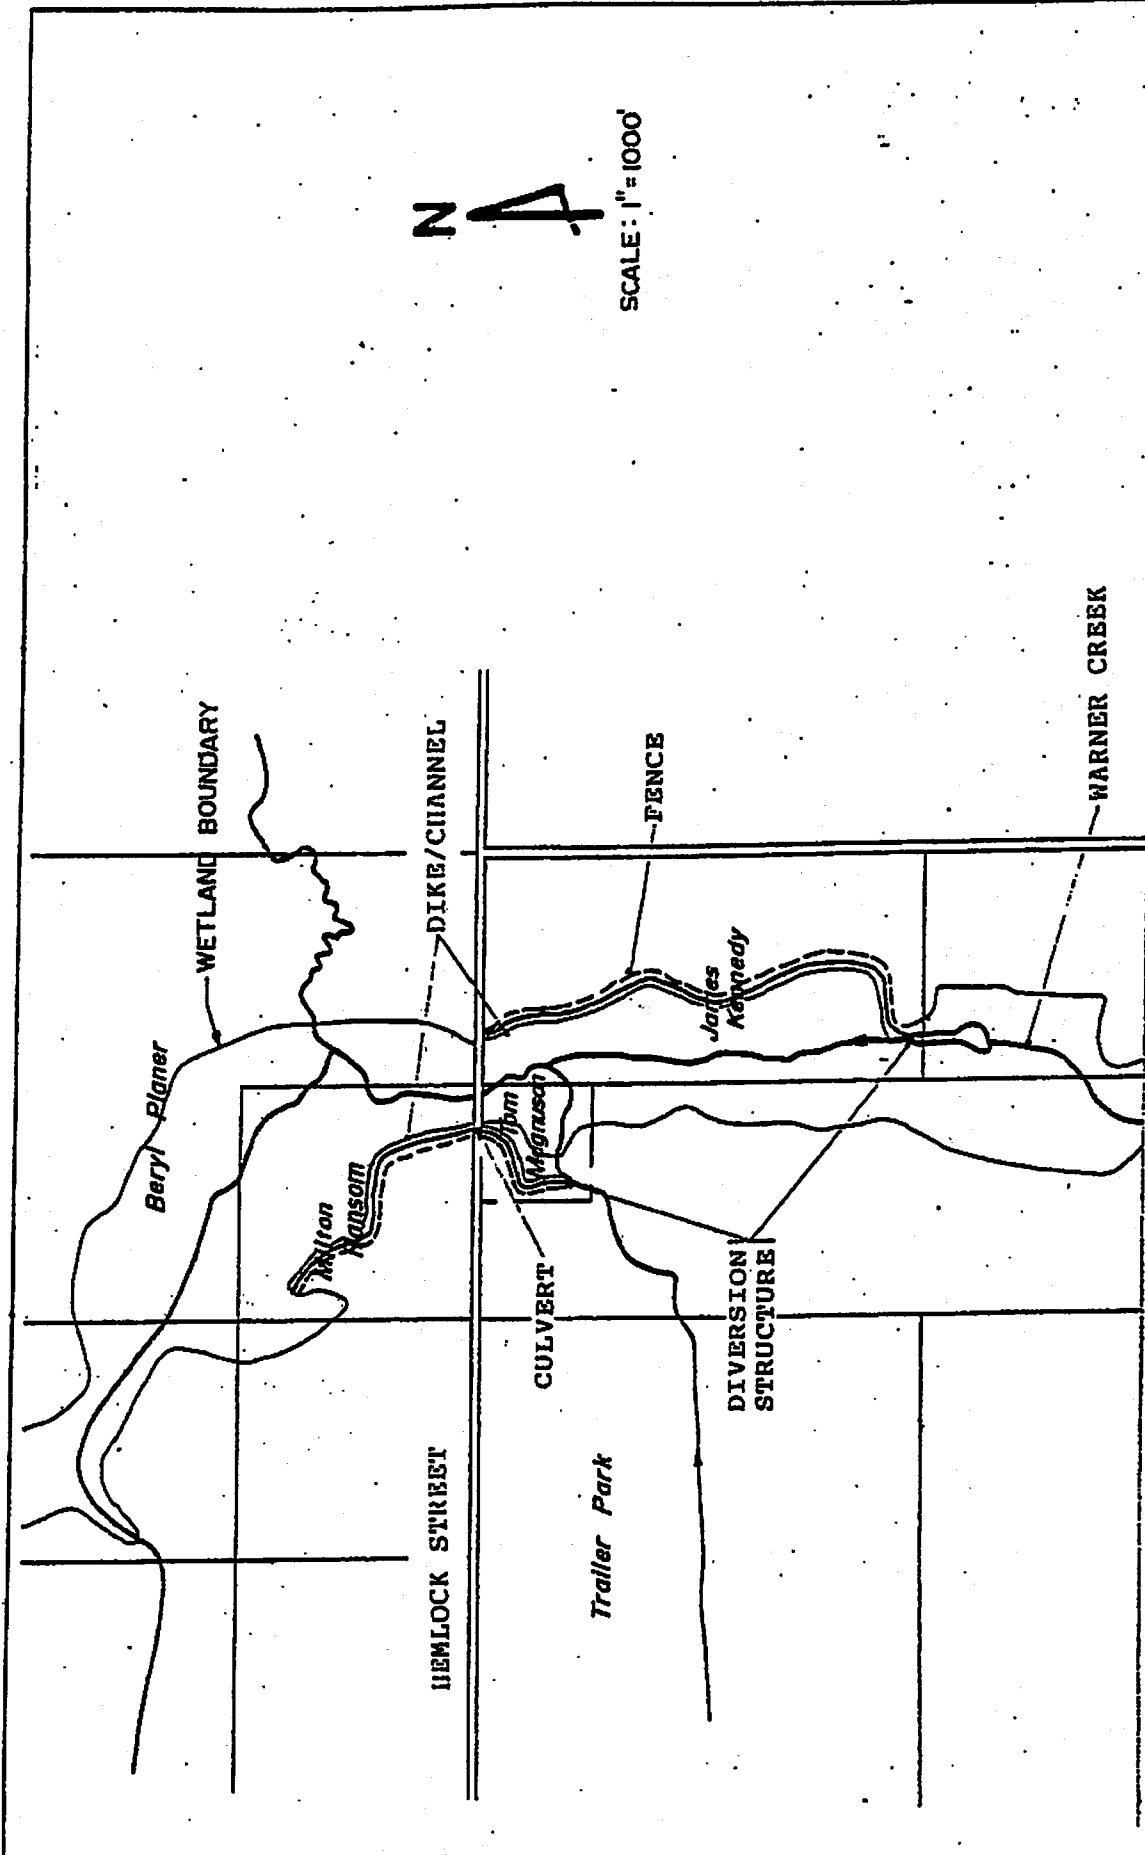
Figure 3

1. Vegetation needs to be removed from channel near diversion structure and two ports.	✓			Kevin - 16 hrs
2. Fence needs repair and tightening	✓			Kevin - 24 hrs

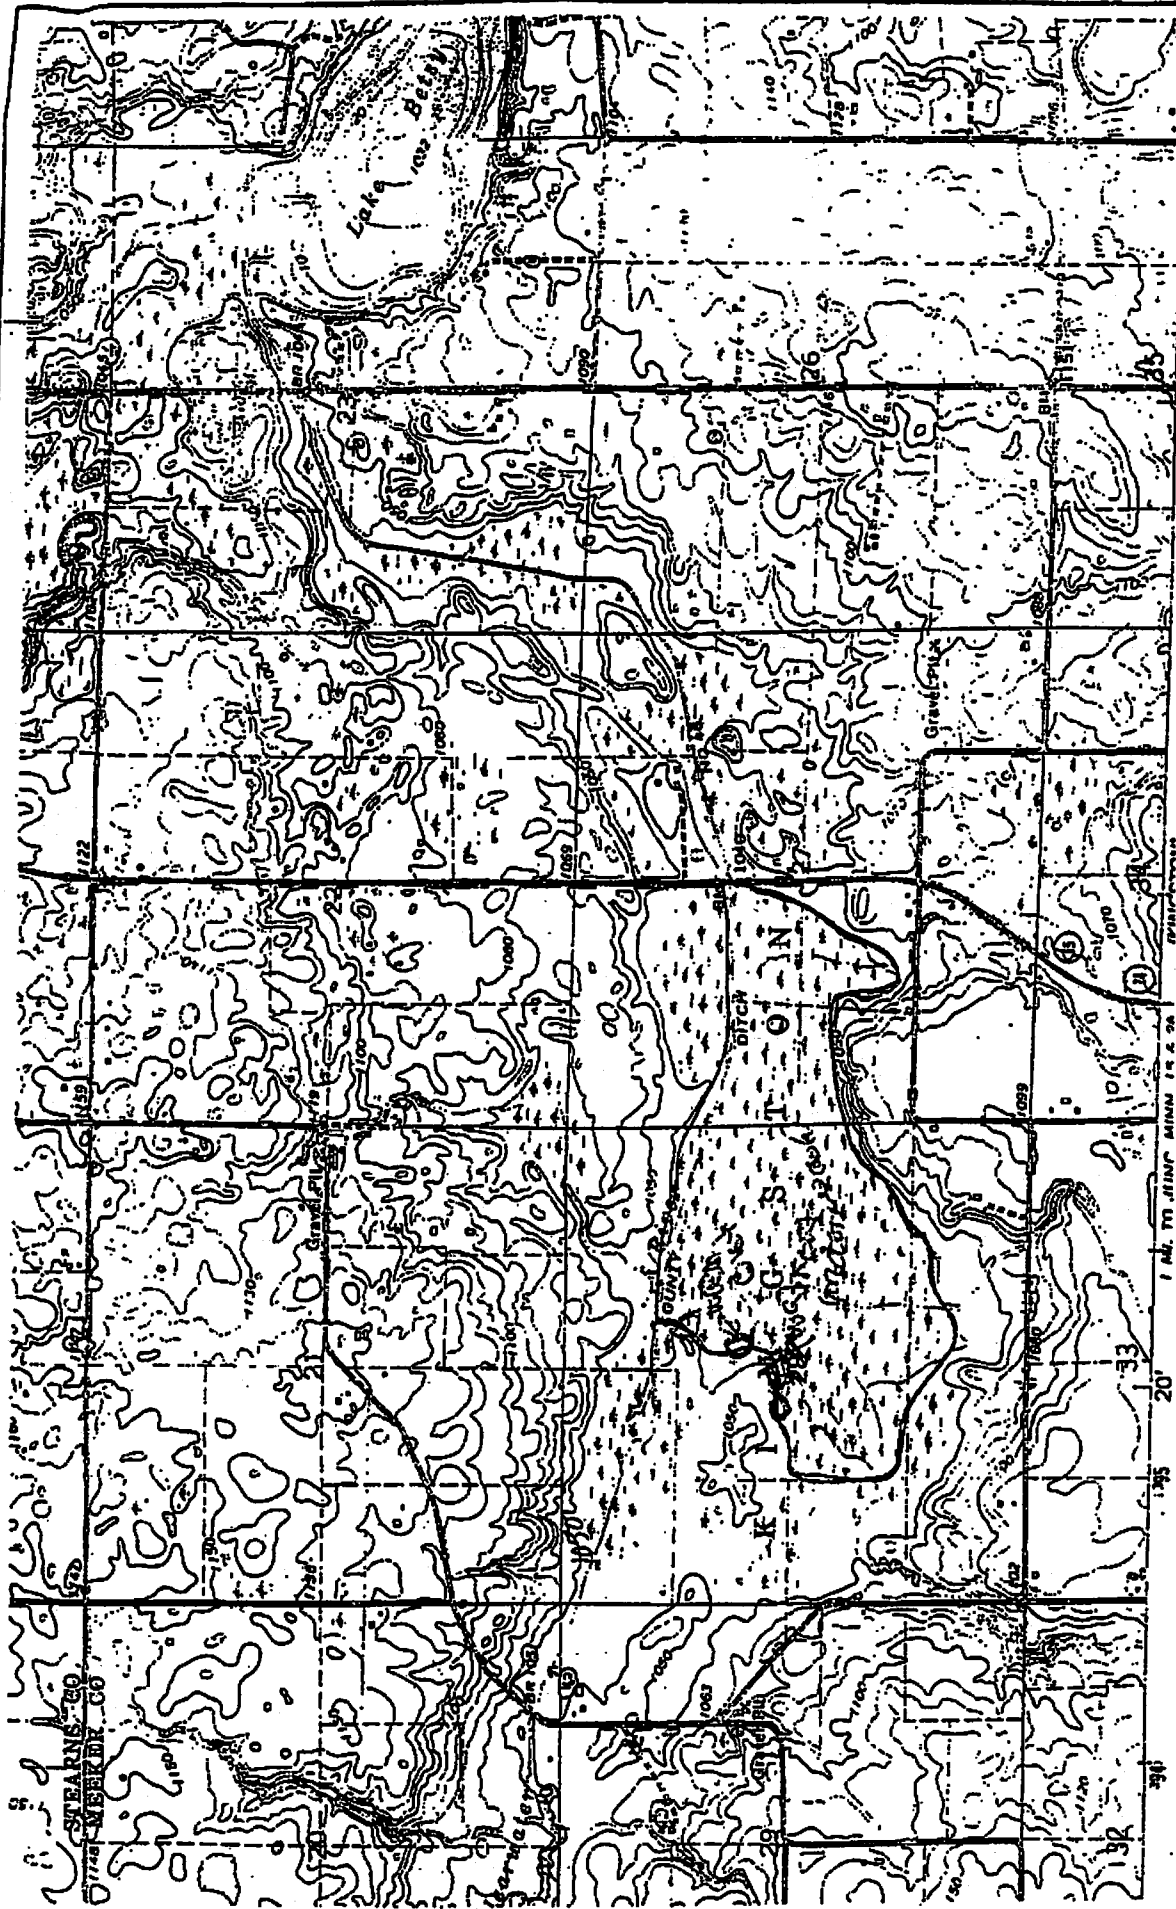
Figure 4

1. Remove sediment from channel in mouth of tributaries and other blockages from channel.	✓			\$4,000 Kevin – 16 hrs
2. Two washouts in berm.	✓			\$10,000

3. Ports in good condition.			✓	
School Section Lake Outlet Project (See Photo 14)				
1. Structures and culverts in good condition.			✓	
Carp Trap				
1. Needs coarse gravel in channel.	✓			\$1,000
Aerator Buildings (see Photos 15, 16)

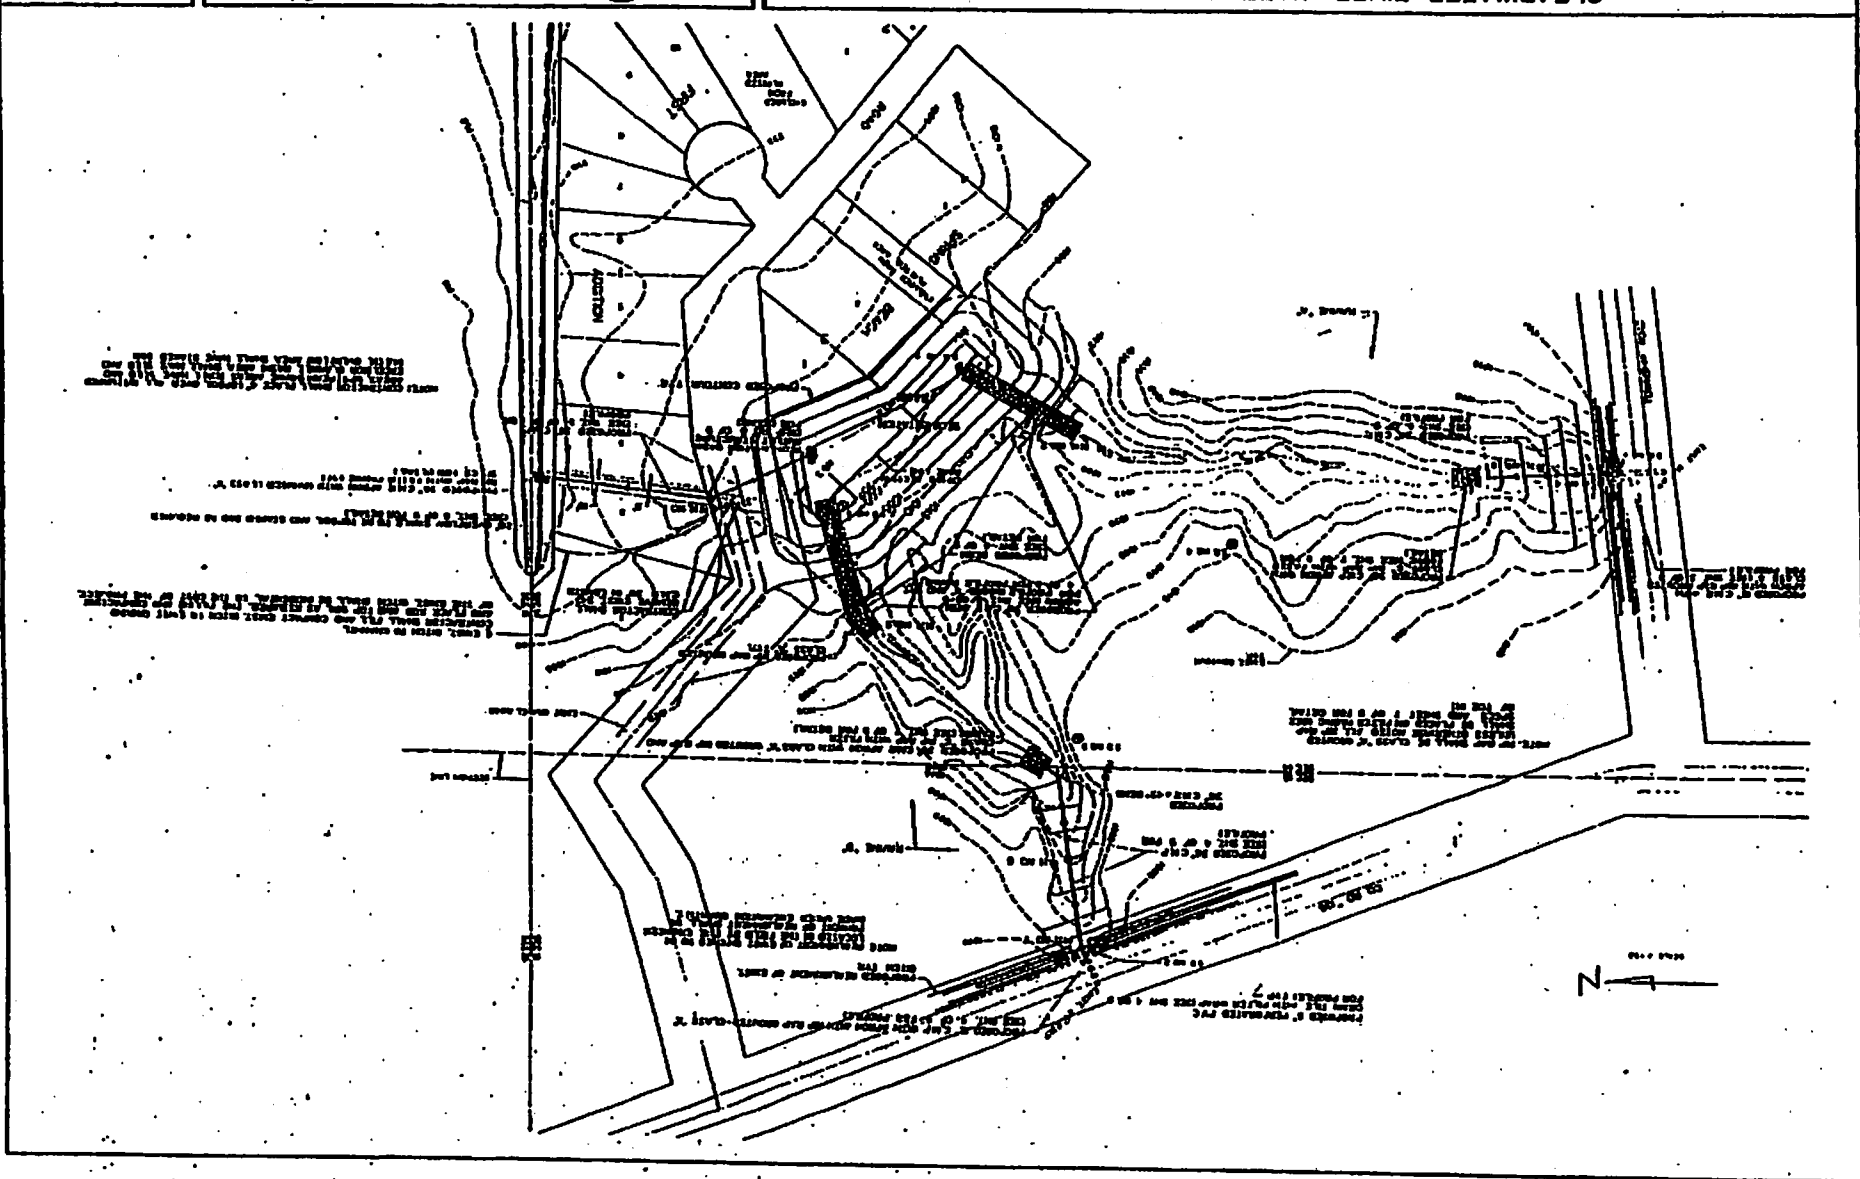
Project	Maintenance			Estimated Cost
	Required	Optional	No Action Now	
Lake Augusta Erosion Control Project (See Figure 5 and Photos 17, 18, 19)				
1. Outlet riser needs repairs and riprap.	✓			\$5,000
Lake Augusta Buffer

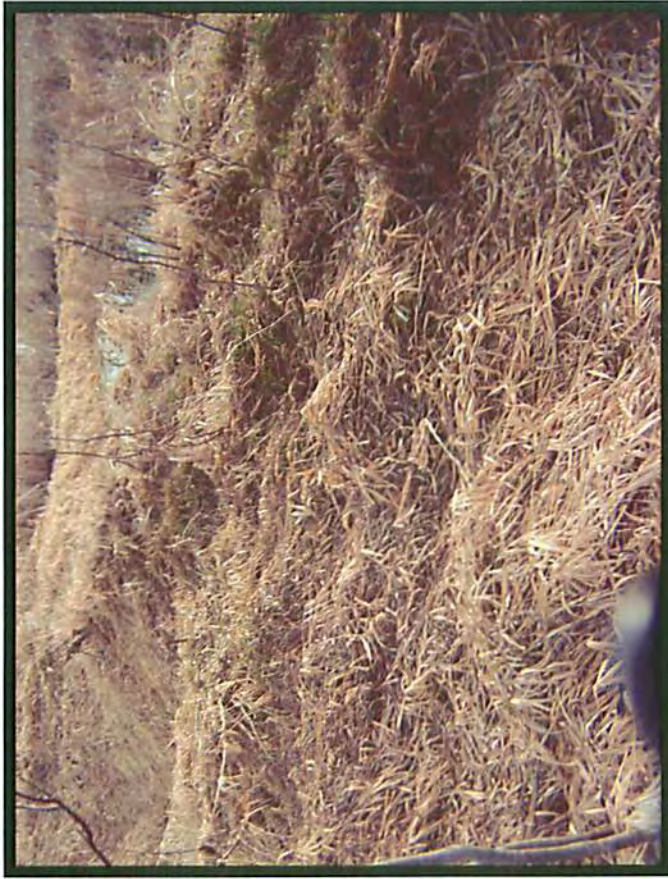
Photo 1

Upper Watkins Wetland (North)
Isolation Project

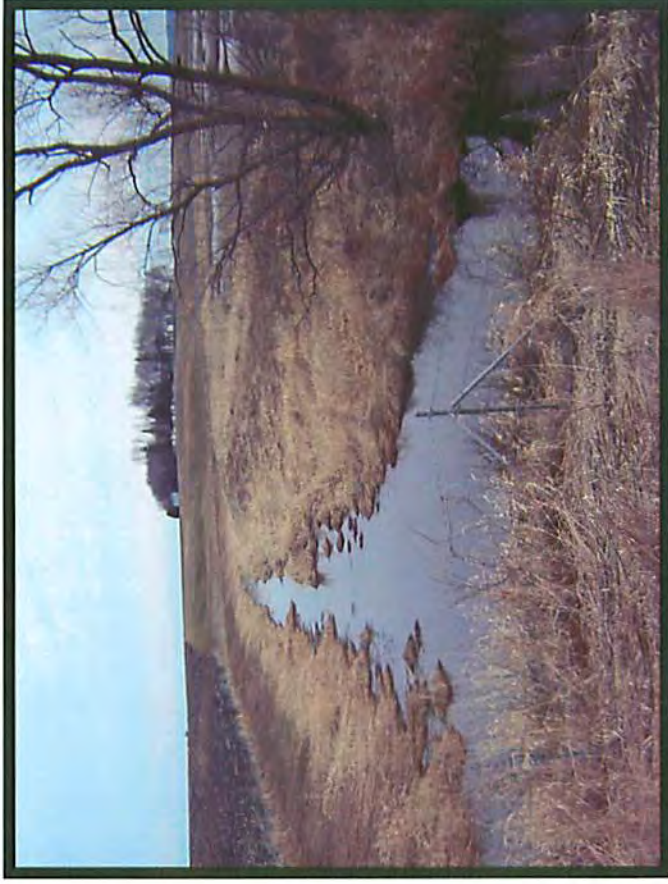
Photo 2

Upper Watkins Wetland (North)
Isolation Project

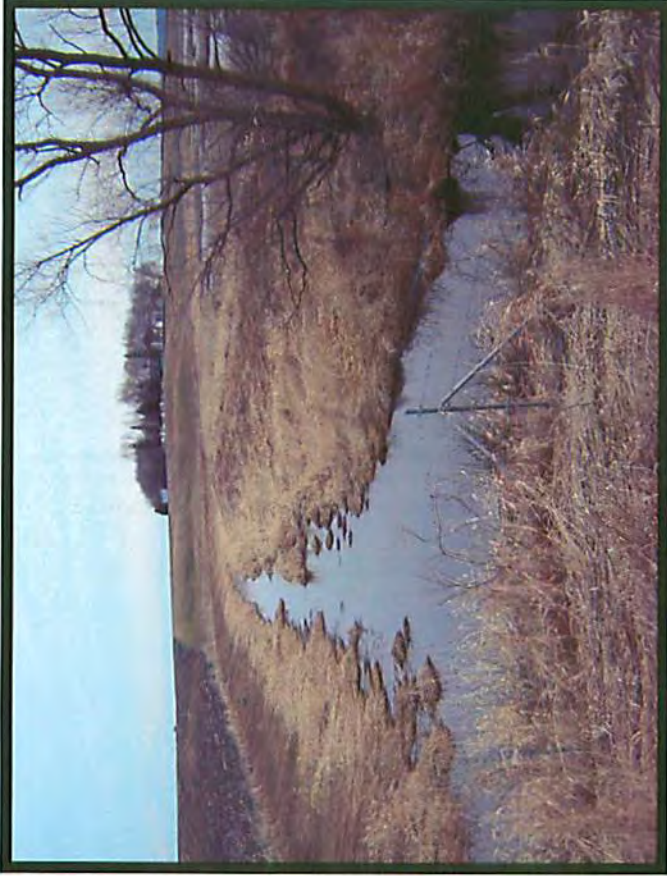
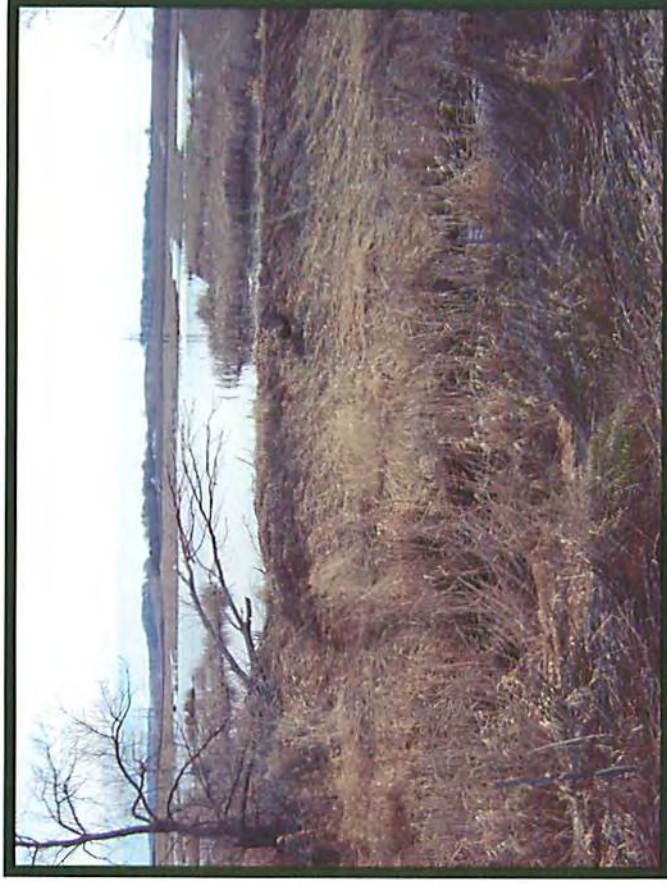
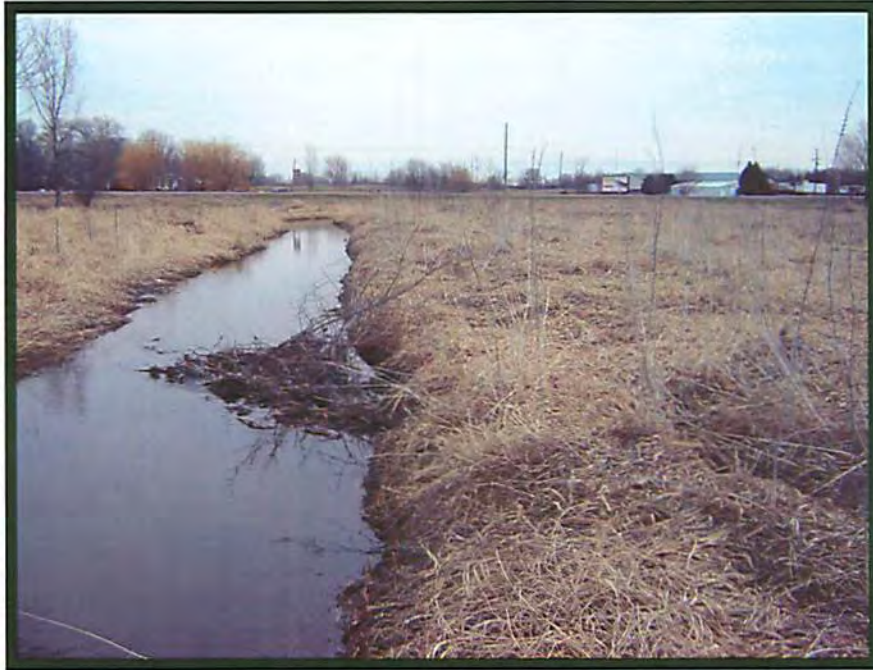
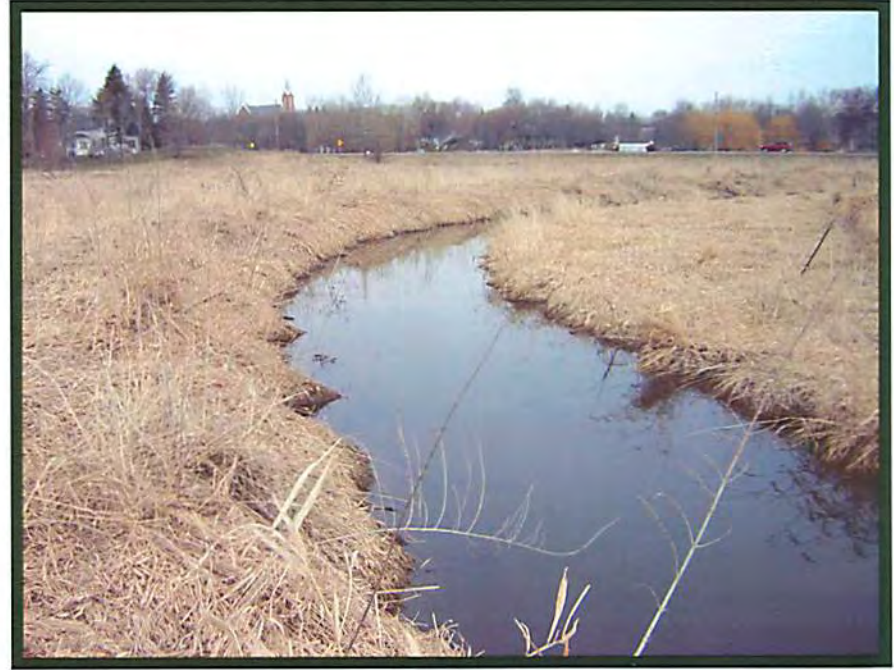
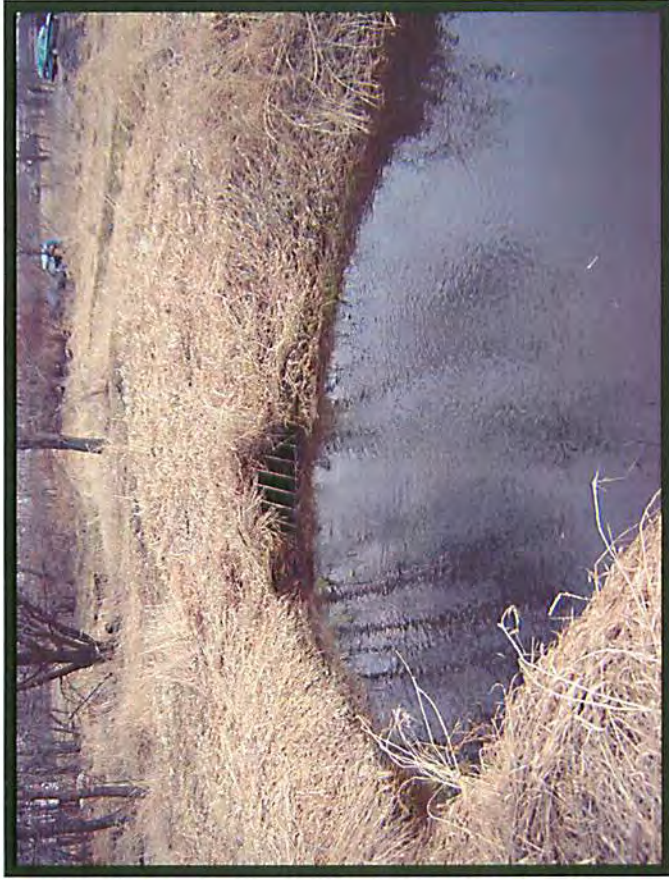
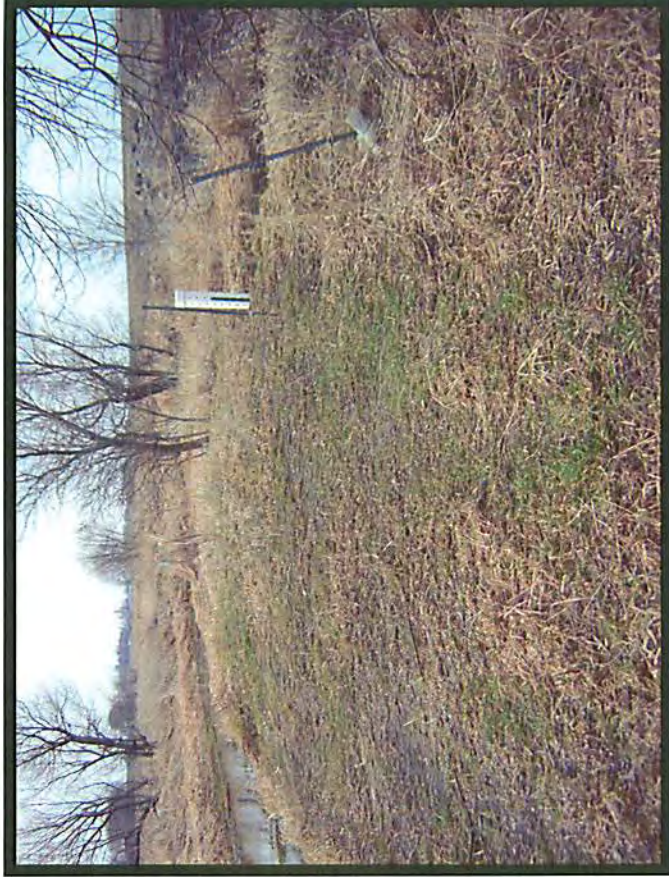
Photo 3
Watkins Wetland (South) Treatment
System

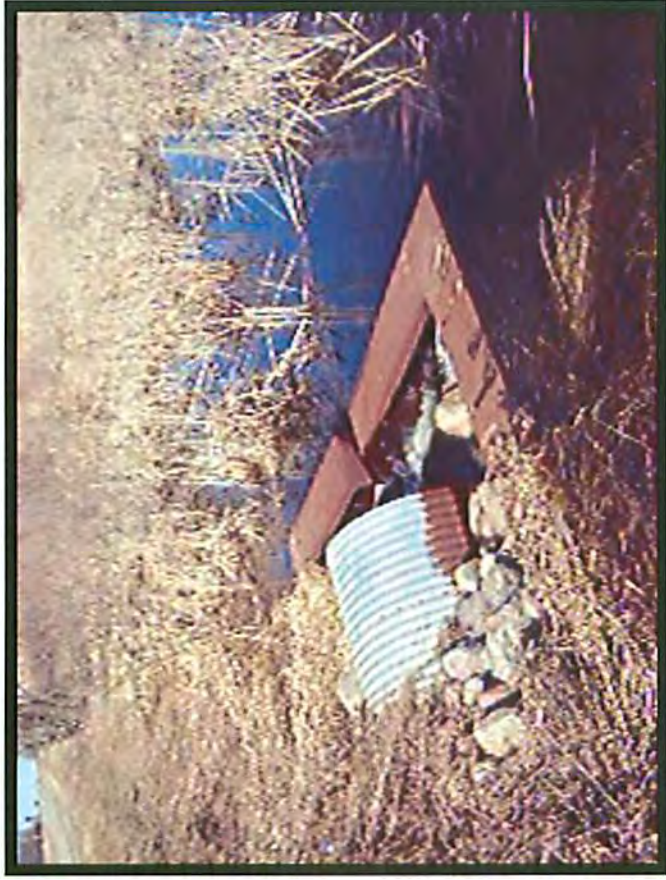
1. Outlet structure in good condition			✓	
Clear Lake Sedimentation Basin (south)				
1. Sedimentation basin in good condition.			✓	
Kingston Wetland Treatment System (See Figure 4 and Photos 10, 11, 12, 13)

Photo 9
Clear Lake (Northeast) Wetland Outlet
Structure

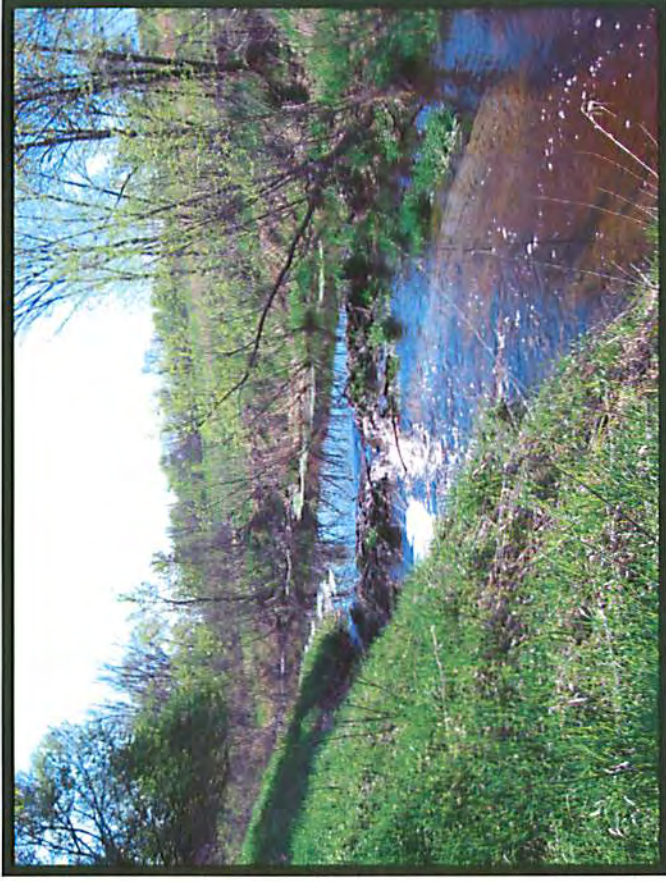
Photo 10
Kingston Wetland Treatment System
Channel Blockage (Beaver Dam)

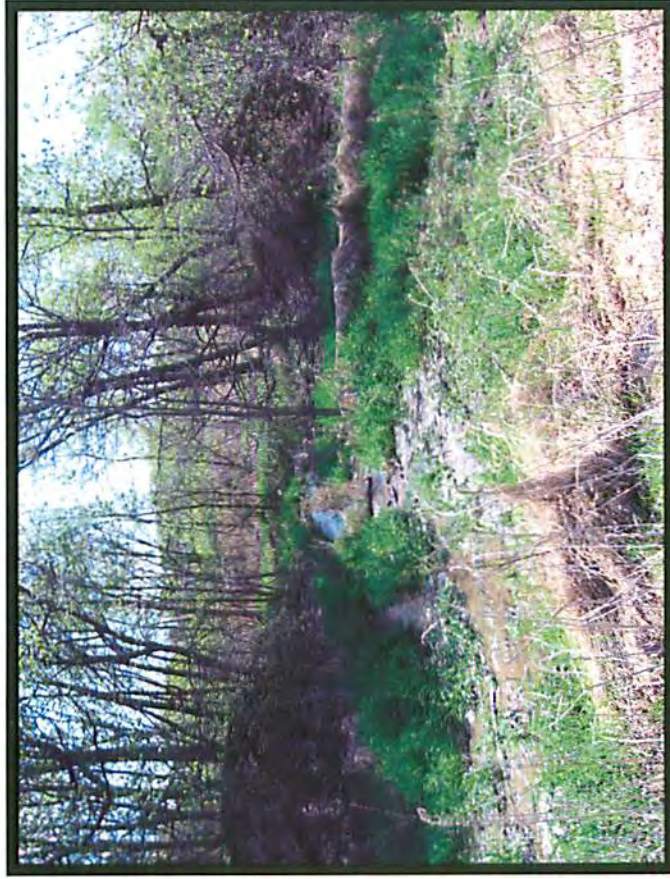
Photo 11
Kingston Wetland Treatment System –
Sediment delta

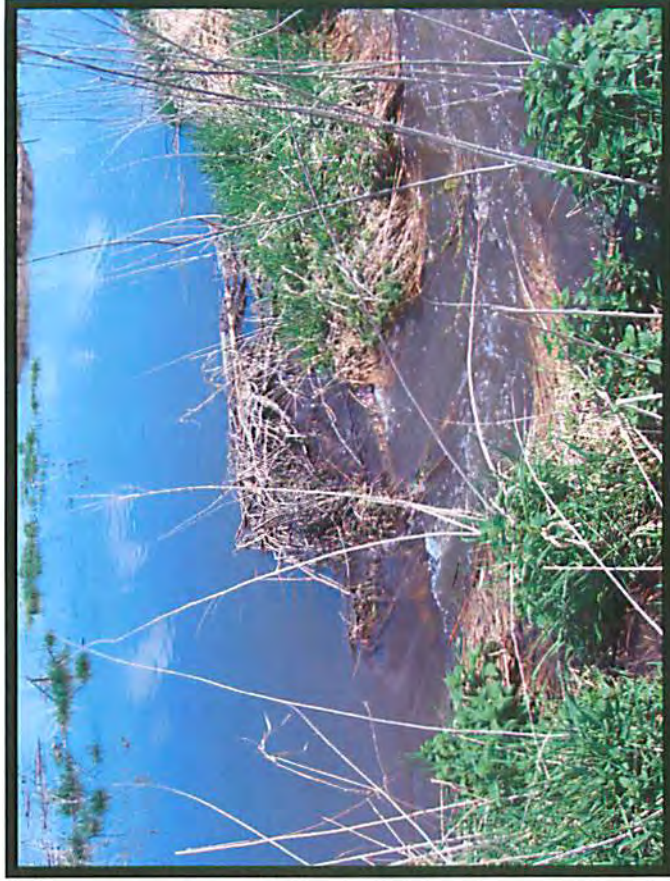
Photo 12
Kingston Wetland Treatment System –
Berm washout

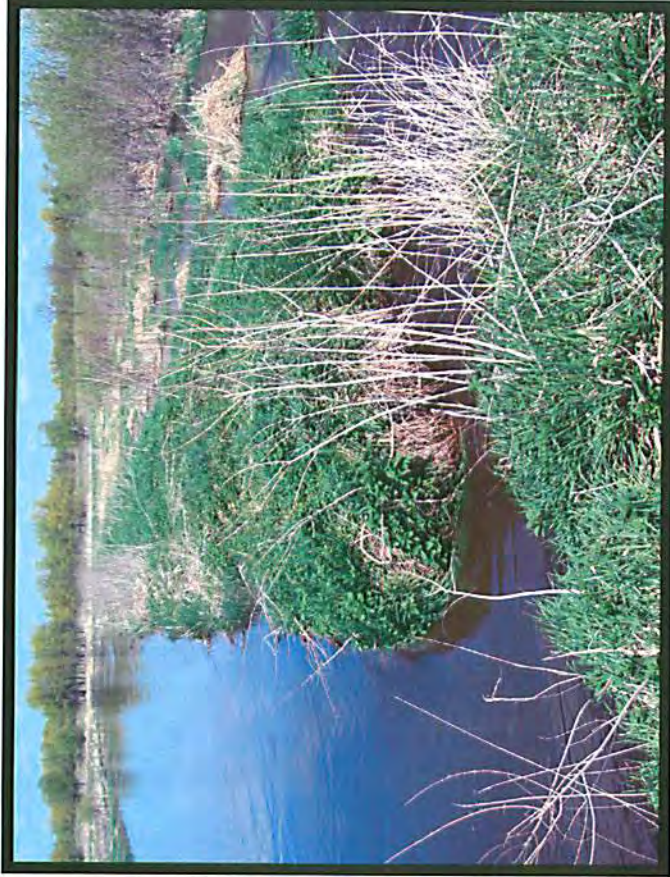
Photo 13

Kingston Wetland Treatment System –
Berm washout

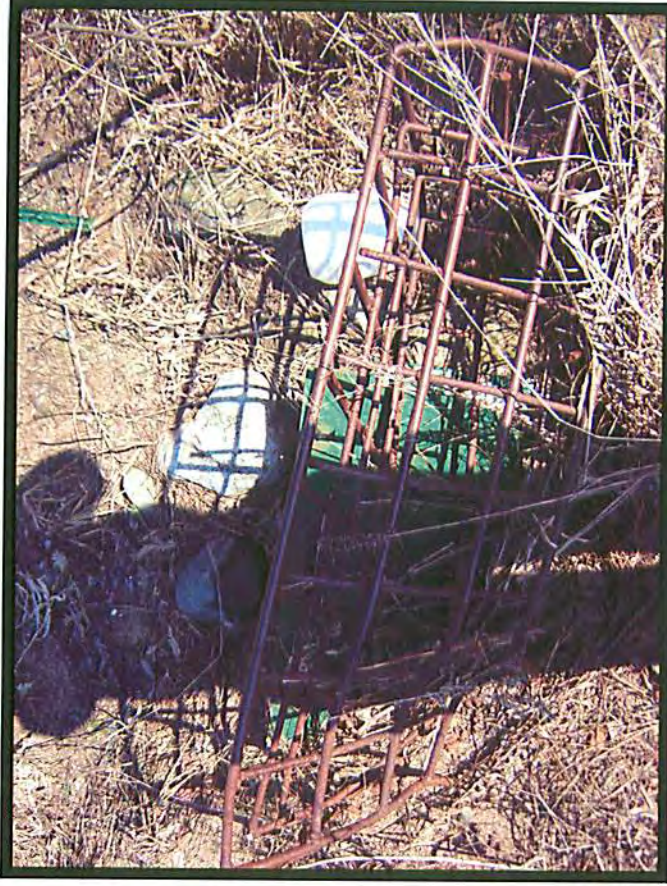
Photo 14

School Section Lake Outlet Structures

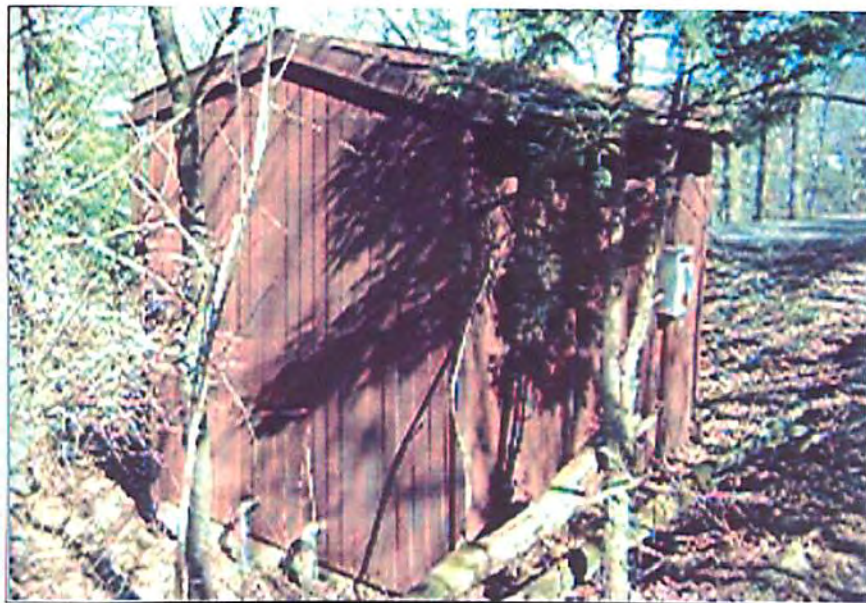
Photo 15

1. Lake Augusta – Good condition, no maintenance needed.			✓	
2. Lake Marie – Good condition, no maintenance needed			✓

Lake Augusta Aeration
Building

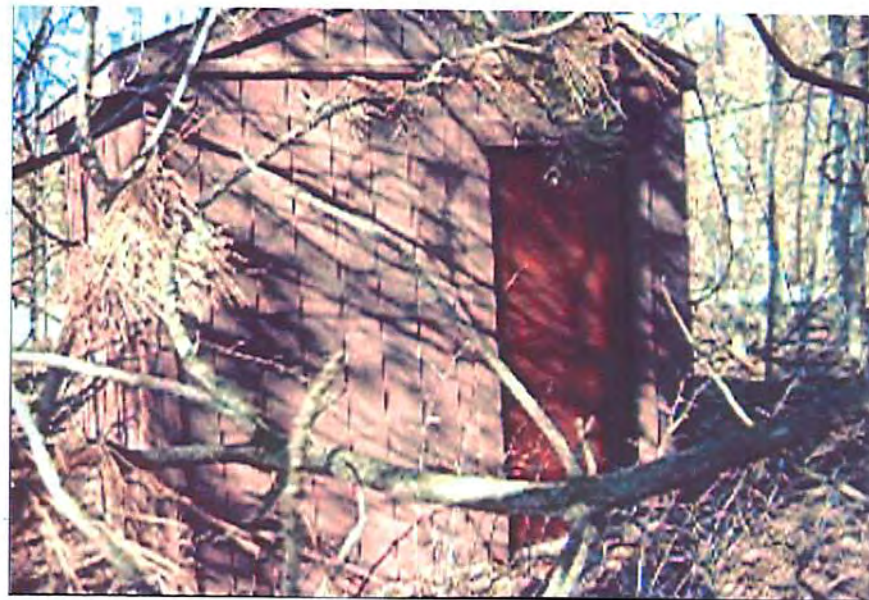
Photo 16

Lake Marie Aeration Building

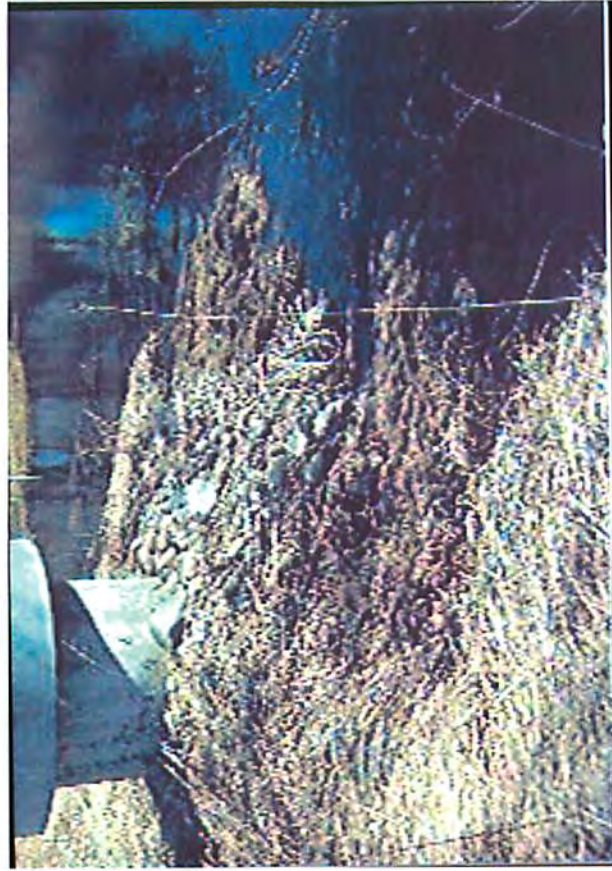
Photo 17
Lake Augusta Erosion Control Project
- Outlet Structure

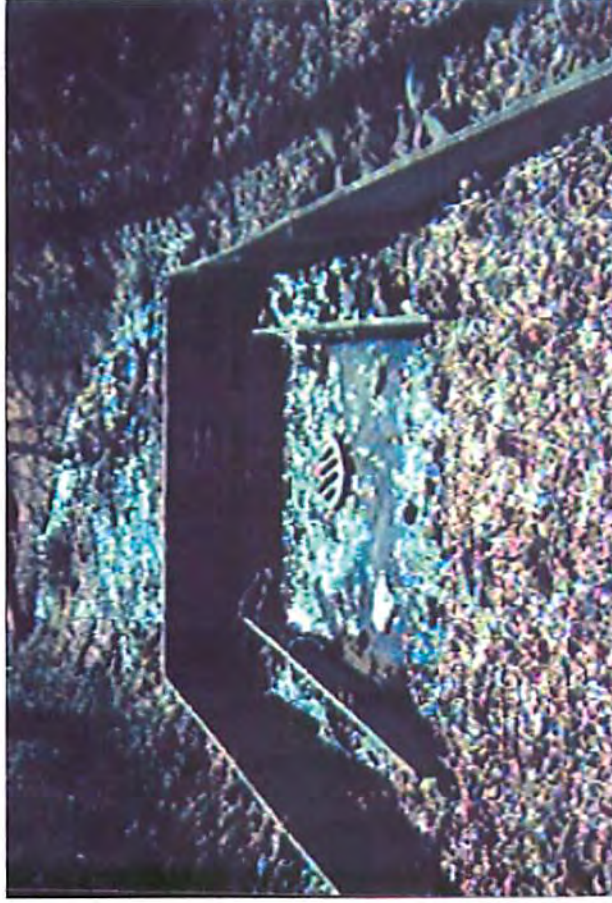
Photo 18
Lake Augusta Erosion Control Project
- Inlet Baffles

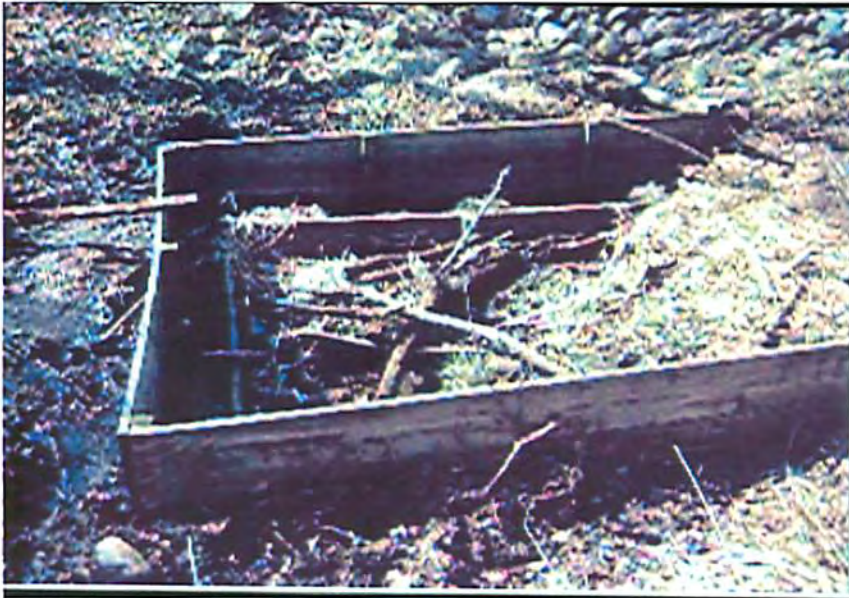
Photo 19
Lake Augusta Erosion Control Project
- Inlet Baffles

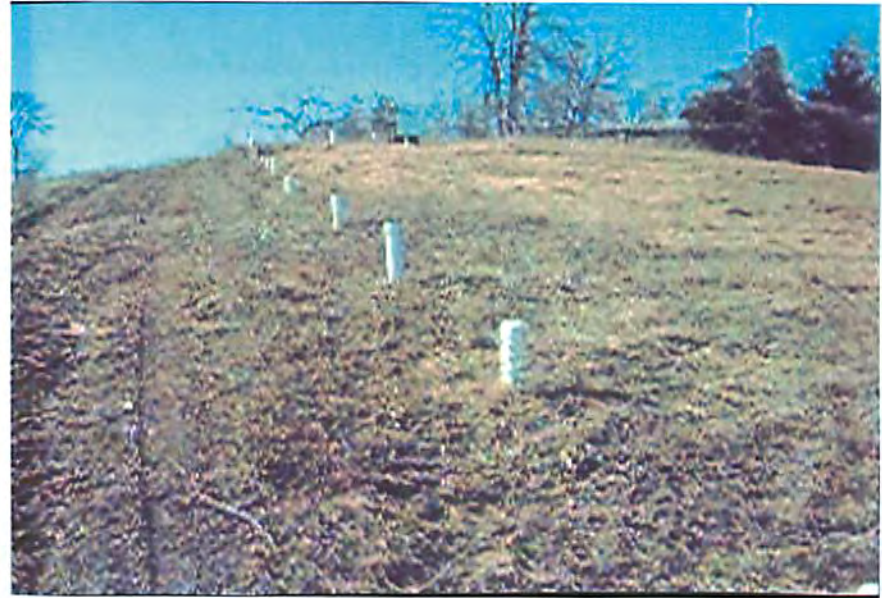
1. Buffer in good condition.			✓	
Rest-a-While Sewer System (See Photo 20)				
1. System in good condition.			✓	
Hidden River Sewage Treatment System				
1. Expose manholes.	✓			By Homeowners
Clearwater Harbor Sewer System (See Photos 21, 22)

Photo 20
Rest-a-While Drainfield
