2006 Project Inspection Report

Prepared for
**Clearwater River
Watershed
District**

April 2006

Re: 2006 Project Inspection Report
Wenck File # 0002-84

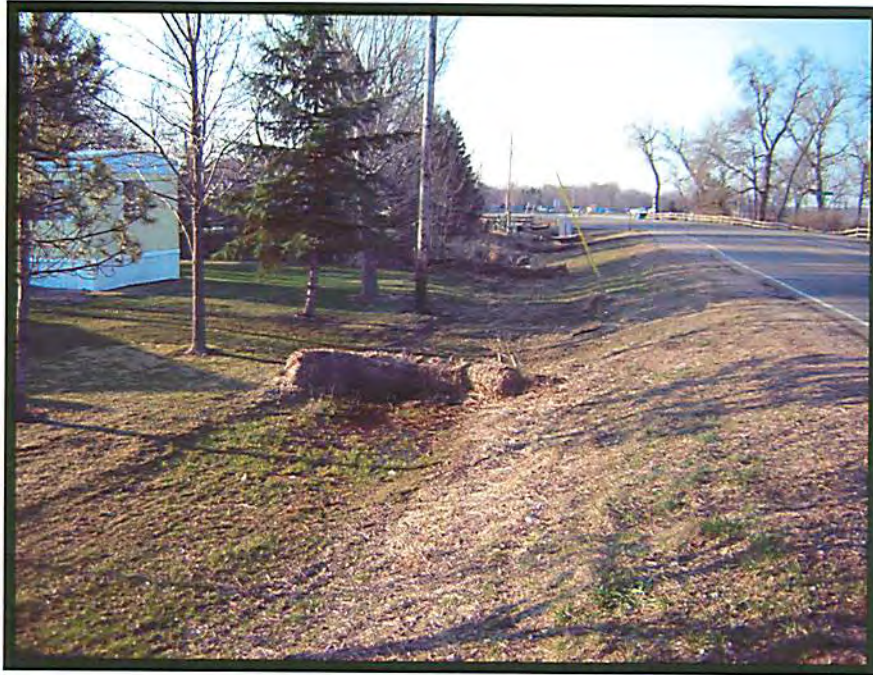
Photo 21
Clearwater Harbor Wastewater
Collection and Treatment System
(Remove check dam)

1. Remove bale checks.	✓			Kevin - 4 hrs
2. Remove silt fence.	✓			Kevin - 4 hrs
3. Summer weed control.	✓			Kevin - 10 hrs
4. Drain field and sand filter in good condition.			✓	
Clearwater Harbor Sewer System - 14416 Beaverwood Rd (See Photo 23)

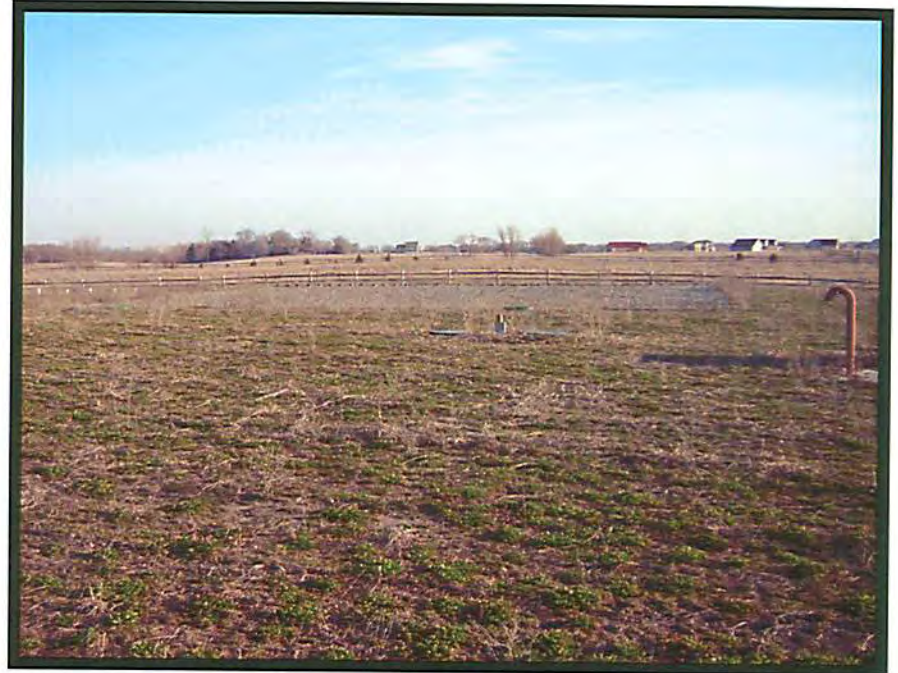
Photo 22
Clearwater Harbor Wastewater
Collection and Treatment System
(Drainfield)

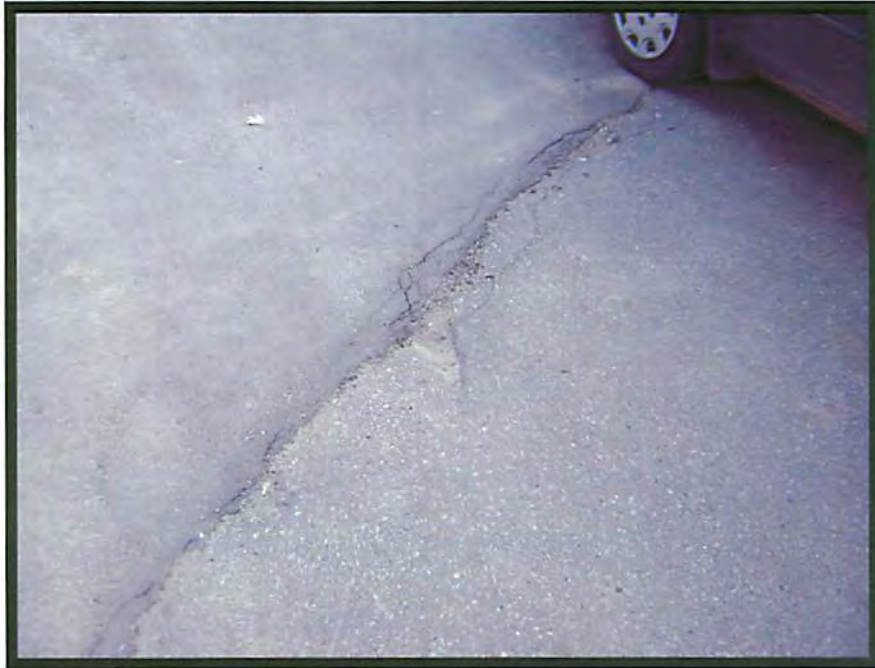
Photo 23
Clearwater Harbor Wastewater
Collection and Treatment System
(Blacktop Seam)

1. Replace soil.	✓			\$5,000
2. Seed and erosion blanket or sod.	✓			
3. Repair seam in blacktop.	✓			
Clearwater Harbor Sewer System-Staging Area (See Photo 24)

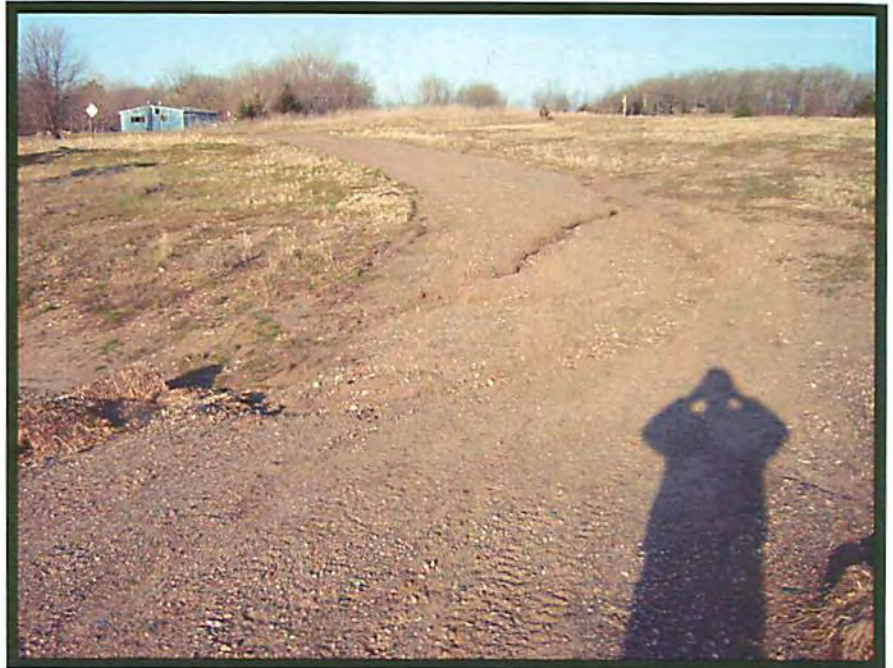
Photo 24
Clearwater Harbor Wastewater
Collection and Treatment System
(Erosion Repair)

1. Trail and driveway	✓			
Pleasant Lake Outlet Project (See Photo 25)				
1. Manhole lock needs repair	✓			Kevin - 2 hrs
Annandale Wetland Treatment System (See Figure 3 and Photos 26, 27)

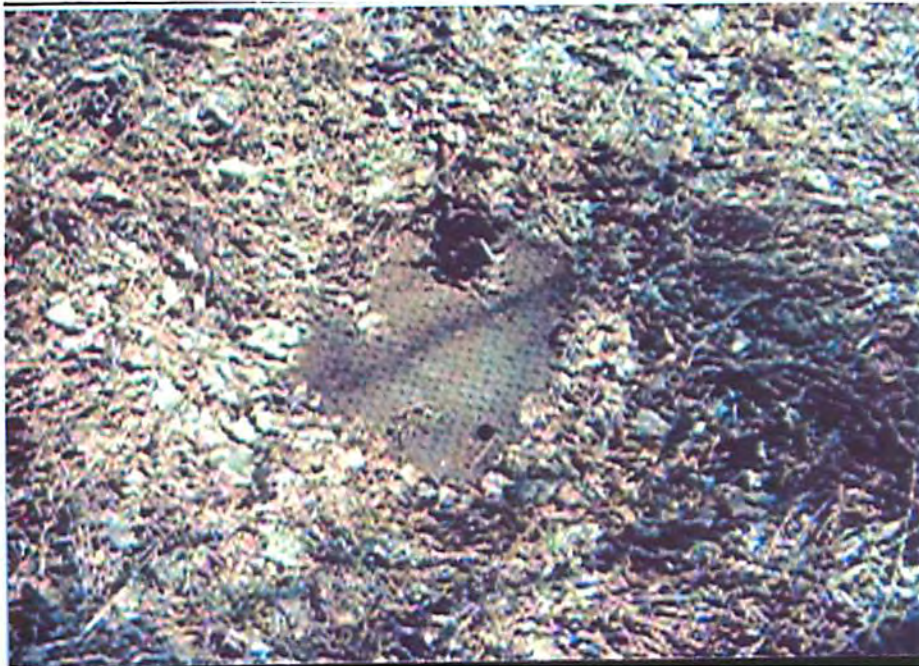
Photo 25
Pleasant Lake Outlet Manhole

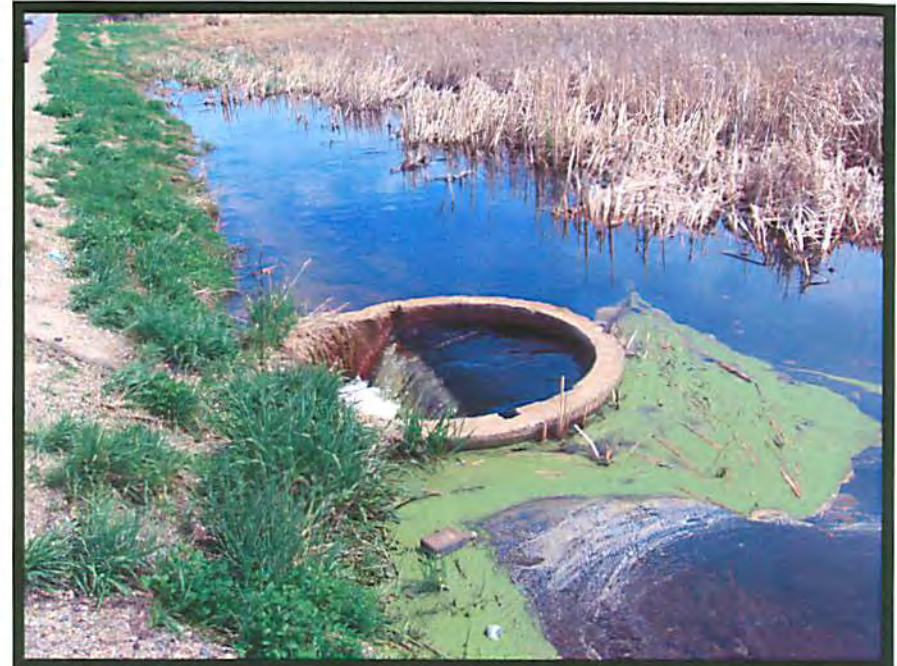
Photo 26
Annandale Wetland Treatment System
Outlet Structure

1. Vegetation needs to be removed from channel near diversion structure and two ports.	✓			Kevin - 16 hrs
2. Fence needs repair and tightening	✓			Kevin - 24 hrs

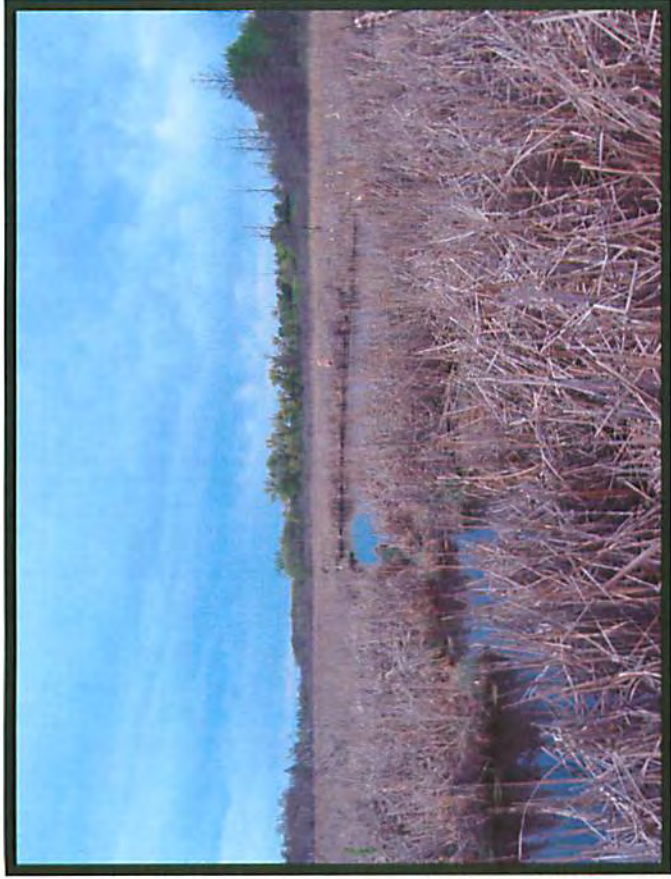
Photo 27
Annandale Wetland Treatment System
– Clogged channel
