2002 Project Inspection Report

Prepared for
**Clearwater River
Watershed
District**

June 2002

Table 1
Clearwater River Watershed District
Annual Project Inspection
May 2002

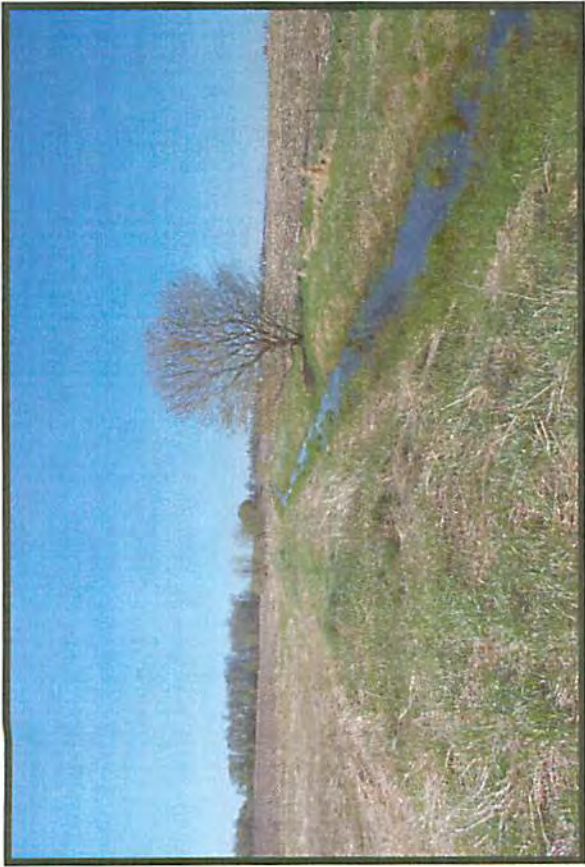
Photograph 1: Watkins Wetland - West Side (Channel A)

Project	Maintenance			Estimated Cost
	Required	Optional	No Action Now	
Watkins Wetland Treatment System (south) (see Figure 1 and photos 1 and 2).				
1. West side (Channel A) flowing normal, channel ports open.			✓

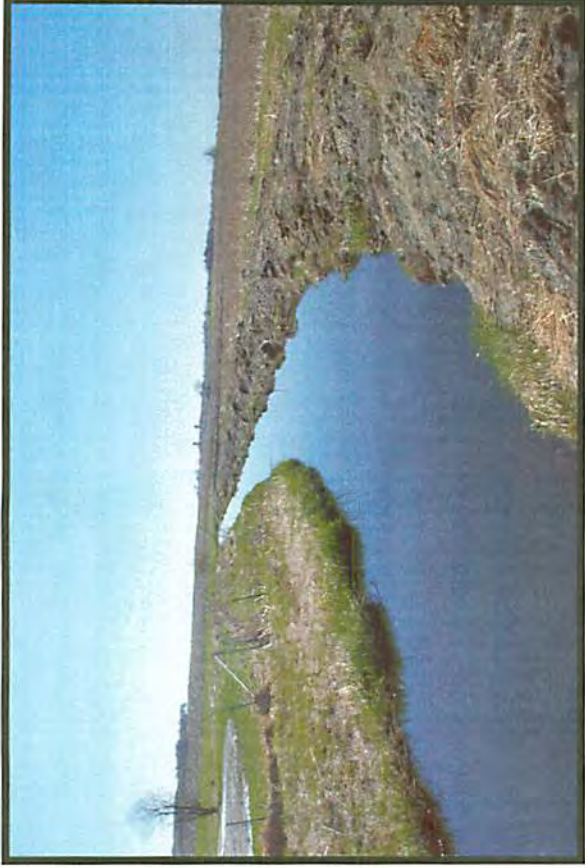
Photograph 2: Watkins Wetland - East Side (Channel B) (maintained in 2001)

2. East side (Channel B) flowing normal, channel ports open.			✓	
3. Fence needs repair and tightening along east side.	✓			Kevin 8 hrs.
Upper Watkins Wetland Isolation Project (north) (see Figure 2 and photos 3 and 4).

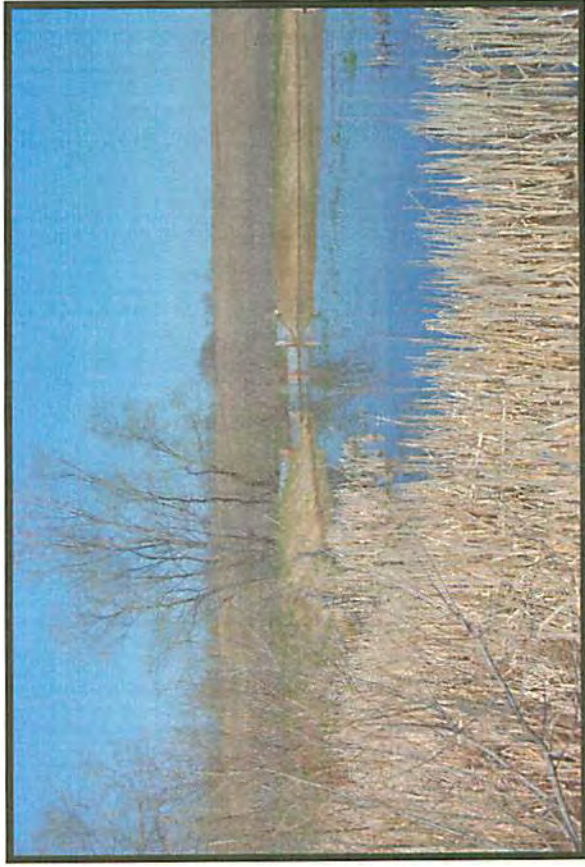
Photograph 3: Upper Watkins Wetland - West Overflow Structure

1. Ditches and overflow structures in good condition.			✓	
2. Field erosion along north ditch (David Bates property). Have owner consider a buffer strip.		✓		Merle 4 hrs.

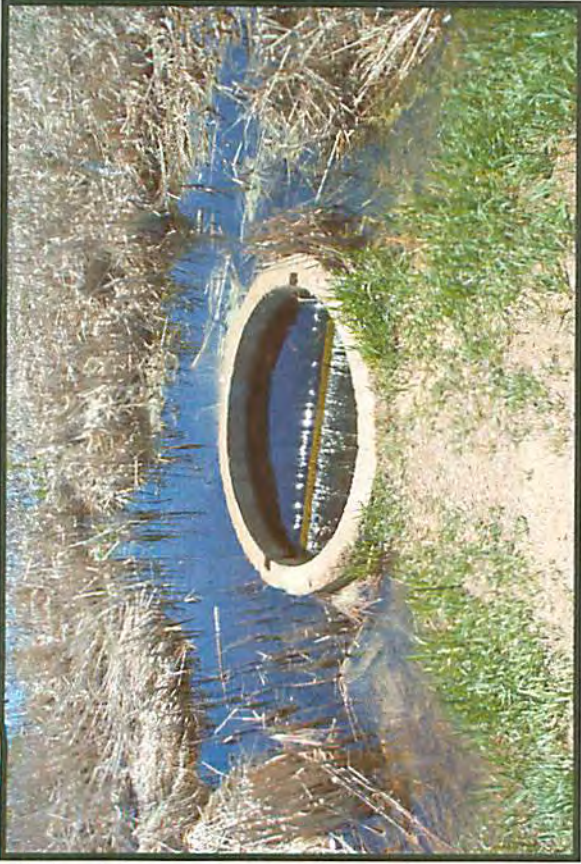
Photograph 5: Annandale Wetland – Outlet Structure

3. Fence needs repair and tightening.	✓			Kevin 8 hrs.
Annandale Wetland Treatment System (see Figure 3 and photos 5, 6, and 7).				
1. Ditch and overflow structure in good condition.			✓

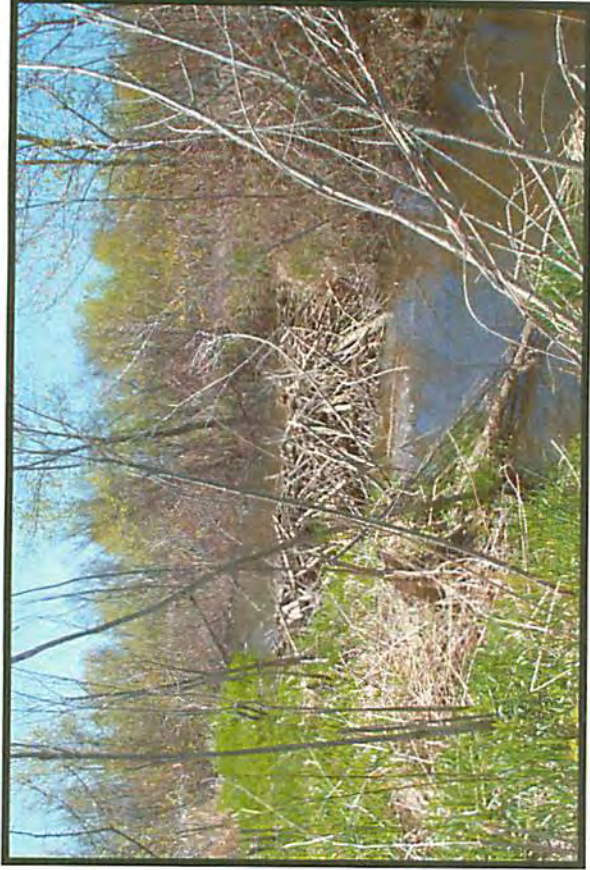
Photograph 6: Annandale Wetland – Beaver Dam in SW channel

2. Large beaver dam on SW ditch. Remove dam, cut away brush and clean culverts.	✓			\$2,000
School Section Lake Outlet Project (see photo 8).				
1. Outlet structure and culverts in good condition.			✓

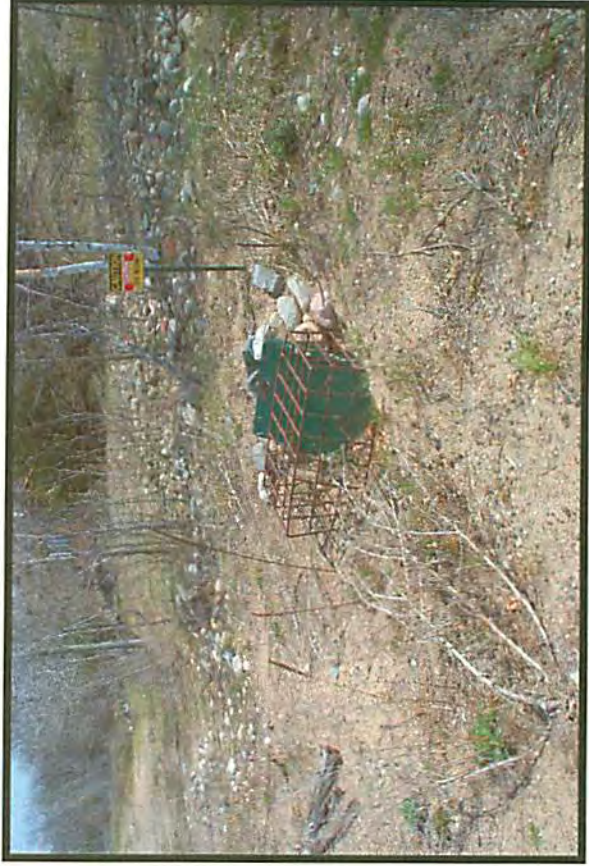
Photograph 8: School Section Lake – Outlet Structure

2. Downstream culvert and structures in good condition.			✓	
3. Water level 4 feet below overflow level.			✓	
Pleasant Lake Outlet Project (see photo 9).

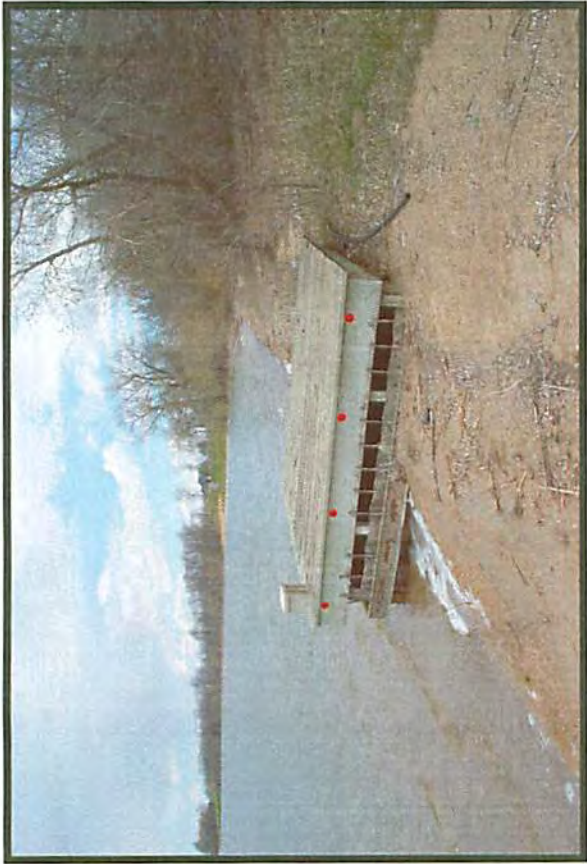
Photograph 9: Pleasant Lake - Outlet Structure

1. Outlet structure in good condition.			✓	
2. Water level 8 in. below overflow level.			✓

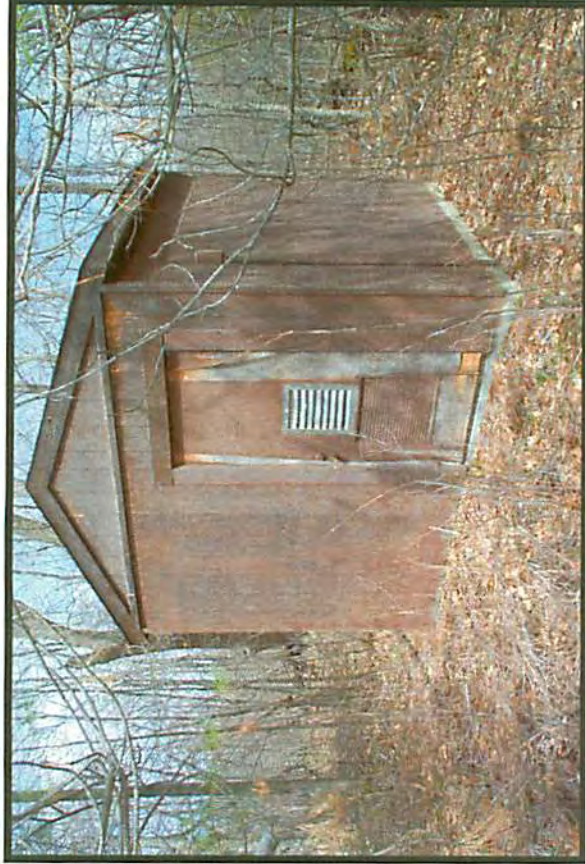
Photograph 14: Lake Marie – Aeration Building

2. Lake Marie – building needs new door and staining and trim brush away.	✓			Kevin 8 hrs. \$300
Carp Trap Project (see photo 15).				
1. Carp trap in good condition.			✓	
Lake Augusta Erosion Control Project (see Figure 5 and photos 16 and 17).

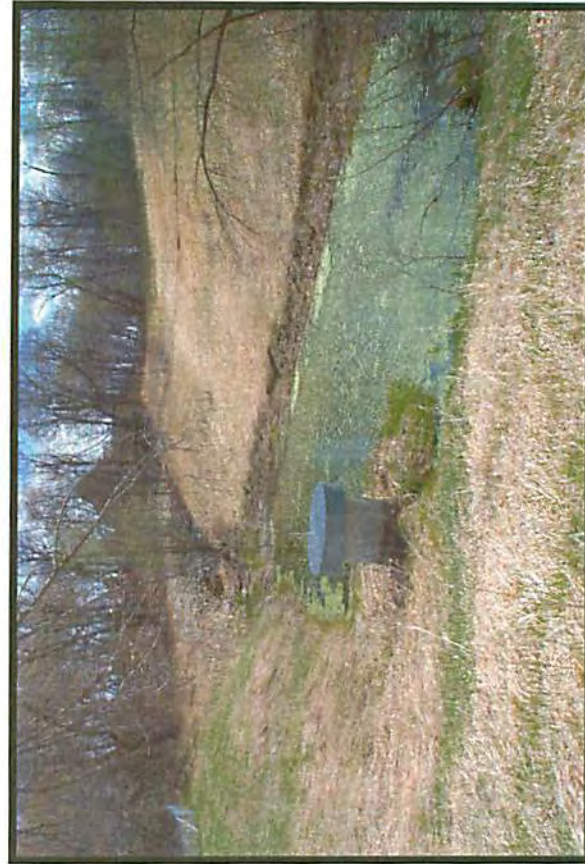
Photograph 16: Lake Augusta Erosion Control Project – Sedimentation Basin

1. Sedimentation basin in good condition.			✓	
2. Drop manhole structure in good condition. Needs riprap (3 C.Y.)	✓			\$700
3. Buffer strip working extremely well.			✓	
Clear Lake Sedimentation Basin (south) (see photos 18).

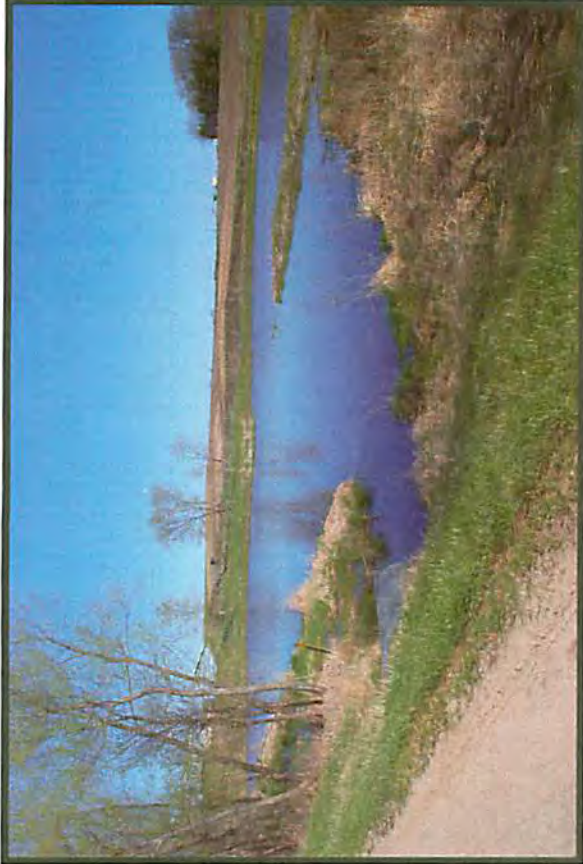
Photograph 18: Clear Lake Sedimentation Basin (south)

1. Sedimentation basin in good condition.			✓	
Clear Lake Wetland Outlet Structure (northeast)(see photo 19).				
1. Outlet structure in good condition.			✓	
Hidden River Sewage Treatment Facility (see photo 20).

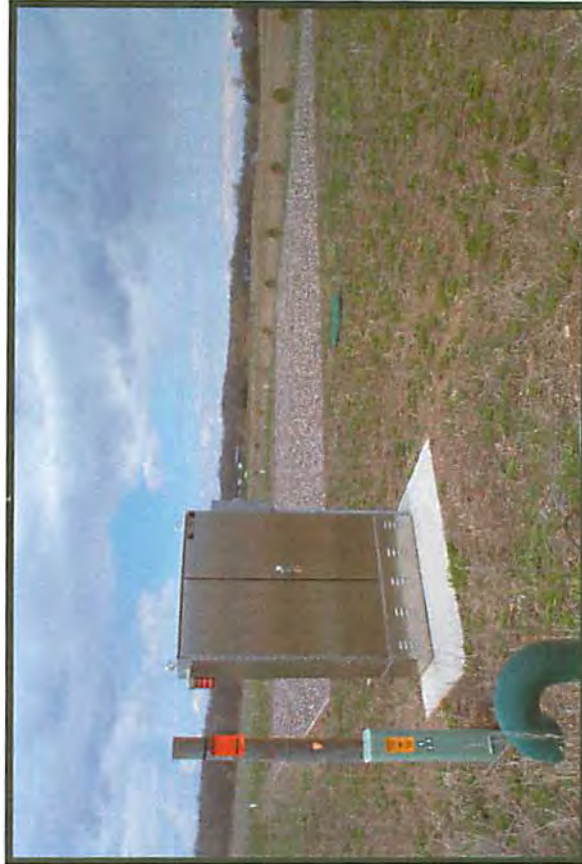
Photograph 20: Hidden River Sewage Treatment Facility

1. Treatment facility in good condition.			✓
