2003 Project Inspection Report

Prepared for
**Clearwater River
Watershed
District**

June 2003

Table 1
Clearwater River Watershed District
Annual Project Inspection
May 2003

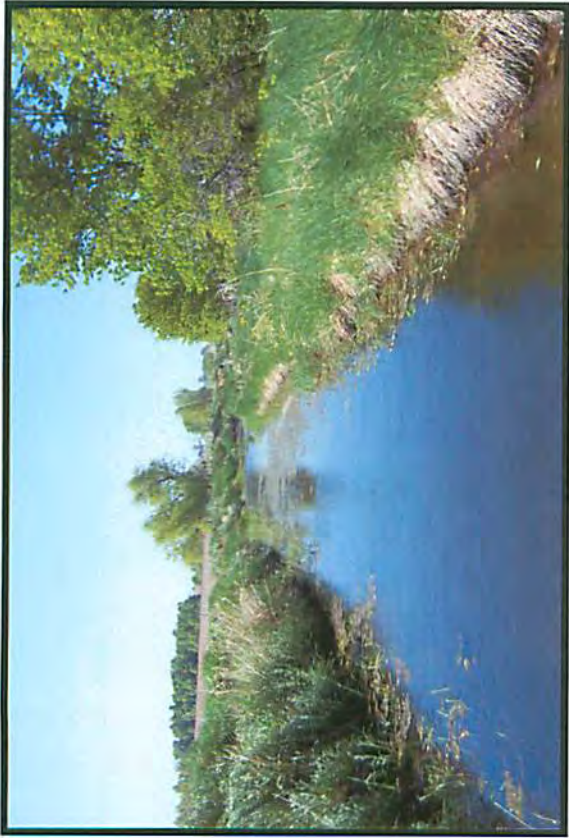
Project	Maintenance			Estimated Cost
	Required	Optional	No Action Now	
Watkins Wetland Treatment System (south) (see Figure 1 and photos 1 and 2).				
1. West side (Channel A) flowing normal, channel ports open.			✓

Photograph 1: Watkins Wetland – west side (Channel A).

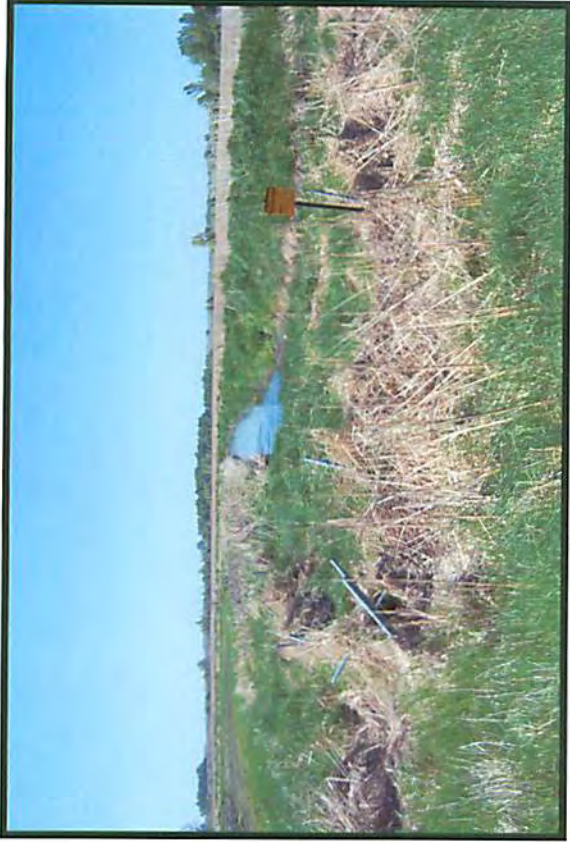
2. East side (Channel B) flowing normal, channel ports open.			✓	
Upper Watkins Wetland Isolation Project (north) (see Figure 2 and photo 3).				
1. Ditches and overflow structures in good condition.			✓

Photograph 2: Watkins Wetland – east side (Channel B).

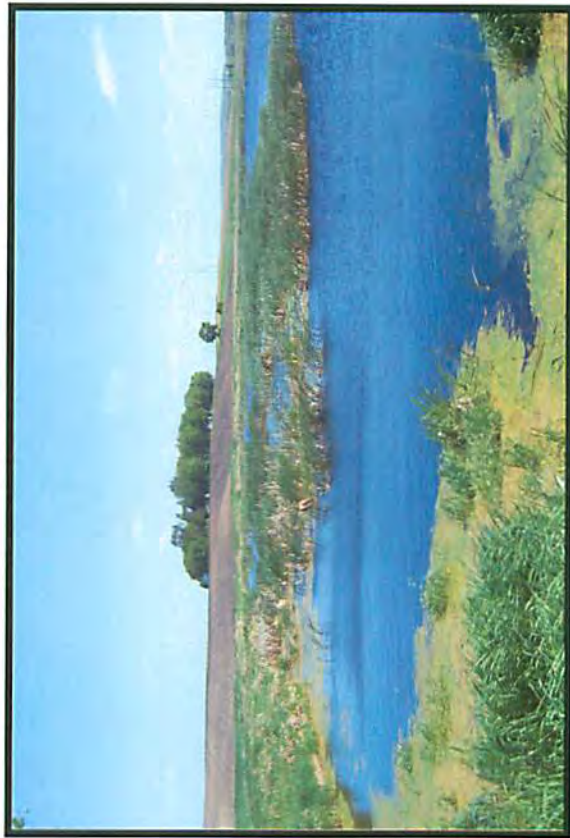
2. Fence needs repair and tightening.	✓			Kevin 8 hrs.
Annandale Wetland Treatment System (see Figure 3 and photos 4 and 5).				
1. Ditch and overflow structure in good condition.			✓	
School Section Lake Outlet Project (see photo 6).

Photograph 3: Upper Watkins Wetland Isolation Project.

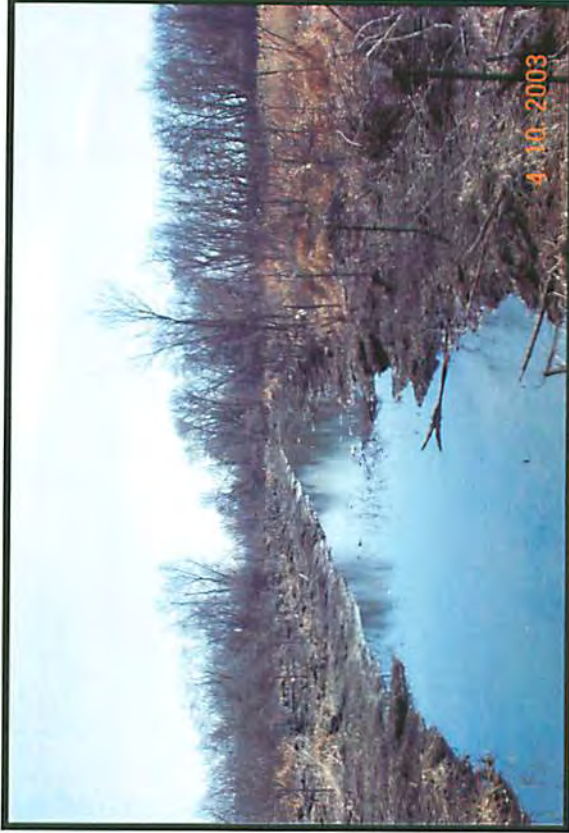
Photograph 4: Annandale Wetland – south ditch.

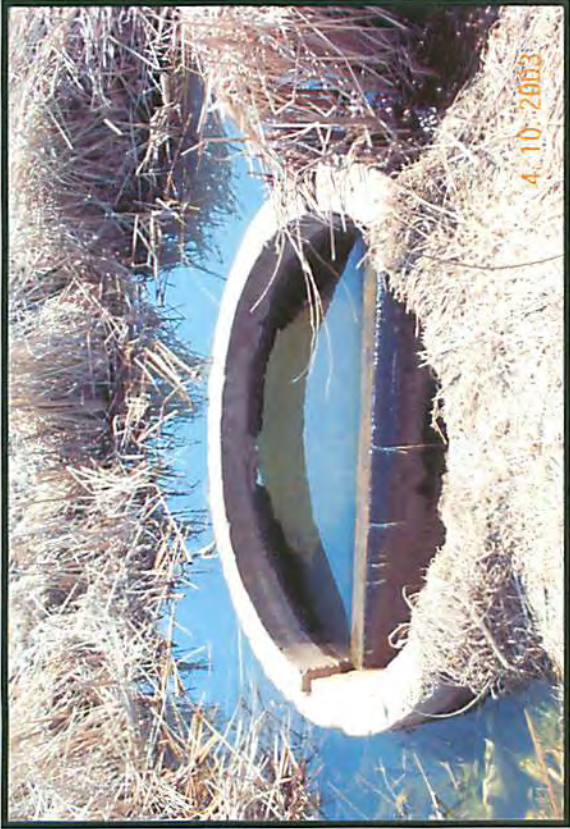
Photograph 5: Annandale Wetland – outlet structure.

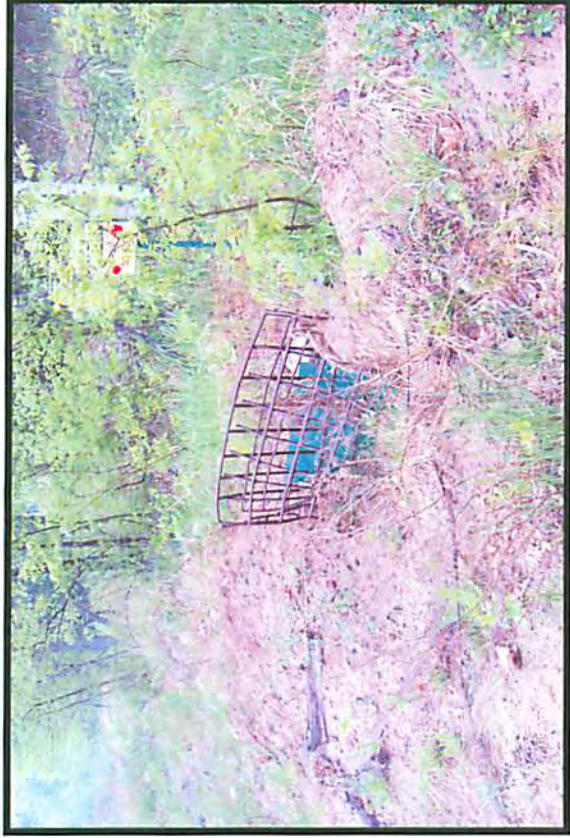
1. Outlet structure and culverts in good condition.			✓	
2. Downstream culvert and structures in good condition.			✓	
Pleasant Lake Outlet Project (see photo 7).

Photograph 6: School Section Lake – outlet structure.

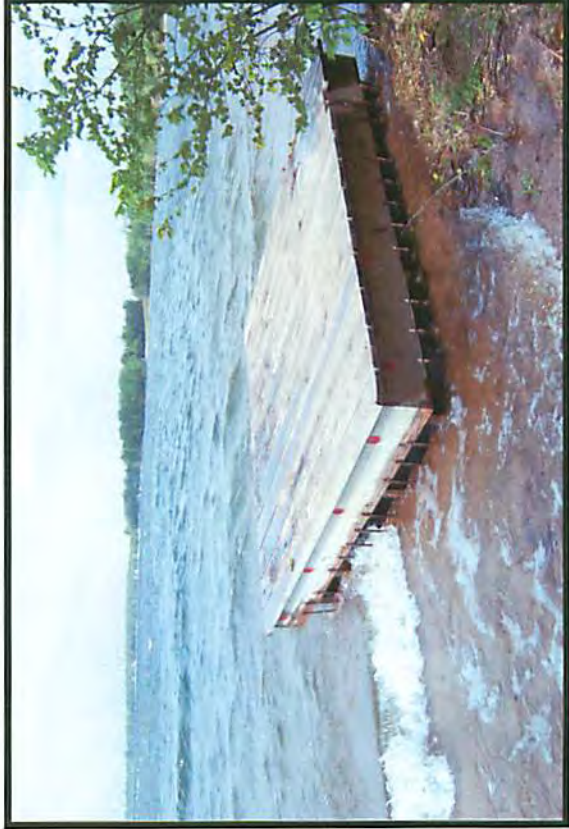
1. Outlet structure moved up by ice.				
2. Sheet piling to be cut off.	✓			Kevin 8 hrs. plus \$200 equipment
Kingston Wetland Treatment System (see Figure 4 and photo 8).

Photograph 7: Pleasant Lake – outlet structure.

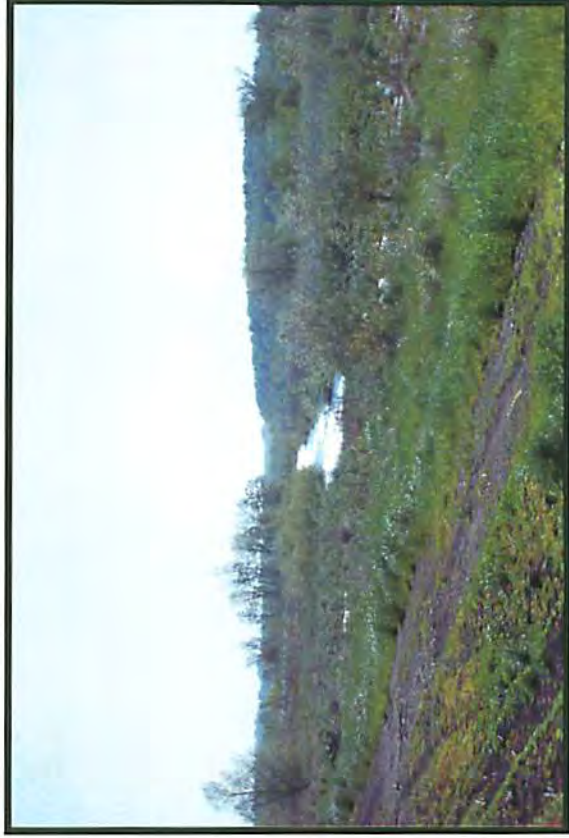
1. Sediment basin in good condition.			✓	
2. Ditches and channel ports open.			✓	
3. Fence repair and tightening.	✓			Kevin 16 hrs.
Aerator Buildings (see photos 9 and 10).

Photograph 8: Kingston Wetland – west ditch.

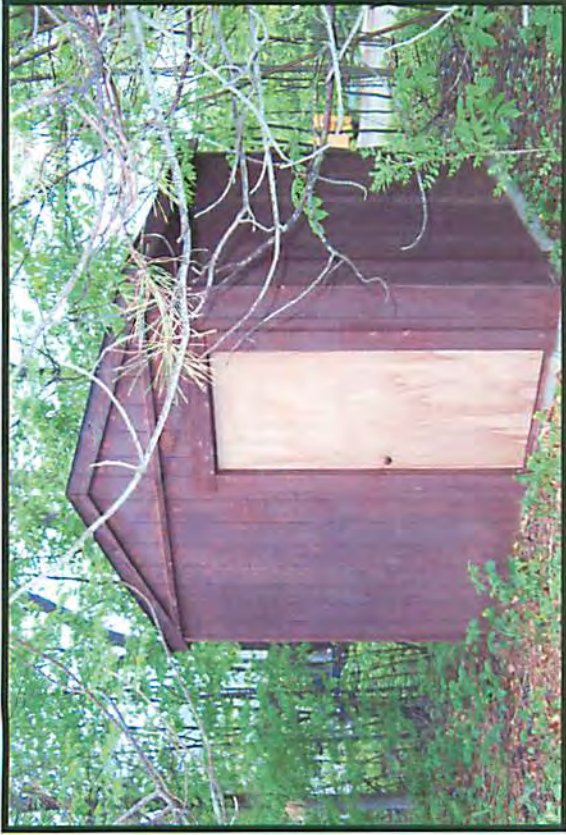
1. Lake Augusta – good condition.			✓	
2. Lake Marie – paint new door.	✓			Kevin 2 hrs. \$50
3. Remove aerator buildings, piping in lake and restoration.		✓		\$3,000 ea.

Photograph 9: Lake Marie – aerator building.

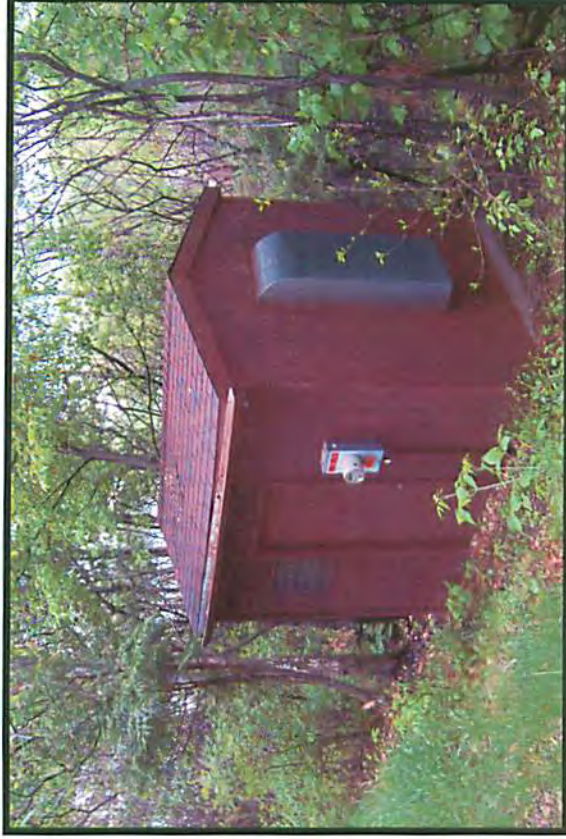
Photograph 10: Lake Augusta – aerator building.

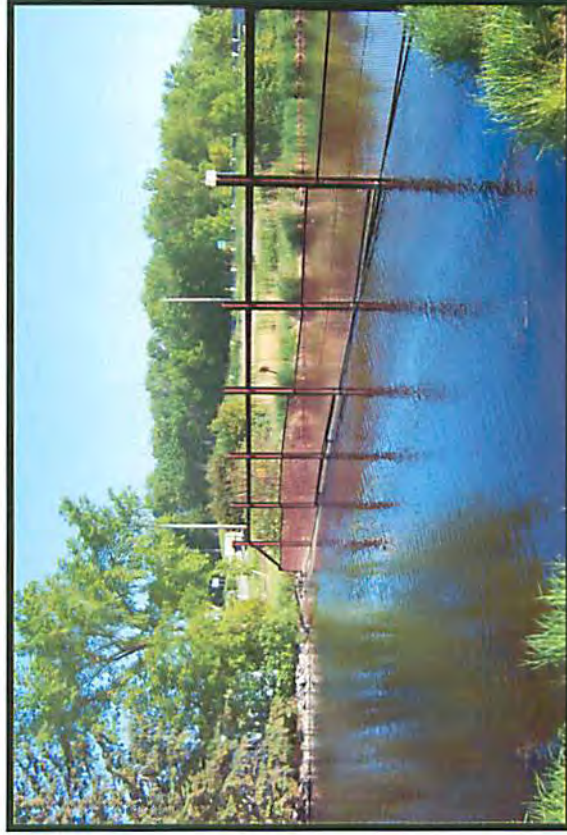
Project	Maintenance			Estimated Cost
	Required	Optional	No Action Now	
Carp Trap Project (see photo 11).				
1. Carp trap needs riprap and bottom leveling (completed 5/31/03).	✓			\$3,000
Lake Augusta Erosion Control Project (see Figure 5 and photos 12, 13, and 14).

Photograph 11: Carp Trap – Clearwater River.

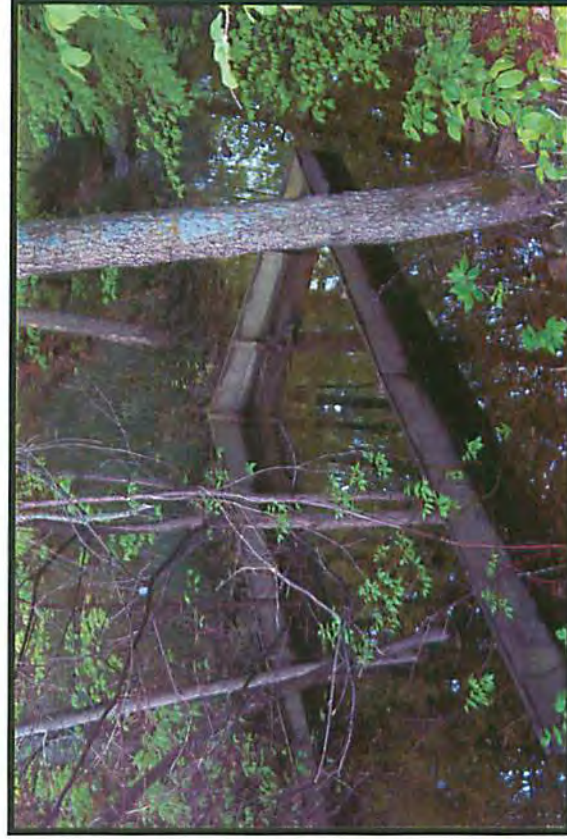
1. Sedimentation basin in good condition.			✓	
2. West drop inlet structure needs 18" manhole riser section, sediment and tree removal, and baffle adjustment.	✓			\$5,000

Photograph 12: Lake Augusta Erosion Control Project – west drop inlet structure.

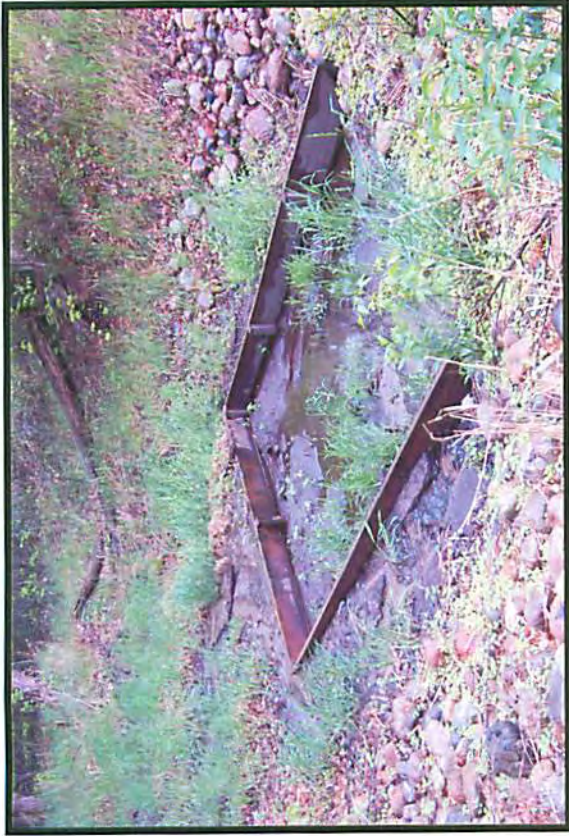
3. South drop inlet structure needs sedimentation removal.	✓			\$2,000
4. Riprap at outlet in channel needs to be pulled out of the channel and replaced around apron.	✓			\$1,000
Clear Lake Sedimentation Basin (south) (see photo 15).

Photograph 13: Lake Augusta Erosion Control Project - south drop inlet structure.

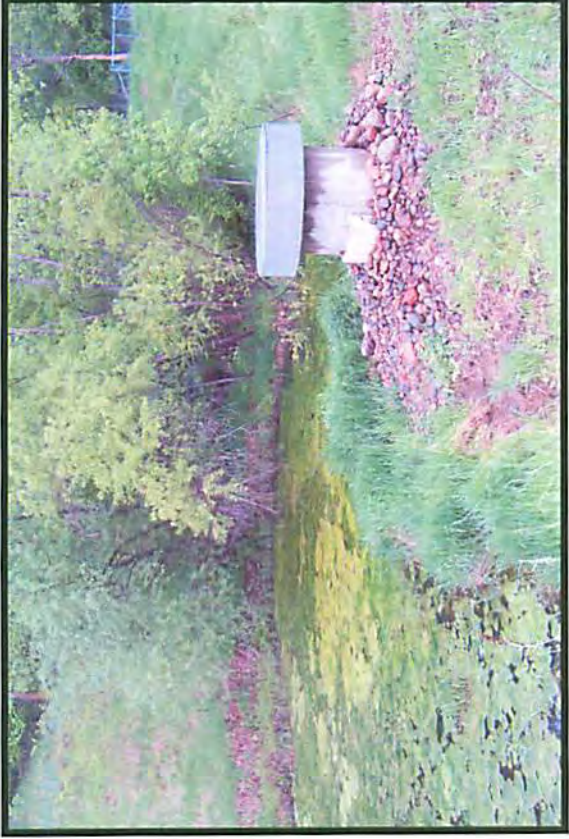
Photograph 14: Lake Augusta Erosion Control Project - sedimentation basin.

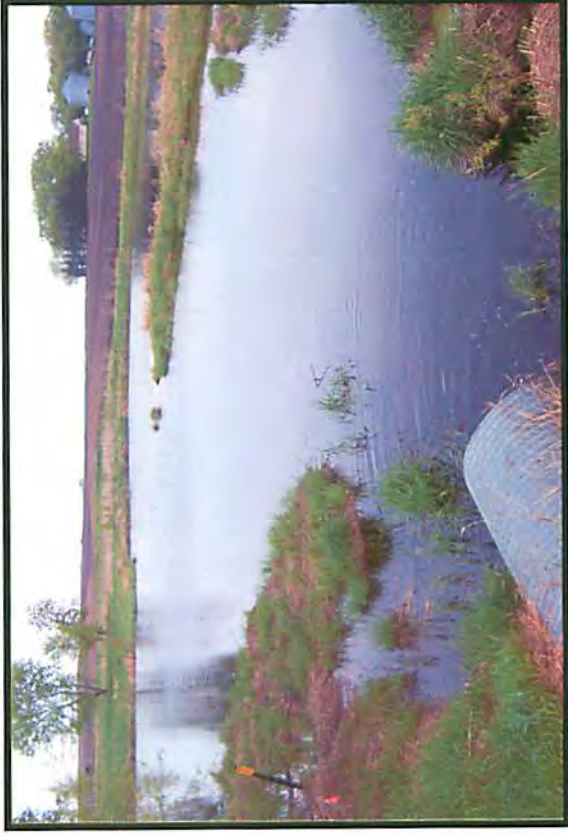
1. Sedimentation basin in good condition.			✓	
Clear Lake (northeast) Wetland Outlet Structure (see photo 16).				
1. Outlet structure in good condition.			✓	
Hidden River Sewage Treatment Facility (see photo 17).

Photograph 15: Clear Lake Sedimentation Basin (south).

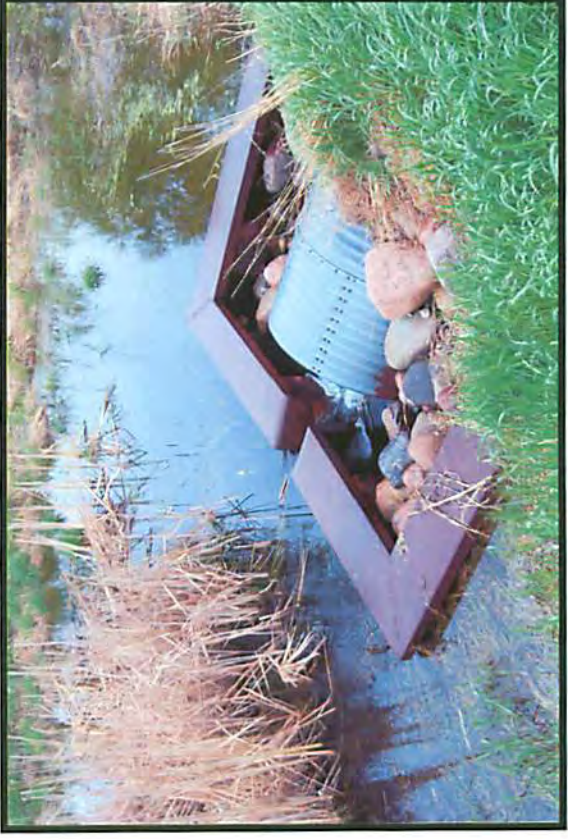
Photograph 16: Clear Lake northeast wetland outlet structure.

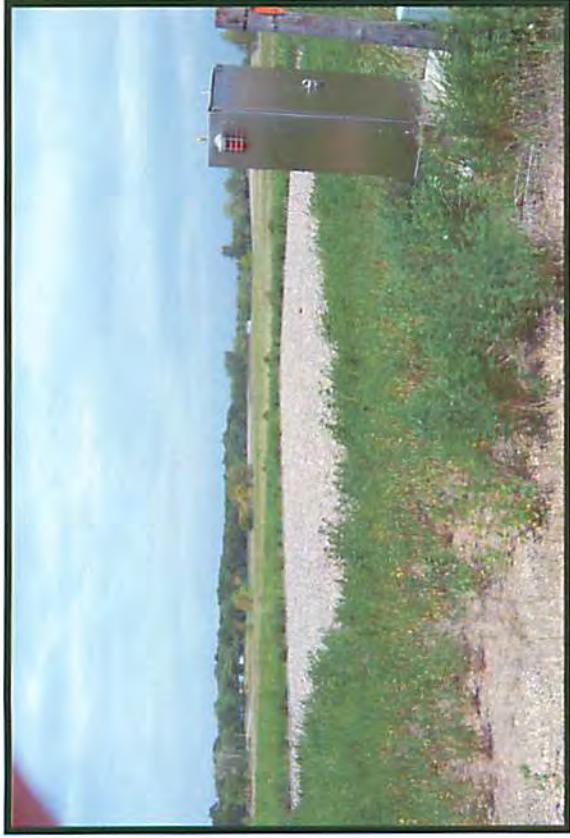
1. Treatment facility in good condition.			✓	
2. Signs need to be installed around drainfield to keep out 4-wheelers and snowmobiles.	✓			Kevin 4 hr. \$300

3. Area needs mowing.	✓			Kevin 8 hr. \$100
4. Septic tank pumping (2).	✓			\$400
5. Replace plantings around site.	✓			\$1,800
Rest A While Sewage Treatment Facility (see photos 18, 19 and 20).

Photograph 17: Hidden River Sewage Treatment Facility.

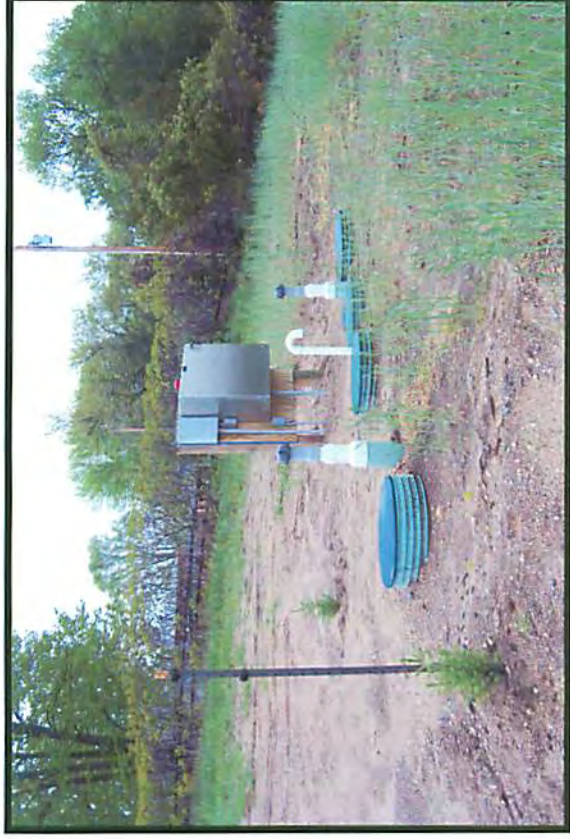
1. Treatment facility in good condition.			✓	
2. Sedimentation basins have major erosion.	✓			Have owner repair.

Photograph 18: Rest A While Sewage Treatment Facility.

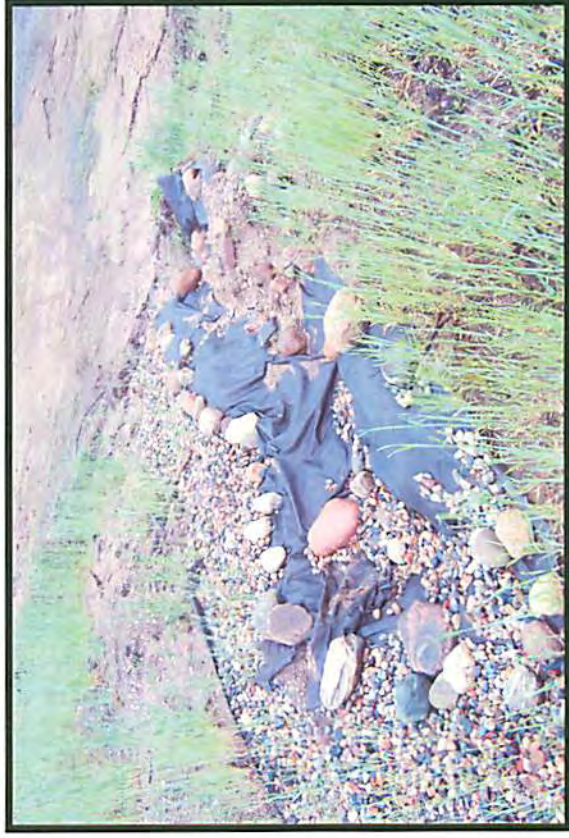
Photograph 19: Rest A While - east sedimentation basin.

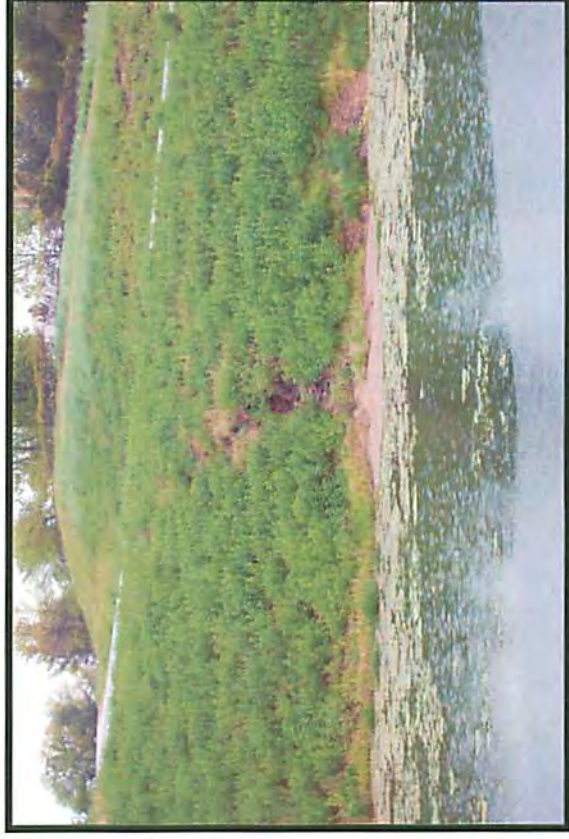
Photograph 20: Rest A While - west sedimentation basin.
