2014 PROJECT INSPECTION REPORT

The mission of the Clearwater River Watershed District is to promote, preserve, and protect water resources within the boundaries of the district in order to maintain property values and quality of life as authorized by MS 103D.

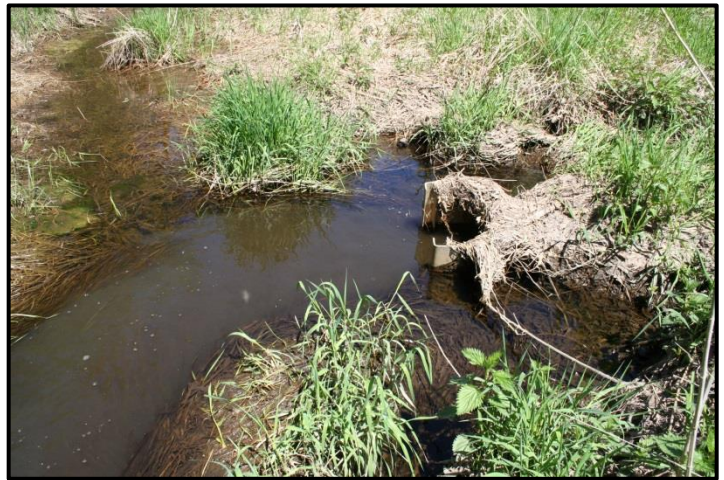
A small portion of the west channel berm is overgrown with woody vegetation. Ten ports were easily located on the west channel. Port #1 is dry, but seems capable of moving water. A break in the berm has formed at port #2's location (numbering from the road northward). The majority of flow in the west channel enters the wetland at port #2. Port #2 seems to be broken, but more field analysis is need to make that determination. A low spot in the berm is noticeable between ports #3 and #4. Both ports #3 and #4 are dry and sitting out of the water line. Ports #5 and #6 seem to be capable of moving water, and indicators are present of water moving through said ports. Both ports #7 and #8 are dry and sitting out of the water line. Ports #9 and #10 seem to be capable of moving water, and indicators are present of water moving through said ports. The west diversion berm is overgrown with vegetation, but seems to be holding well. All ports should undergo more inspection to ensure they are capable of moving water.

Fencing is missing, damaged, or overgrown in several locations throughout the project area. The central diversion structure seems to be in good condition. The channels themselves were noted to be holding sediment and large amounts of emergent vegetation. It is unclear whether this is causing any issues.

Staff recommends work be undertaken to remove all woody vegetation from the western diversion berm and channel berm (preferably in fall). Work should also be undertaken to repair the breach and low spot in the western channel berm. A more thorough inspection of all ports should be undertaken to determine if any work is needed to return them to operational capacity, but this is considered optional for this year. Staff also recommends the Board determine whether fencing should be replaced, or if placement of signage is more appropriate.

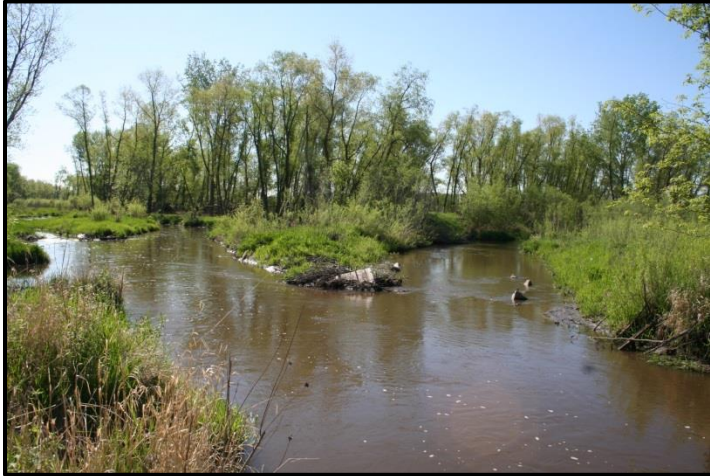
Visual inspection indicated the newly re-meandered low-flow channel, limestone filter berm, and rock riffle structure were in good condition. The re-meandered channel has re-vegetated well, and is holding its shape. Staff recommends the accumulated sediment in the basin immediately below the old diversion be removed to allow for further sedimentation during high flow conditions. This basin is located at the head of the high-flow old diversion channel. Staff also notes the option to replace the remnants of fencing with signage.

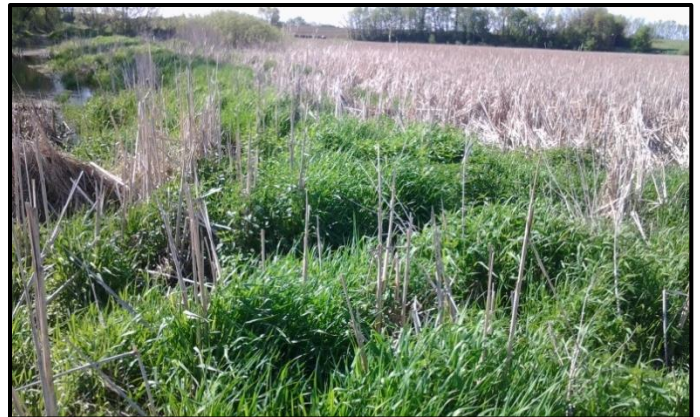
A portion of the isolation berm was cleared of woody vegetation by Conservation Corps of Minnesota (CCM) work crews in late April. Portions of the berm still have woody vegetation that should be cleared (preferably in fall). There is one small breach in the berm, on the northern end of the isolation area. Currently water is flowing into, not out of, the wetland at this location. This breach needs to be repaired. Other than this breach and a couple of low spots, the berm seems to be in good condition.

The wooden weir structures are in good condition. Woody vegetation around one weir should be cleared. Diversion channels around the isolation berms seem to be in good condition. Fencing around the Isolation Project is in good condition in most area; a few spots the fencing is broken, missing, or overgrown.

In addition to the repairs to the small breach in the berm, staff recommends additional work on removal of woody vegetation, along with treatment of noxious weeds (mainly thistles). Weed treatment should be conducted later this summer to minimize weed interference with neighboring farm fields. Berm repairs should be conducted in the winter, to allow access with heavy machinery. Removal of woody vegetation should occur (preferably in fall).

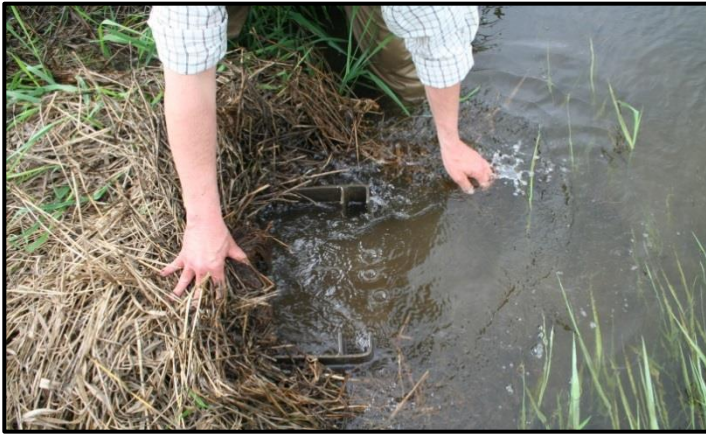
The diversion berm was cleared of all woody vegetation by CCM work crews in late April. The berm is in good condition. Several of the individual ports are clogged and in need of cleaning. Large sections of fencing are either missing, damaged, or overgrown. The overflows are in good condition.

Staff recommend noxious weeds (mainly thistles) be treated later this summer to minimize their interference with neighboring farm fields, and for the individual ports to be cleaned to allow flow to enter the wetland. Staff also recommends decision on whether to begin repairs to fencing, or if placement of signage might be a feasible alternative.

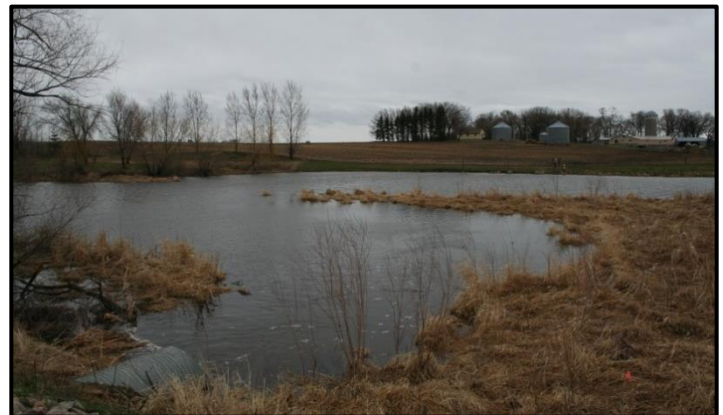
Site inspection was conducted April 29, 2014. Project is a two-cell sedimentation basin. No depth survey was taken of the basin this year. Last survey was conducted in 2012, and indicated a slight buildup of sediment in the northern cell of the basin. Staff recommends Board consider a five-year depth survey schedule, and survey the basin again in 2017. Overall, basin seemed to be in good condition.

Other items to note: 1) the placement of the notch weir above the inlet to the basin should lead to less sediment enter the basin, increasing the basin's useful life, 2) the source of the delta that formed on the southwestern end of the southern cell has been rectified due to the District cooperative effort with Forest Prairie Township in improving the road ditching and drainage above that location.

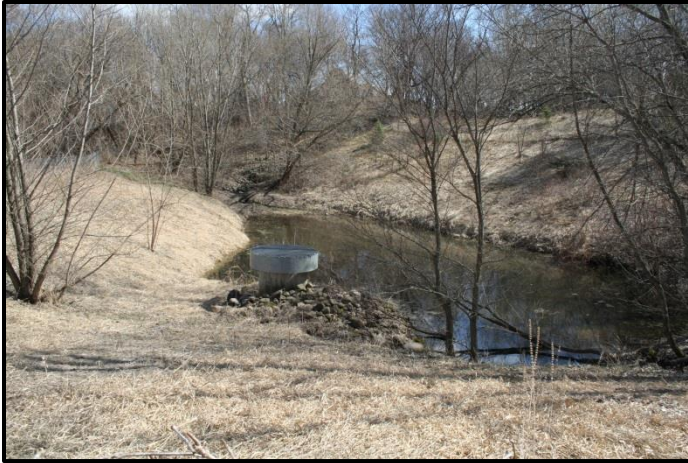
The Lake Augusta Erosion Control Project is in good condition overall. The riser is in good condition. The inlet boxes are in okay condition. The outlet is in good condition, with riprap slowing moving into channel as natural scouring occurs. The fencing around the basin is in need of minor repair (excess vegetation cleared from fence, straightening bent portions of fence). These repairs are considered optional. Staff recommends a depth survey be made of the basin via boat to determine amount of sedimentation and need for cleanout.

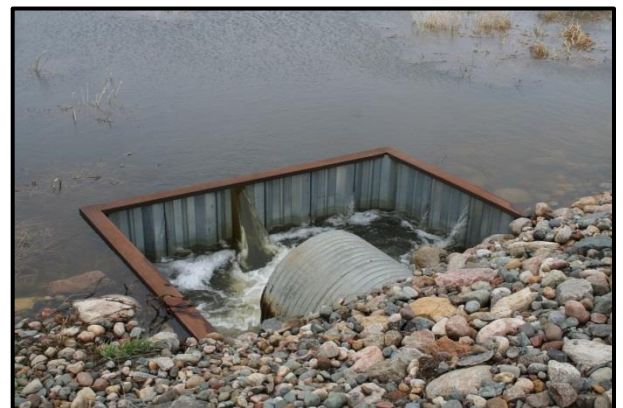
The notch weir structure is in good condition, with no additional work needed. The sand-iron filter is in need of a slight modification to its outlet tile, in order to facilitate more accurate water sampling. This sampling is needed to ensure the filter is operating properly. See drawing in [Appendix A](#) for more information.

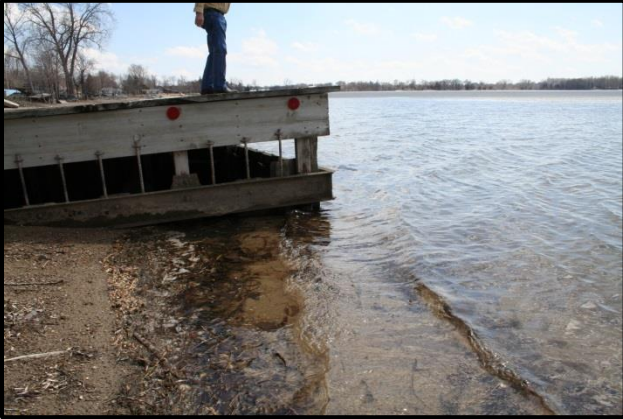
Over all, the outlet control structure is in okay condition. The rebar trash guards on the front of the structure are missing, a couple of sections of wood are in need of repair, and the outlet guillotine valve does not completely close so as to make a watertight seal. Staff recommends the rebar trash guards and wood sections be repaired once water levels on the lake return to normal.

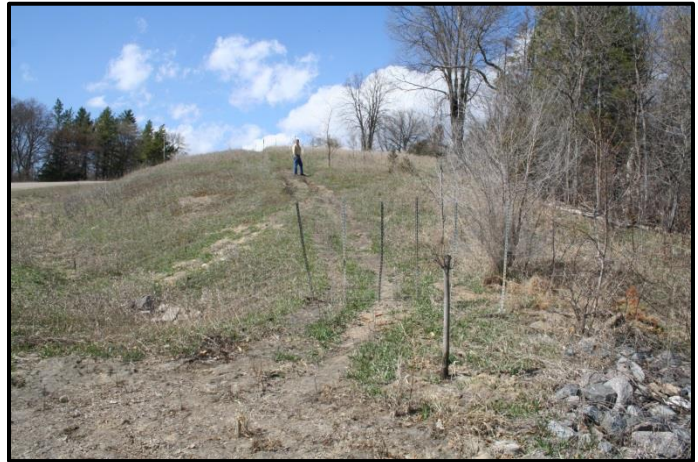
Staff recommends additional control of woody vegetation in treatment area (preferably in fall), along with additional fencing placed to discourage four-wheelers and lawn mowers from driving along hillside and dumping refuse on property. Staff also recommends the western sedimentation basin be treated to control algae growth due to resident complaints, and pumping of individual septic tanks. Septic Check is aware of individual septic tanks that need to be pumped, and will coordinate with pumper. See [Appendix C](#) for a listing of individual tanks to be pumped.

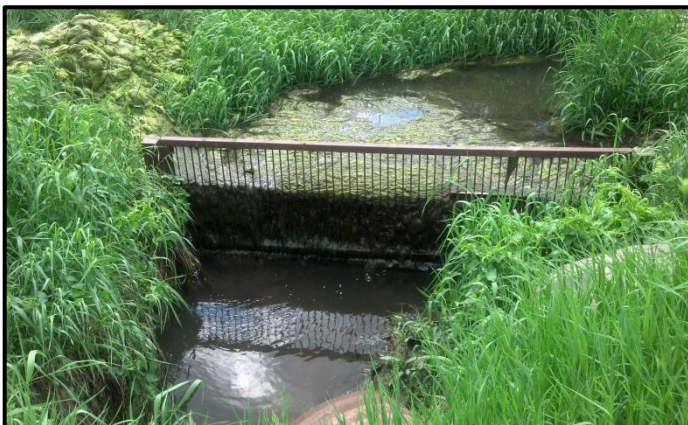
This site was inspected multiple times during the months of May. This barrier is experiencing significant undercutting and erosion along the sides. The barrier is also having a lot of blockage due to floating debris from Henshaw Lake,

requiring frequent cleaning (sometimes three times a day). Temporary repairs have been made to block openings due to undercutting. The culvert located just below the barrier is experiencing erosion due to the amount of water coming out of Henshaw Lake.

Staff recommends the Board consider partnering with MN DNR to discuss the placement of a different type of fish barrier at this location, using the location of the washing out culvert. Agreements with the landowner would have to be developed as part of this project.

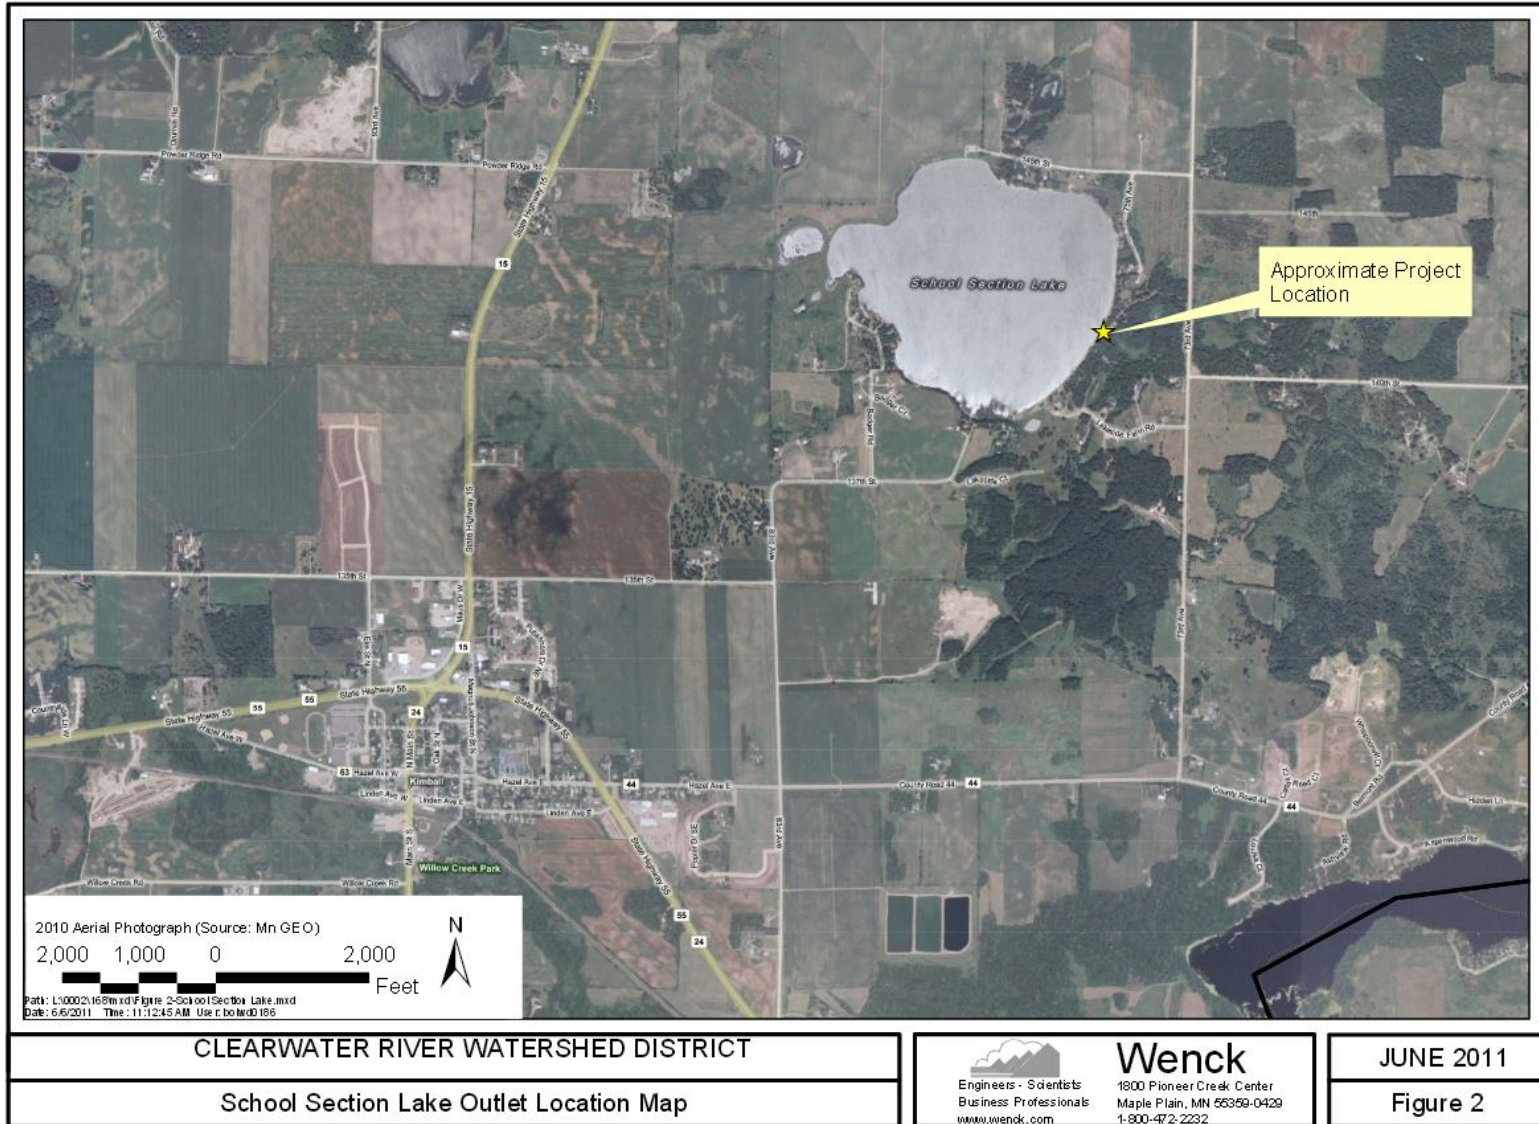
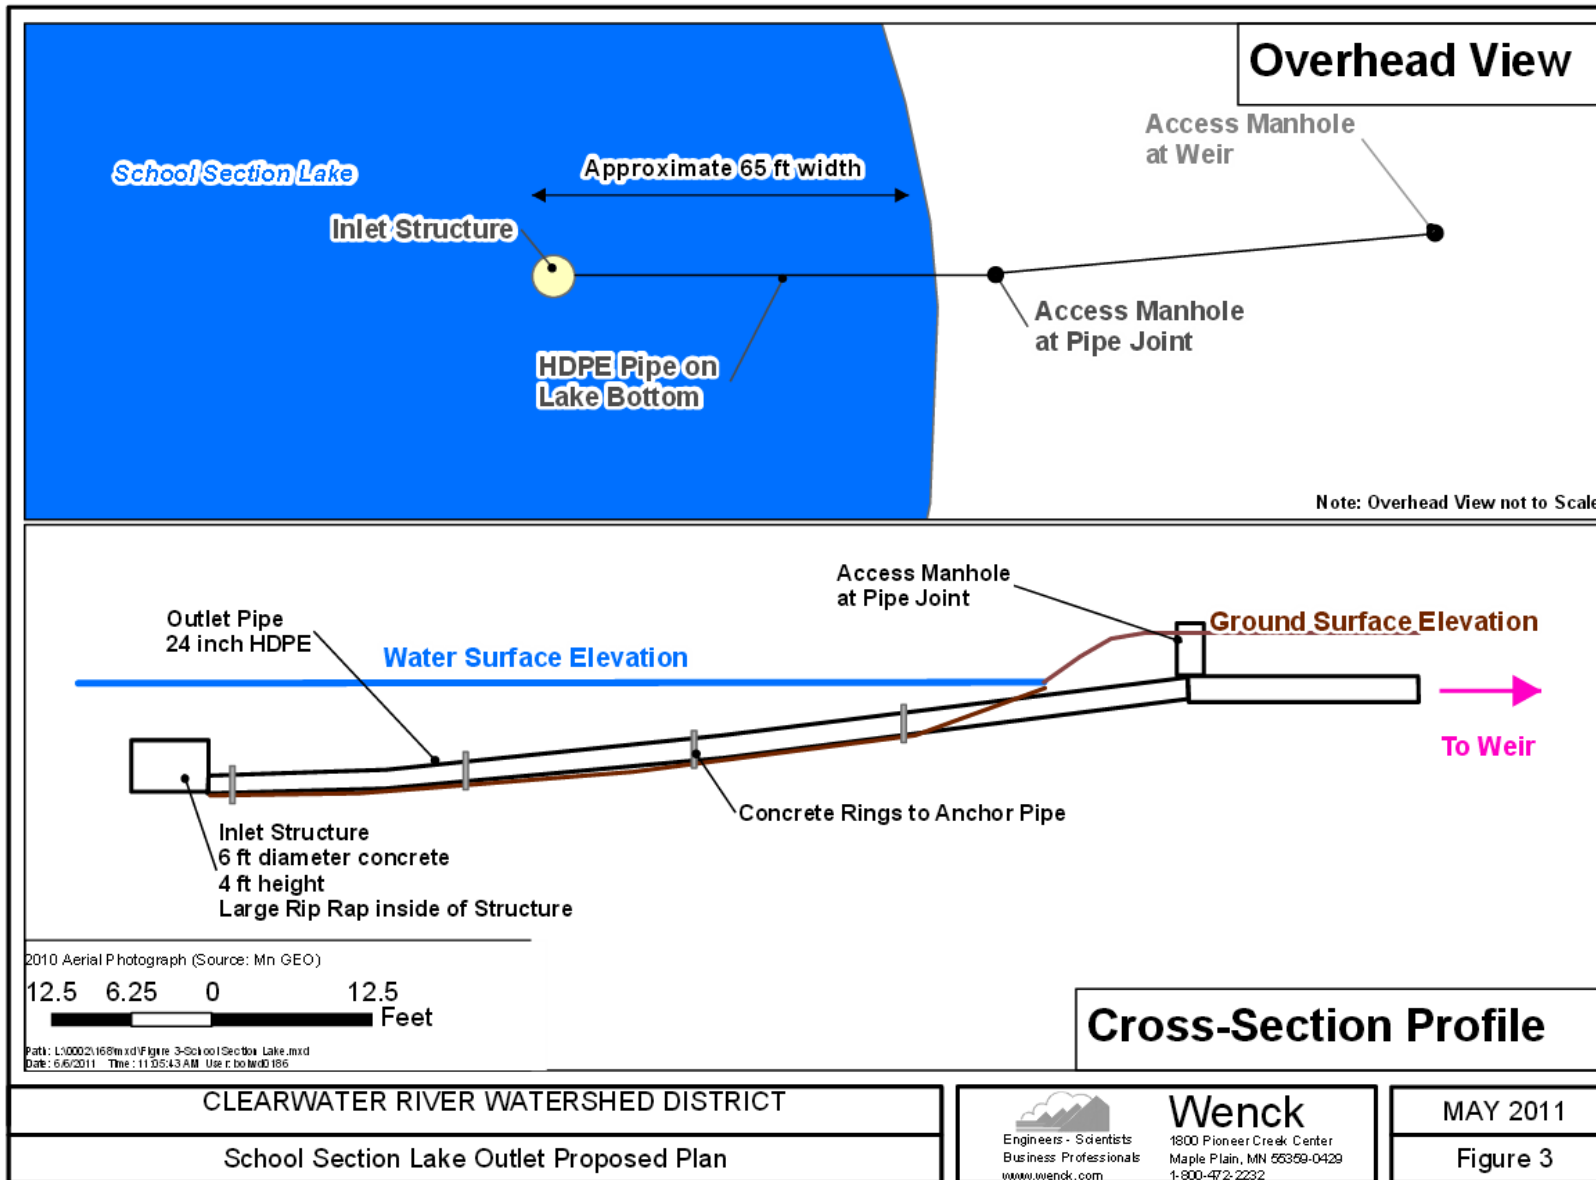
Appendix B: School Section Lake Outlet Modification

Staff notes the option to modify the lake outlet structure in order to protect the outlet from damage and to keep sand and debris from entering the pipe. See figure in [Appendix B](#) for more information.
