Project Inspection Report

Prepared for
**Clearwater River
Watershed
District**

May 2000

Re: Project Inspection Report
Wenck File #0002-14-02

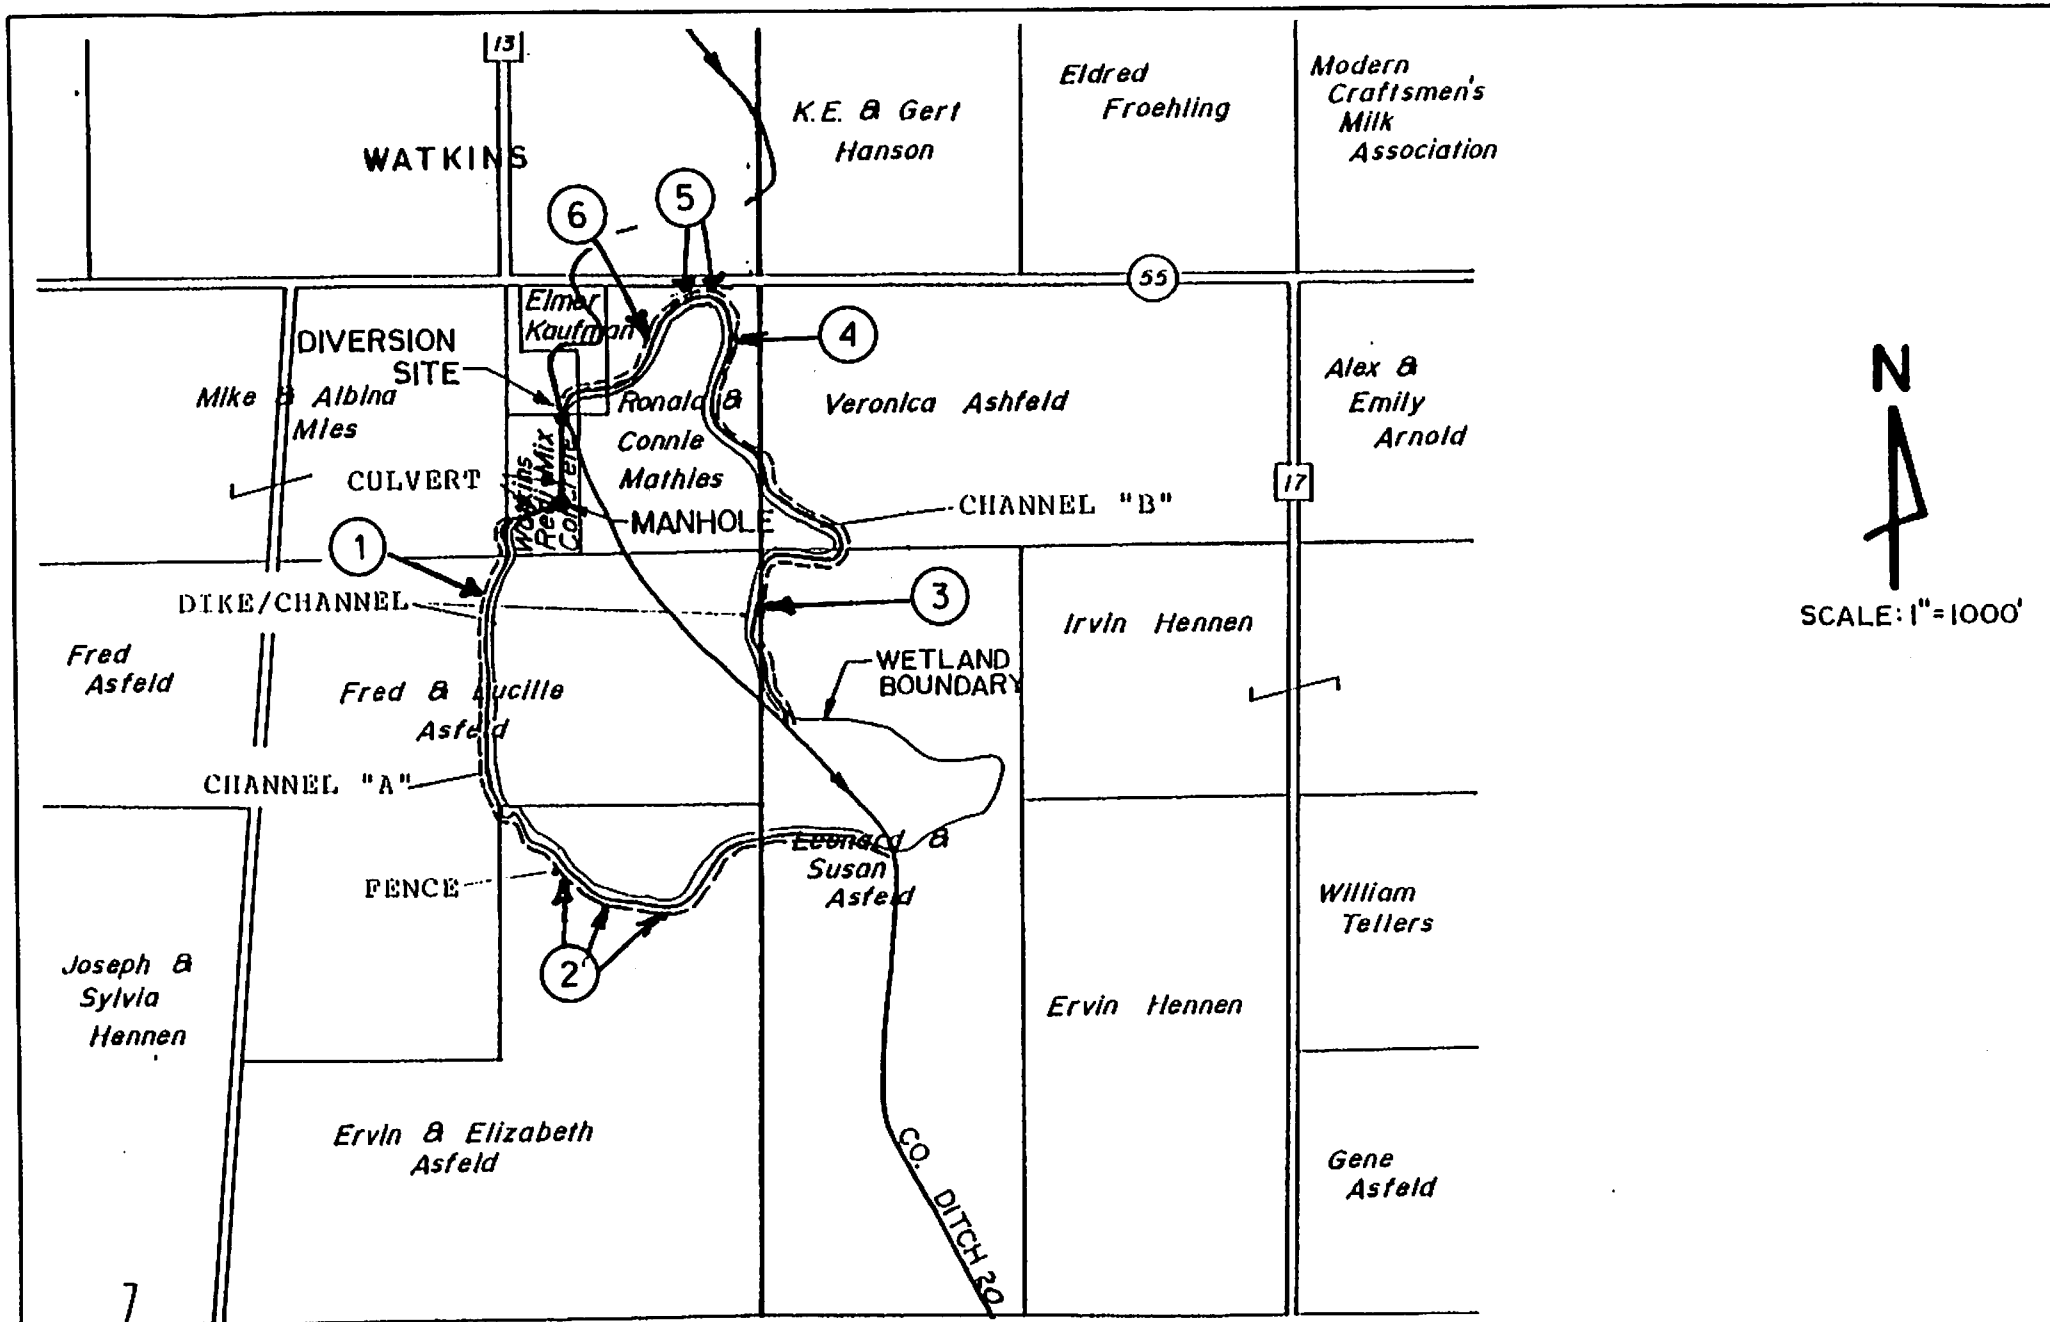
MAY, 2000
 Figure 1

1. Sediment in ditch from end of culvert to 300 feet downstream (west side). 300 ft. x 10 ft. x 2 ft. = 225 C.Y.	X			\$2,000.00
2. Three small washouts along south side stabilized and revegetated.			X

3. Beavers on east side - water level high and channel ports plugged.		X		\$500.00 plus Kevin 8 hours
4. Fence needs repair and tightening along east side and north side.	X			Kevin 8 hours

5. Two washouts on north berm. - One at culvert under Highway 55 - 8 ft. wide. - One 200 ft. west of culvert - 6 ft. wide.	X			\$2,000.00
6. Sediment in ditch from gabion structure to 1,000 feet downstream (east side). 1,000 ft. x 10 ft. x 2 ft. = 750 C.Y.	X			\$5,000.00
<i>Annandale Wetland Treatment System (See Figure 2)</i>

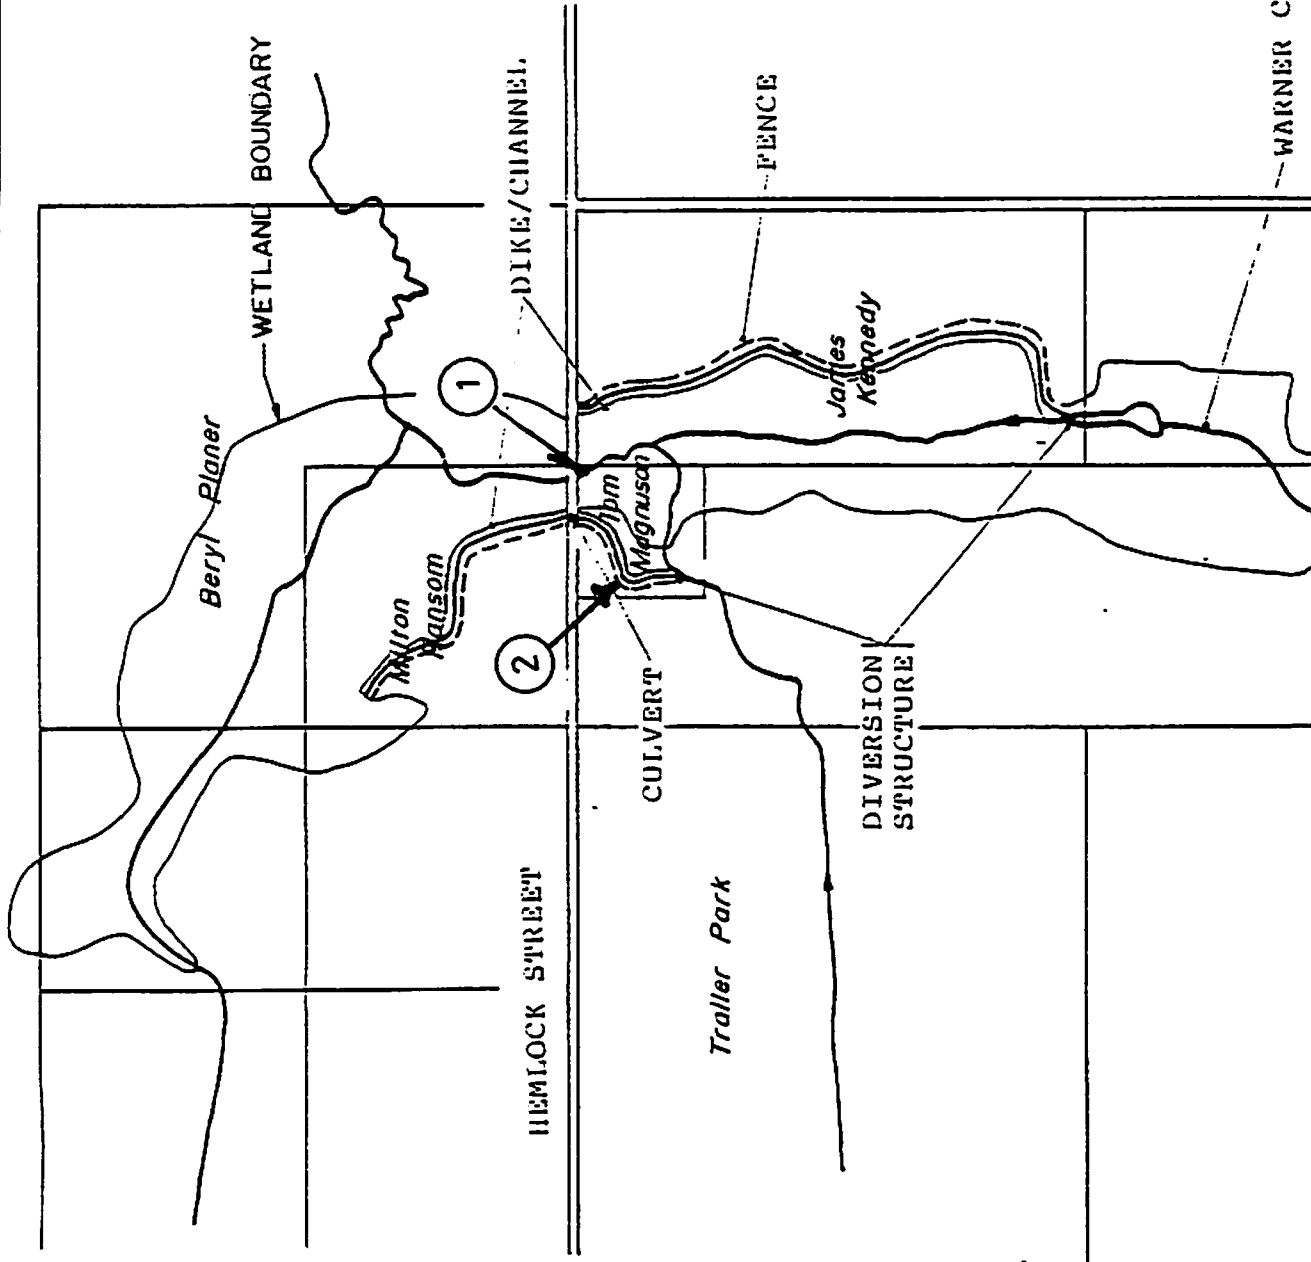
Figure 2

1. Outlet structure and stop logs in good condition.			X	
2. Fence needs repair and tightening. Southwest ditch.	X			Kevin 4 hours
<i>Upper Watkins Wetland Isolation Project (North)(See Figure 3)</i>

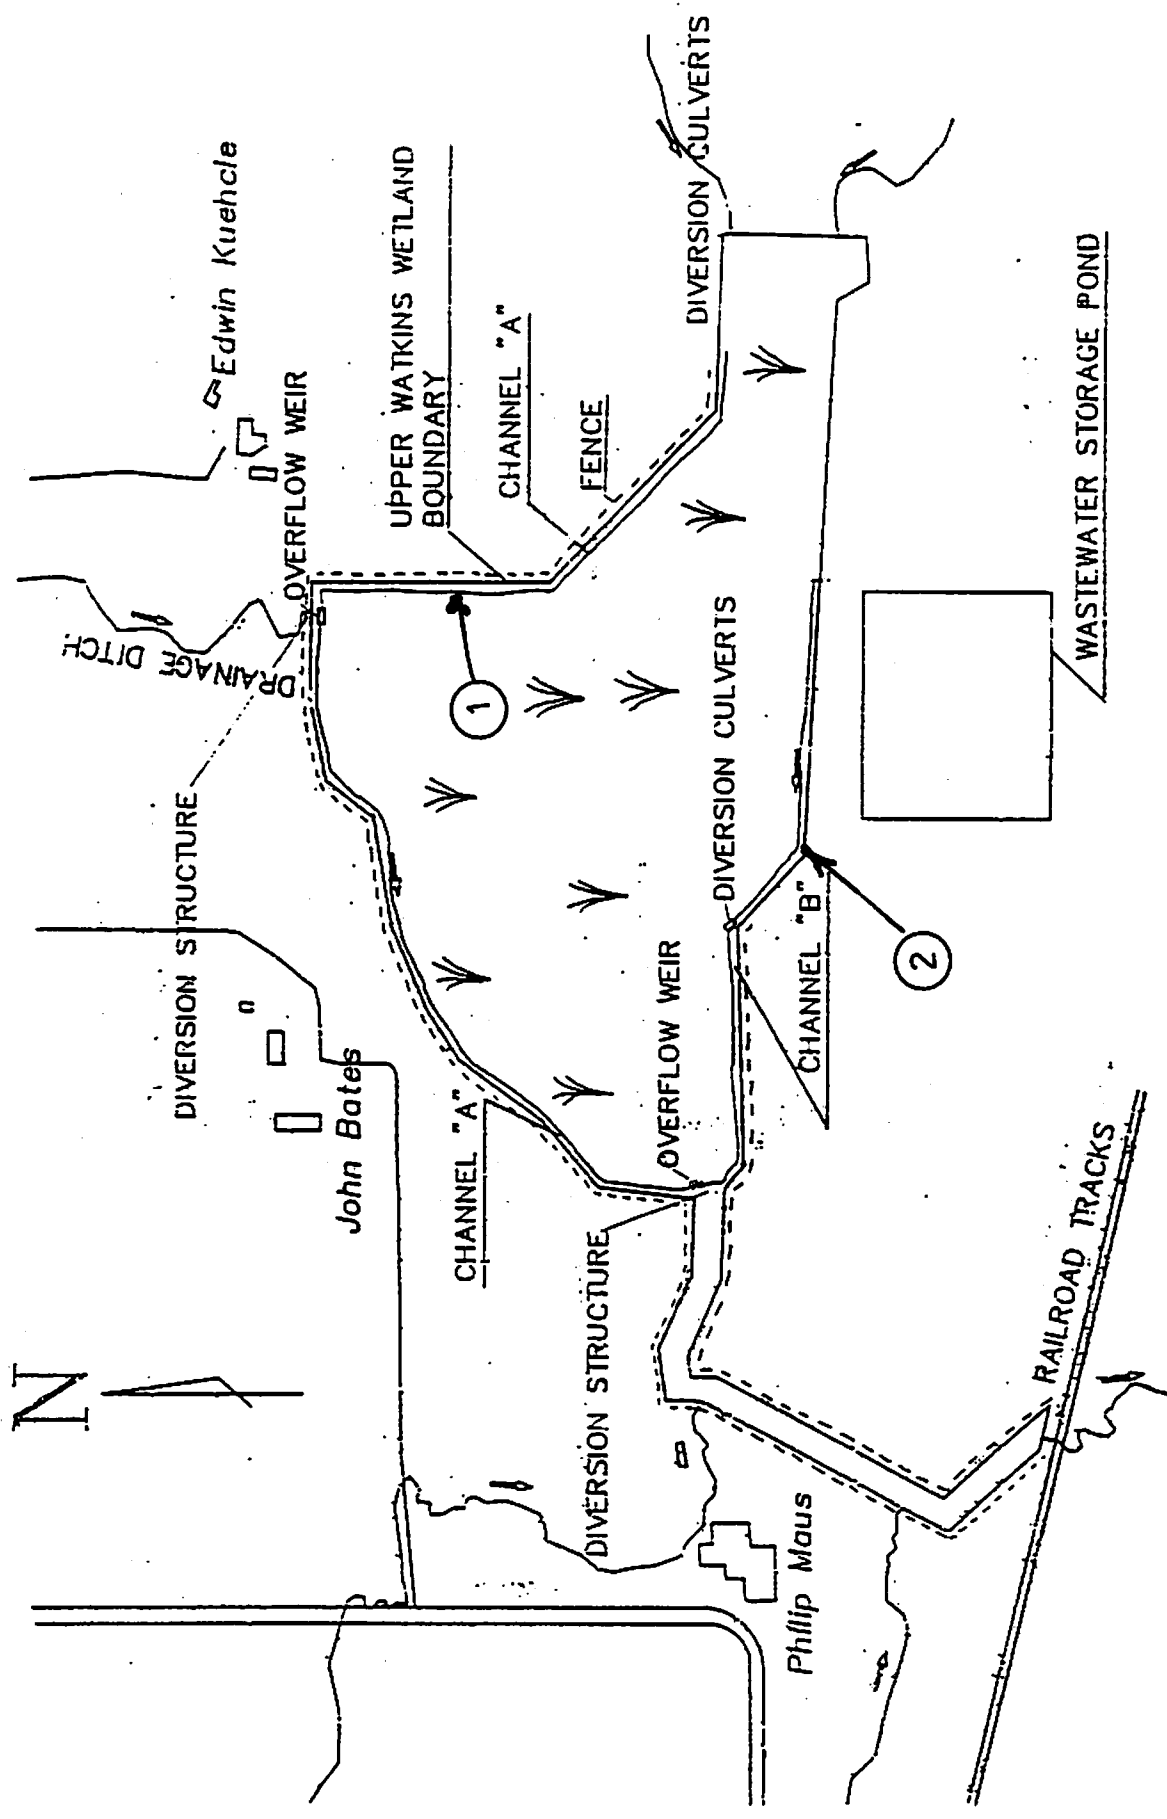
MAY, 2000
Figure 3

1. Small washout in northwest ditch 3 ft. wide stabilized and well vegetated.			X	
2. Ditch along south side filled in with sediment from farm field. 200 ft. x 15 ft. x 3 ft. = 330 C.Y.			X	Talk to farmer for buffer strip

3. Fence repair and tightening.	X			Kevin 8 hours
<i>School Section Lake Outlet Project (See Photo 11)</i>				
1. Outlet structure in good condition.			X

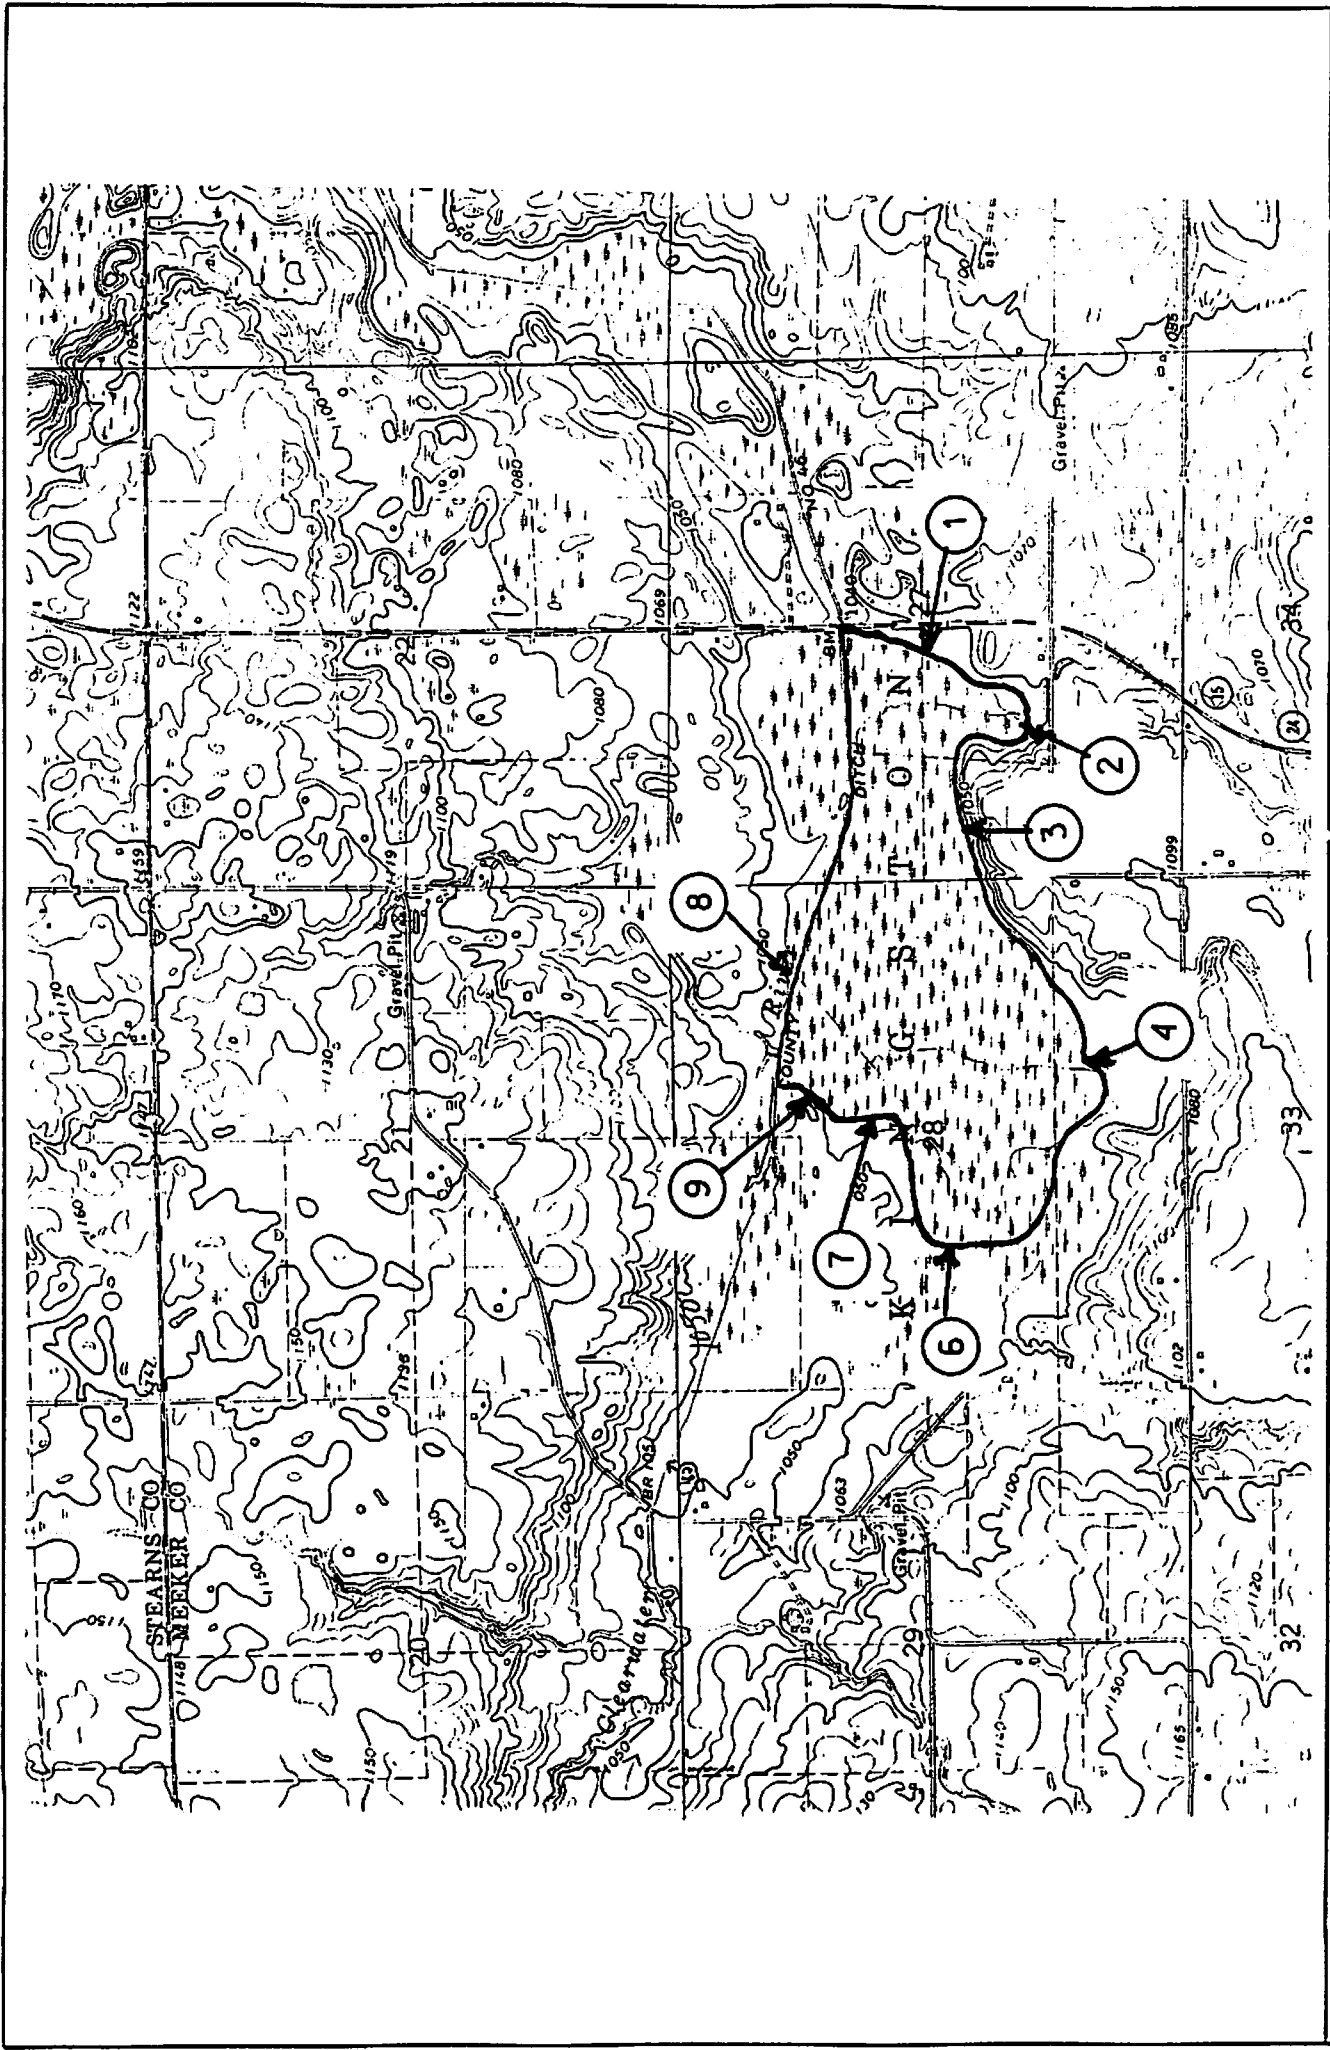
MAY, 2000
Figure 5

1. Structure and overflow in good condition.			X	
<i>Kingston Wetland Treatment Project</i> <i>(See Figure 5)</i>				
1. Water levels high on east end. Beavers in ditch - some channel ports plugged.	X			\$500.00 plus Kevin 8 hours

2. Beaver dam in ditch 300 ft. west of culvert. Water level 2 ft. lower to west.			X	
3. Beaver dam in ditch water 2 ft. lower to west.			X	
4. Beaver dam in ditch/partly washed out.			X

5. Fence repair and tightening.	X			Kevin 16 hours
6. Sediment delta in ditch -southwest sed basin to 900 ft. downstream. 900 ft. x 10 ft. x 2 ft. = 650 C.Y.	X			\$5,000.00

7. Washout 75 ft. south of first overflow structure.	X			\$2,000.00
8. Water enters old river channel 1,000 ft. upstream of State Highway 15.			X	
9. Sediment has filled in 300 ft. of 900 ft. sed basin.			X	
<i>Aerator Buildings</i>

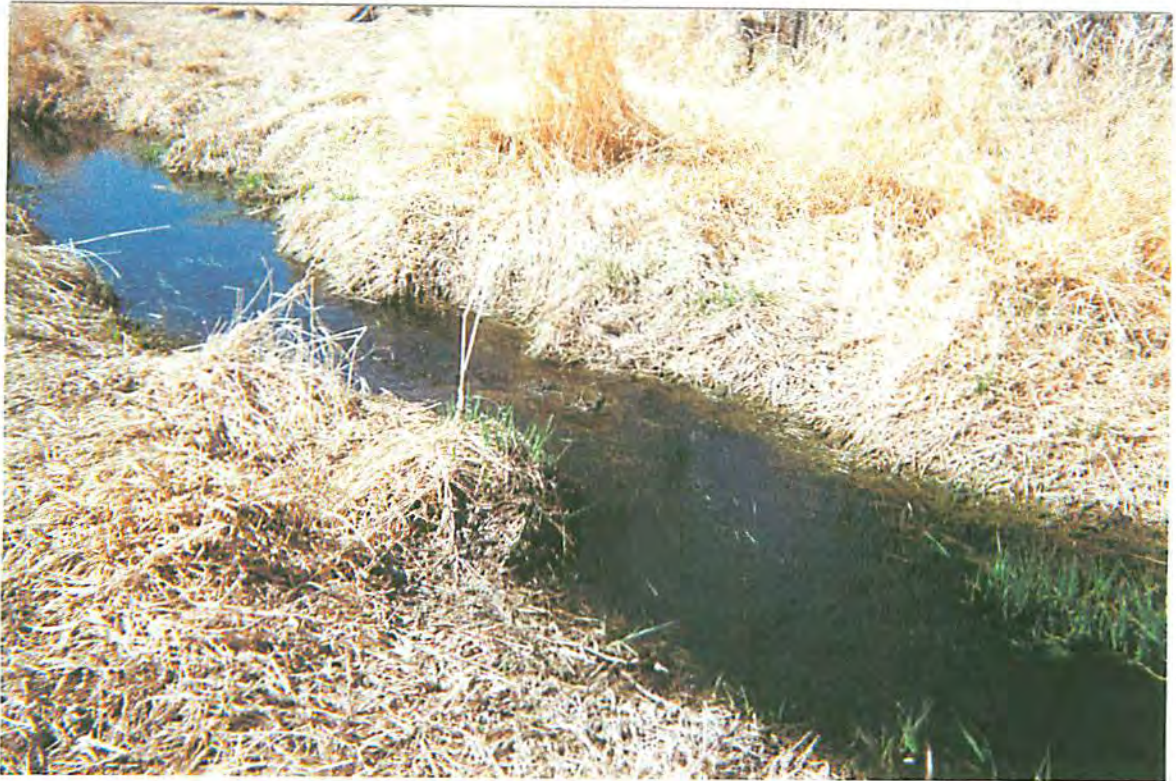
1. **Watkins Wetland Treatment Project
Typical Ditch Section.**

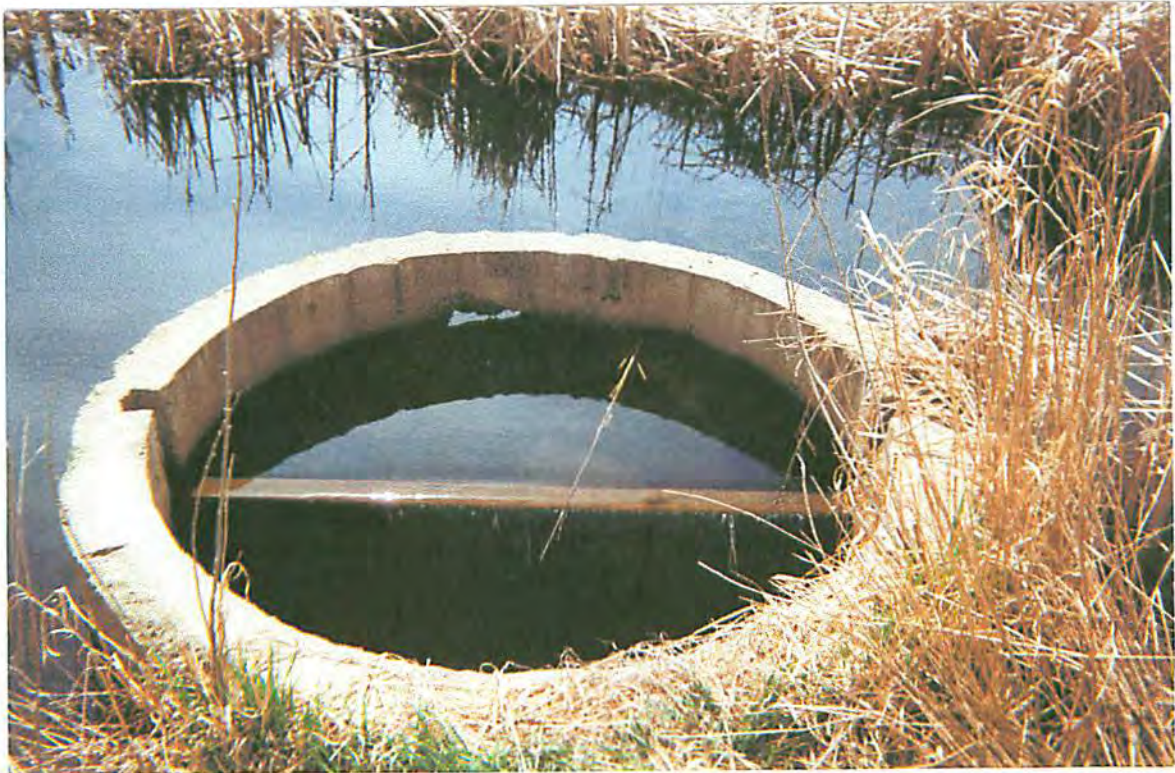
2. **Annandale Wetland Treatment Project
Control, Outlet Structure.**

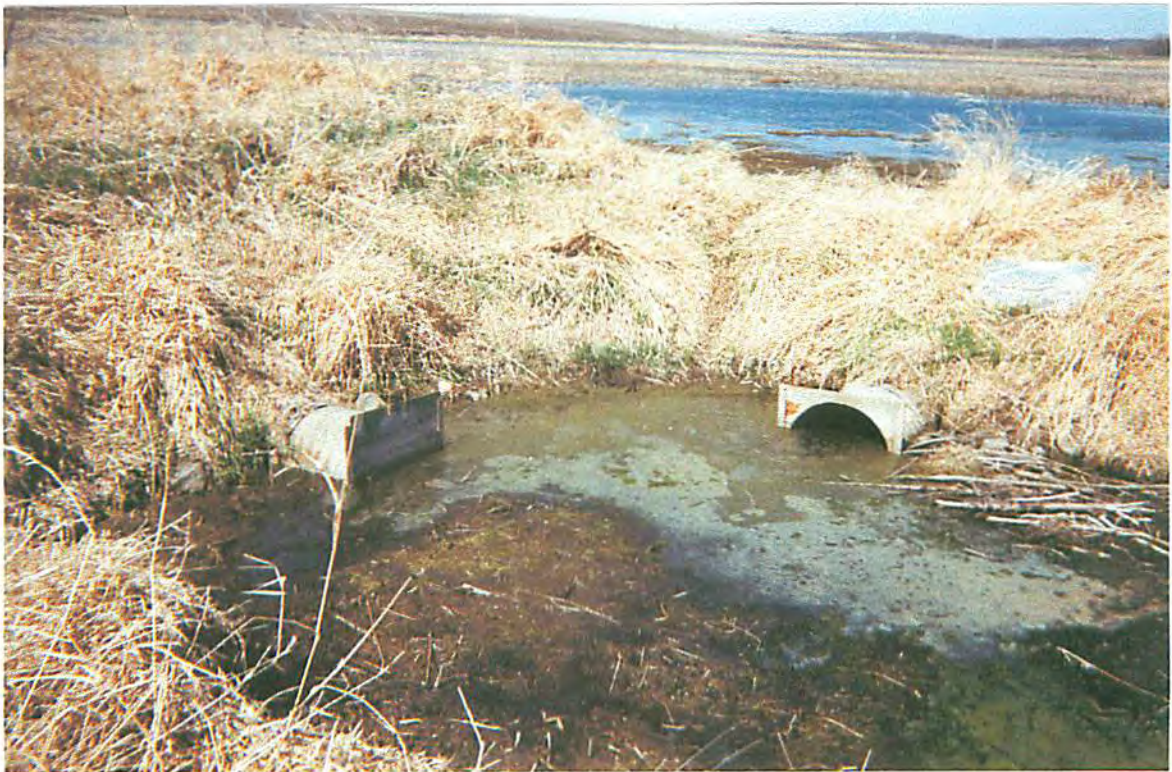
4. Upper Watkins
Wetland Isolation Project.
North Ditch Controls.

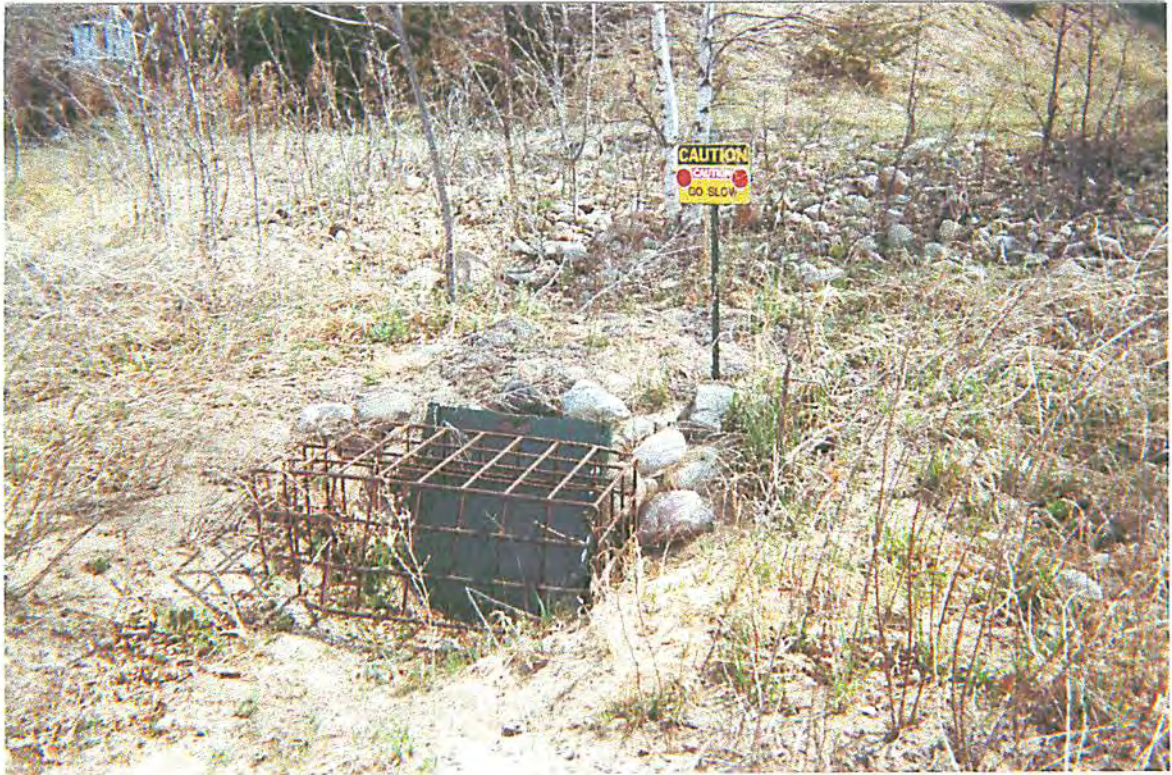
5. School Section
Lake Outlet Project.
New Outlet Structure.

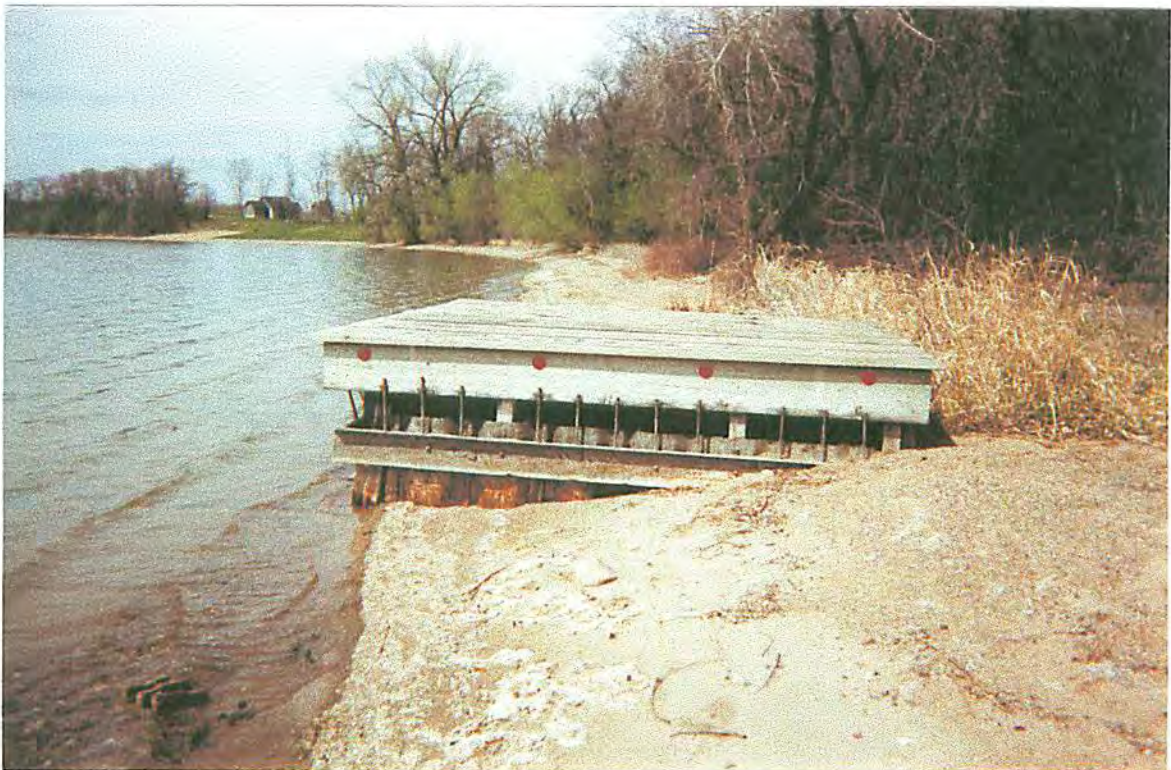
6. Pleasant Lake
Outlet Project .
Outlet Structure.

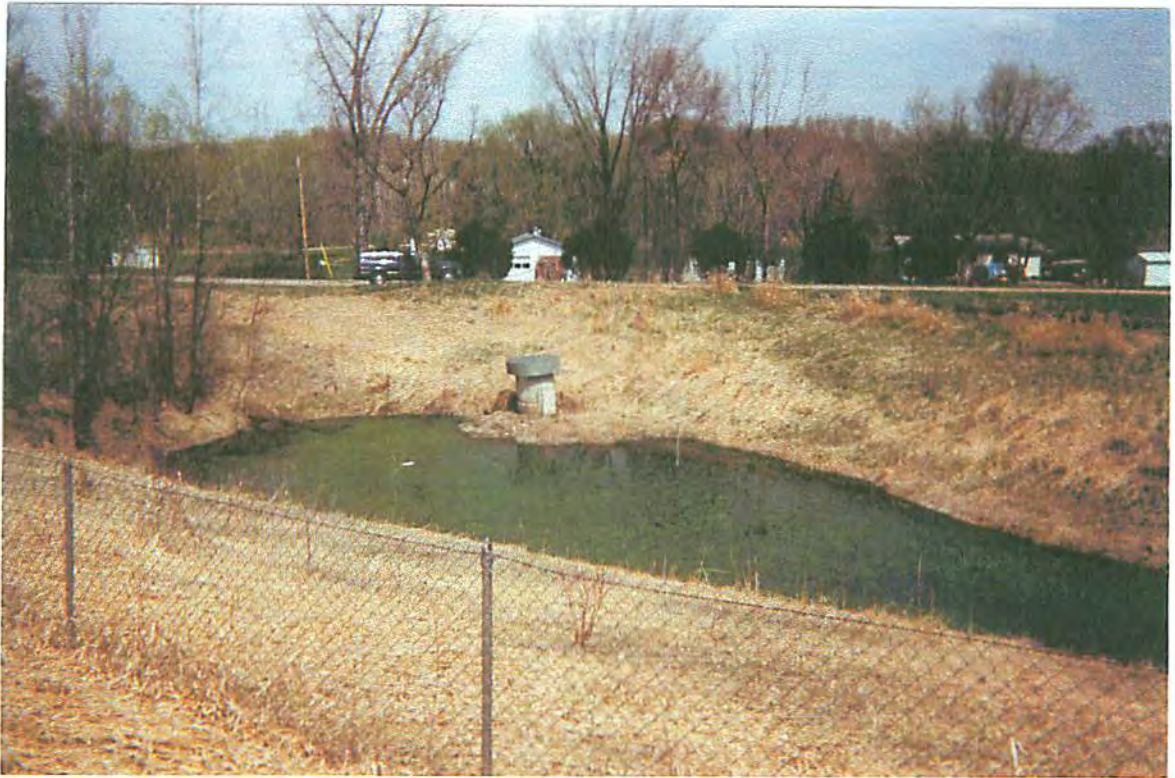
**7. Lake Augusta
Erosion Control Project.
Sedimentation Basin and Overflow Structure.**

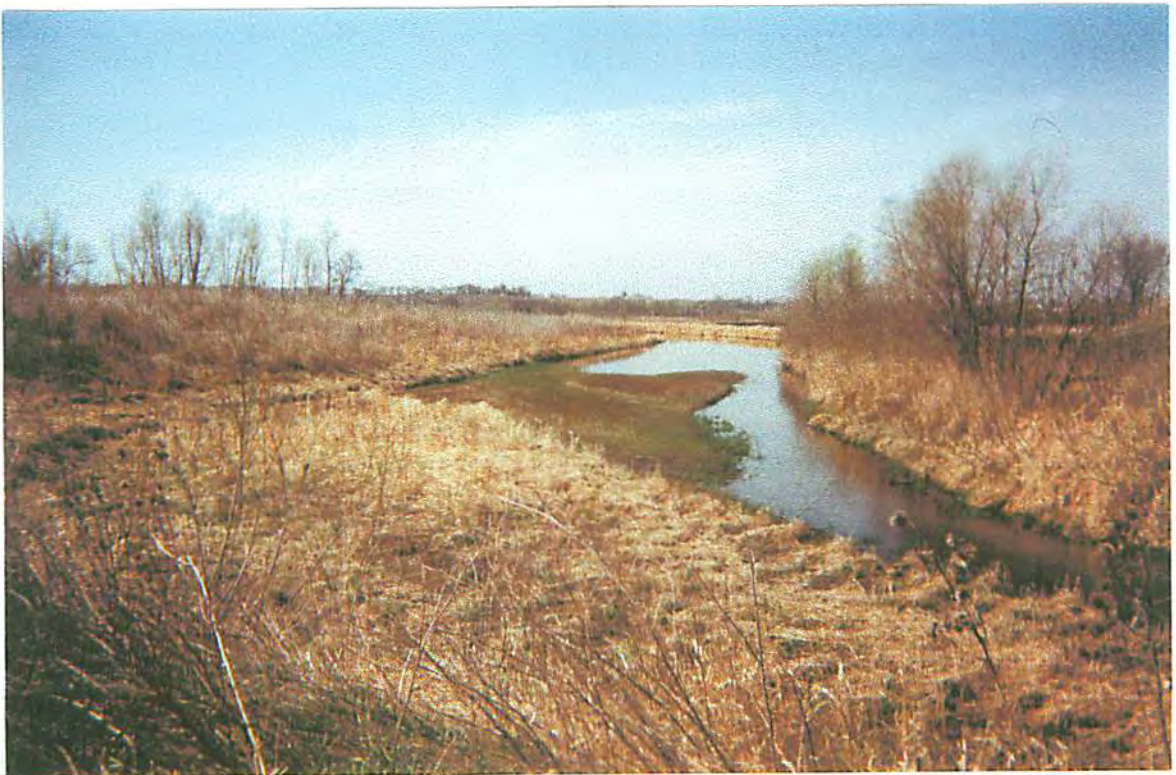
**8. Kingston Wetland Treatment Project
Sedimentation Basin.**

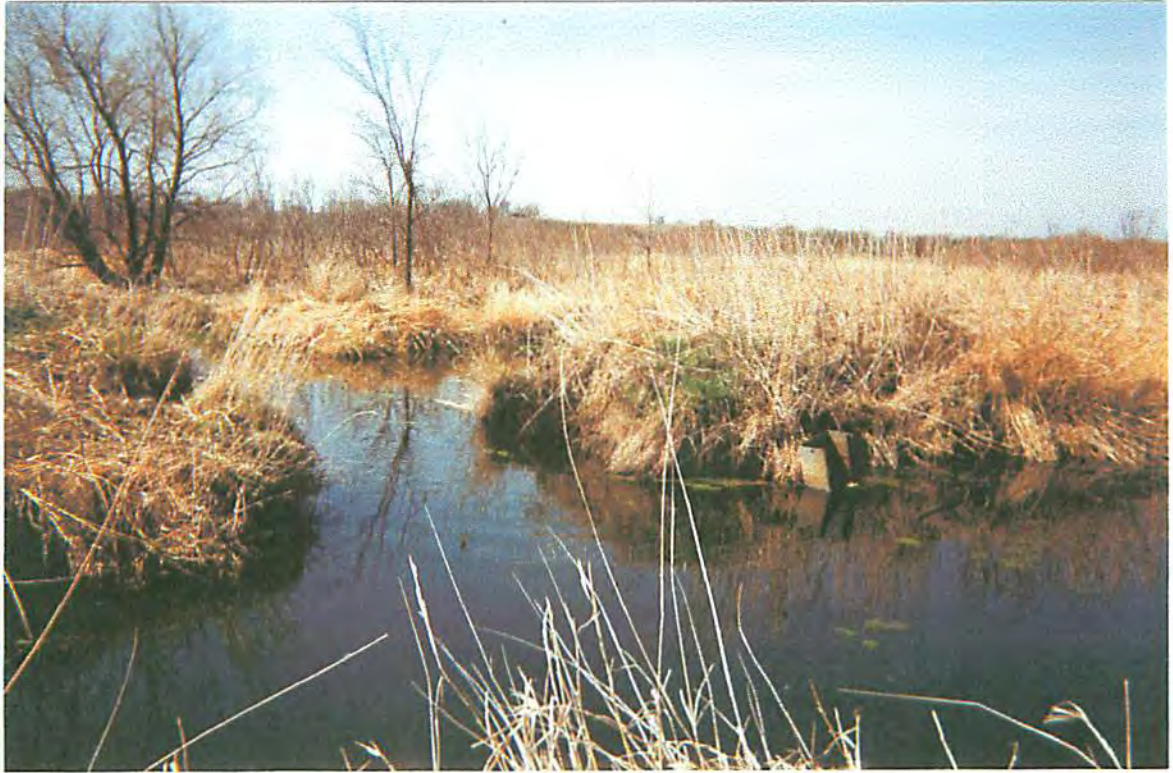
9. **Kingston Wetland Treatment Project
Berm Washout at West Overflow Structure.**

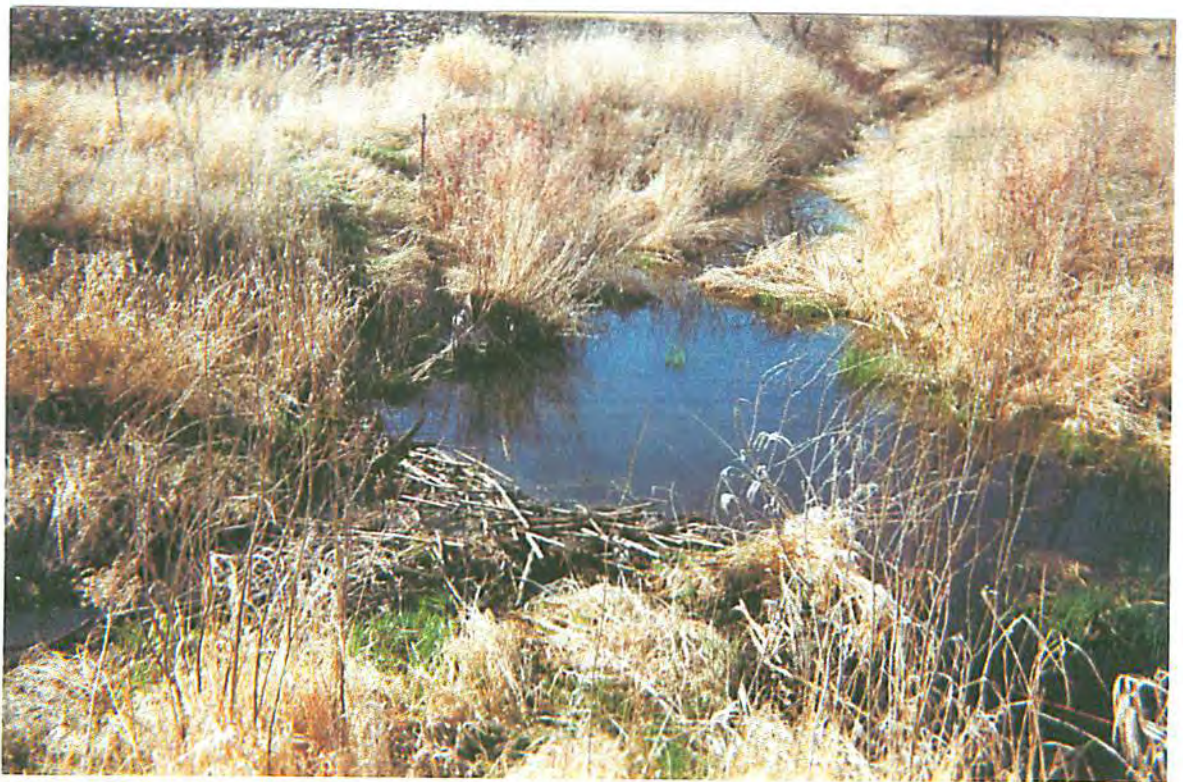
10. **Kingston Wetland Treatment Project
Beaver Dam on Southeast Side.**

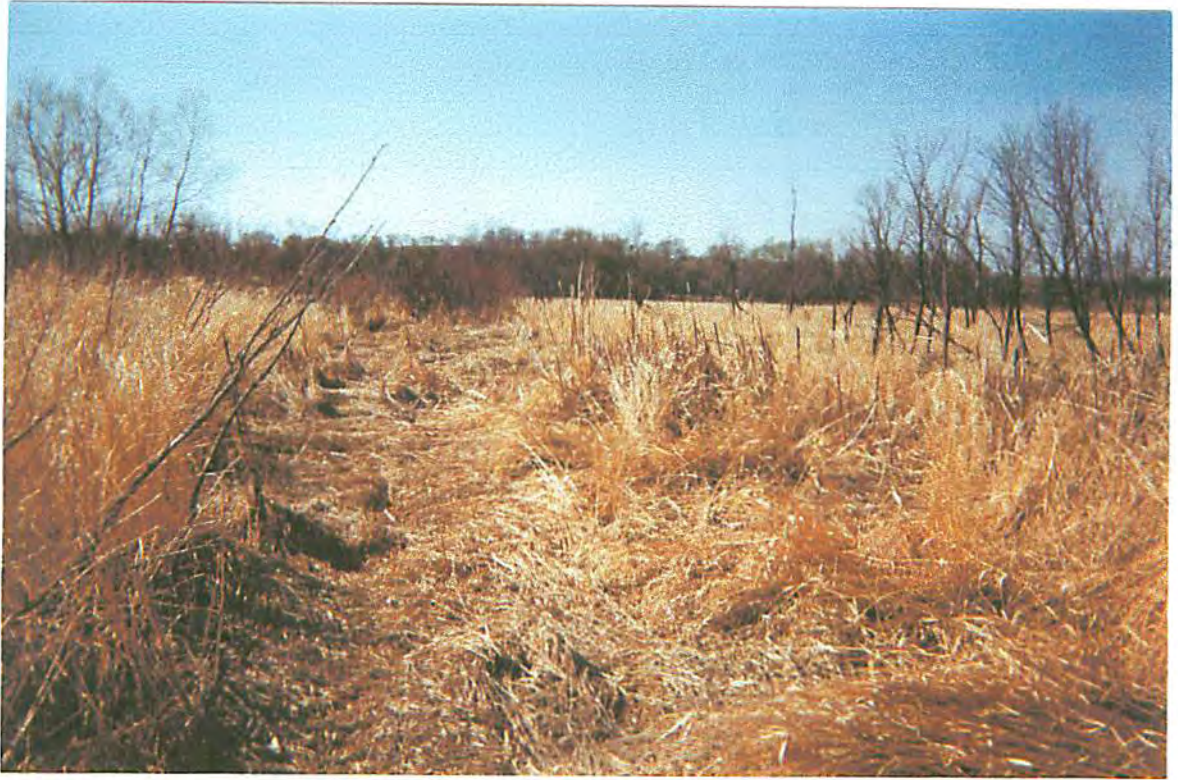
**11. Kingston Wetland Treatment Project
Silted in Ditch West Side.**

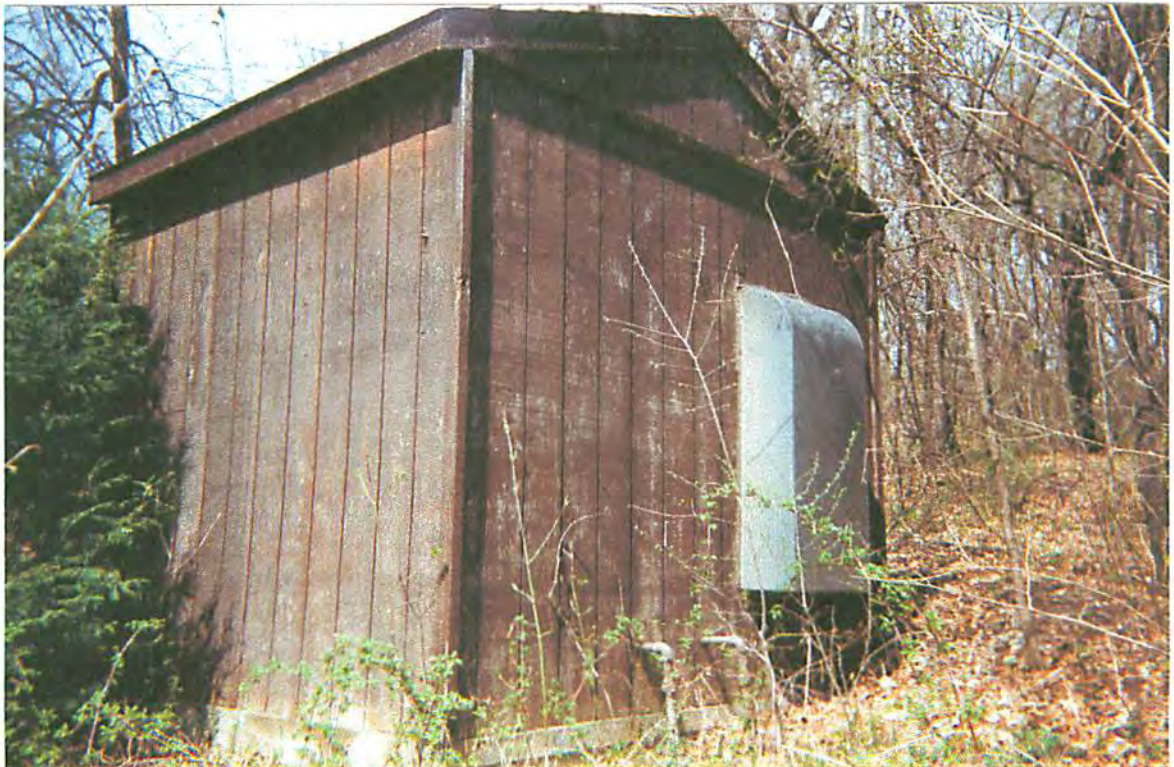
1. Lake Louisa Building needs staining.	X			\$20.00 Kevin 4 hours
2. Lake Marie Building needs staining and new door.	X			\$300.00 Kevin 8 hours
3. Lake Augusta Building needs staining and rain gutters repaired.	X			\$100.00 Kevin 8 hours

**12. Aerator Building
Lake Louisa.**
