2007 Project Inspection Report

Prepared for
**Clearwater River
Watershed
District**

Re: 2007 Project Inspection Report
Wenck File #0002-101

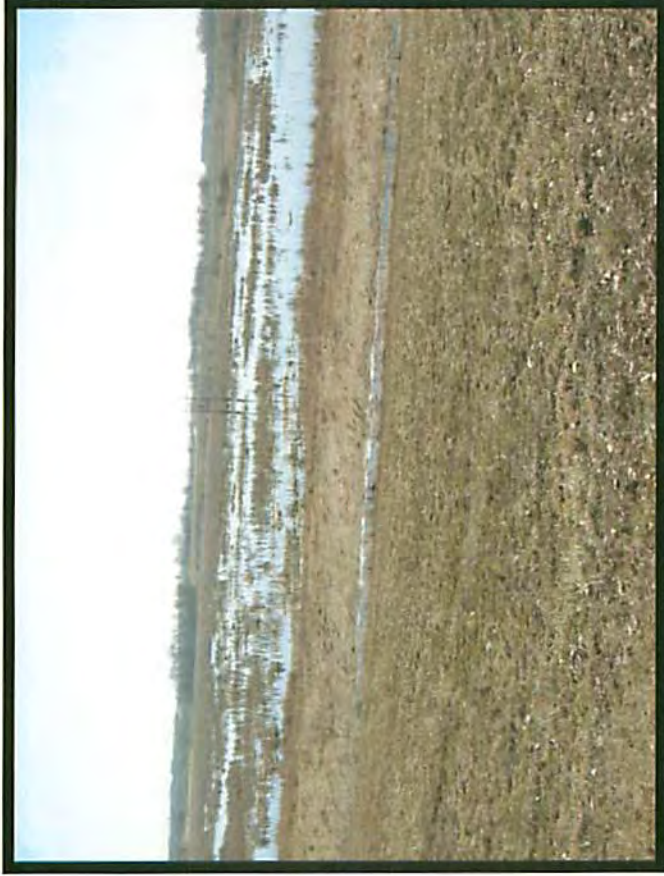
Photo 1-Upper Watkins Wetland Isolation Project
(North)

Project	Maintenance			Estimated Cost
	Required	Optional	No Action Now	
Upper Watkins Wetland Isolation Project (North) (see Figure 1 and Photo 1)				
1. Summer weed control	✓			Kevin- 8 hrs + \$300 for equipment
Watkins Wetland Treatment System (South) (see Figure 2 and Photo2)

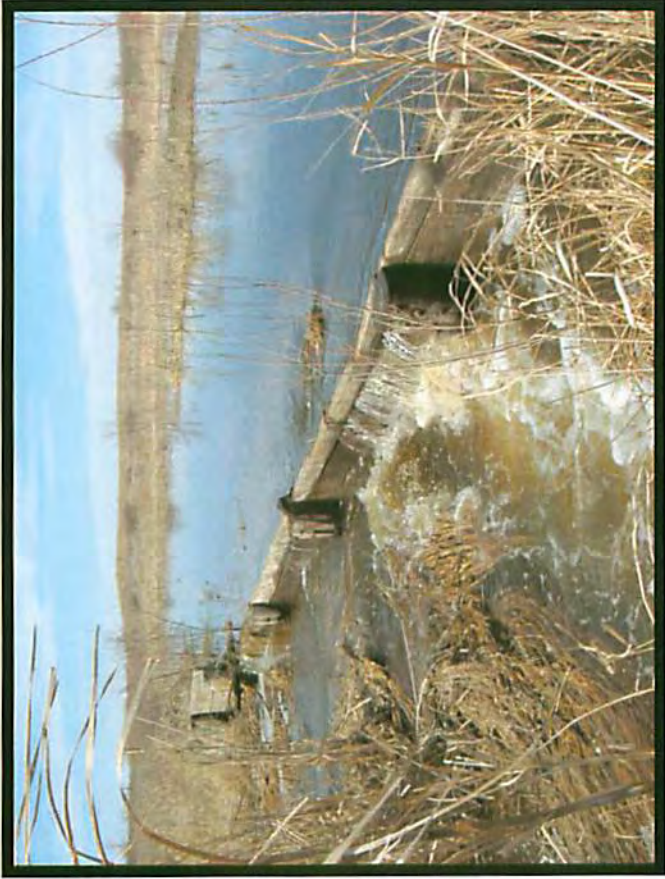
Photo 7-Kingston Wetland Piling Structure Needs
Repair

1. Repair wooden structure at bend in channel.	✓			\$4,000
2. Remove vegetation and debris from some ports. Most ports in good condition.		✓		Kevin - 16 hrs + \$100 for equipment

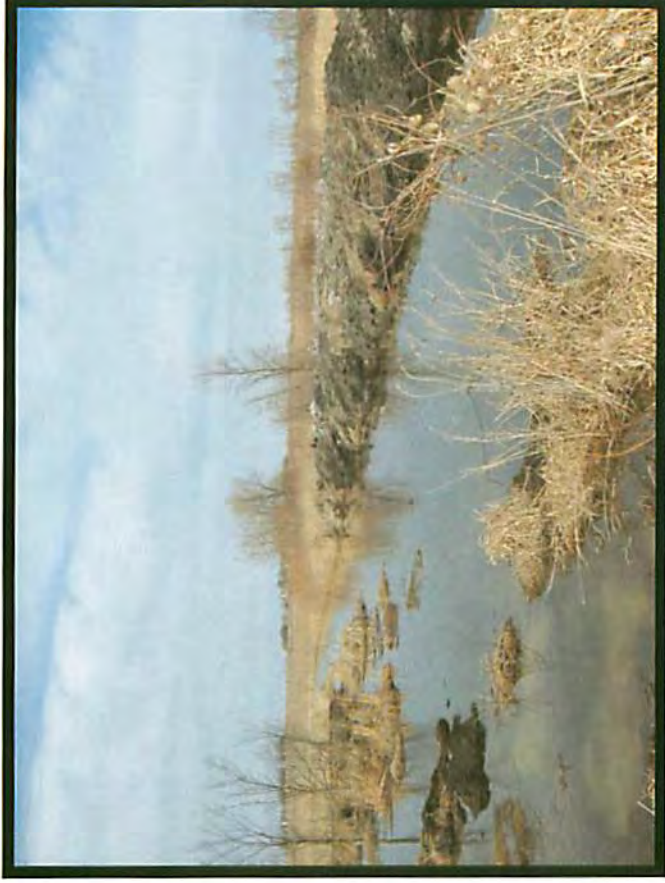
Photo 8-Kingston Wetland Area of 2006 Channel
Repair

3. Reshape channel and reinforce dike to alleviate further problems with dike washouts.		✓		\$6,000
Aerator Buildings (see Photo 9 & 10)				
1. Lake Augusta-Good condition, no maintenance needed.			✓

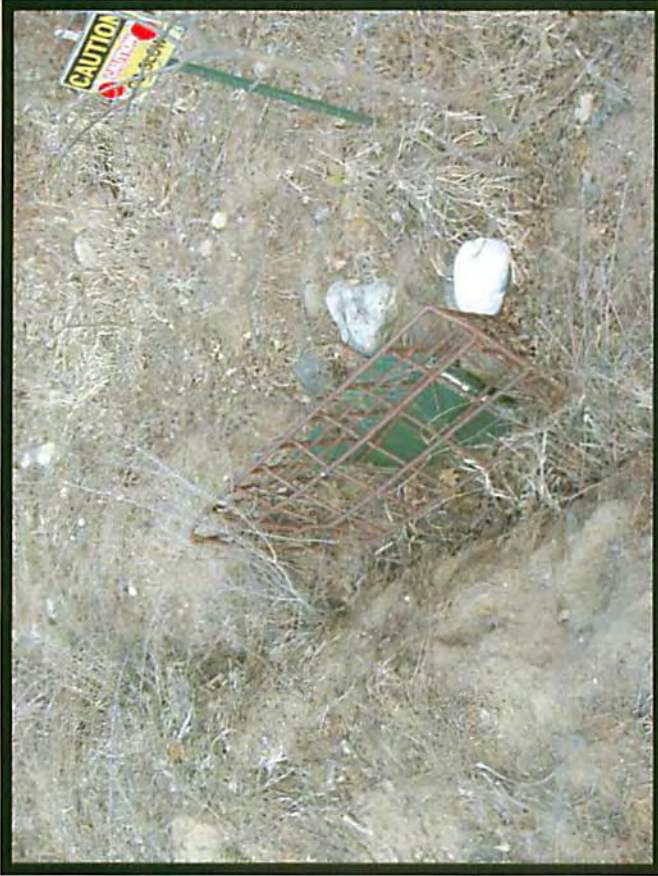
Photo 11-School Section Lake Outlet Project

Project	Maintenance			Estimated Cost
	Required	Optional	No Action Now	
School Section Lake Outlet Project (see Photo 11).				
1. Sand ridge in front of outlet structure.		✓		\$1,000
Rest-a-While Wastewater Treatment System (see Photo 12, 13, & 14)

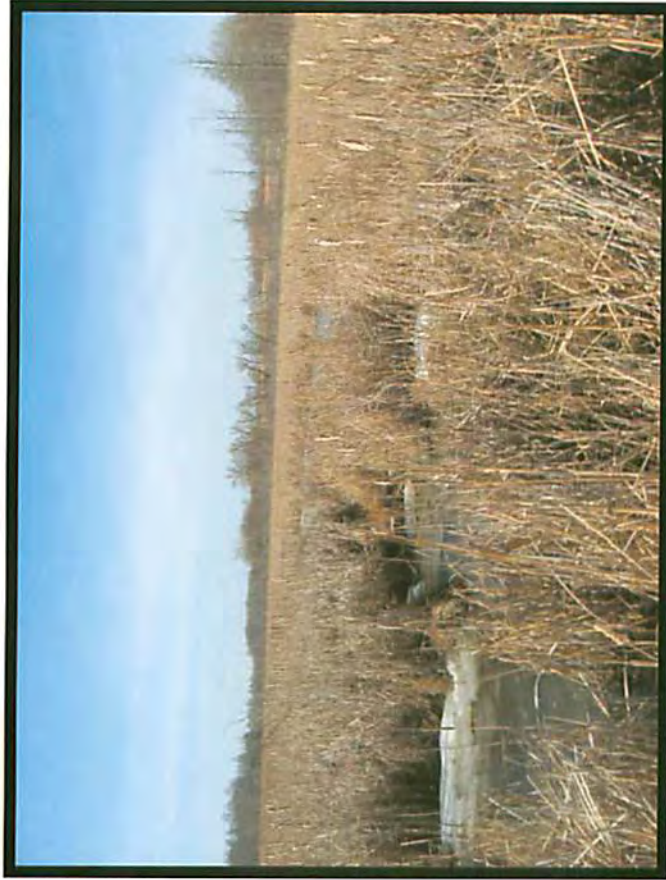
Photo 19-Annandale Wetland Treatment System
Channel Blockage Near Diversion Structure

1. Vegetation needs to be removed from channel near diversion structure and two ports.	✓			Kevin - 16 hrs + \$300 for equipment
2. Beaver dam that is blocking south channel needs to be removed.	✓			Kevin - 16 hrs + \$300 for equipment
Pleasant Lake Outlet Project (see Photo 23).

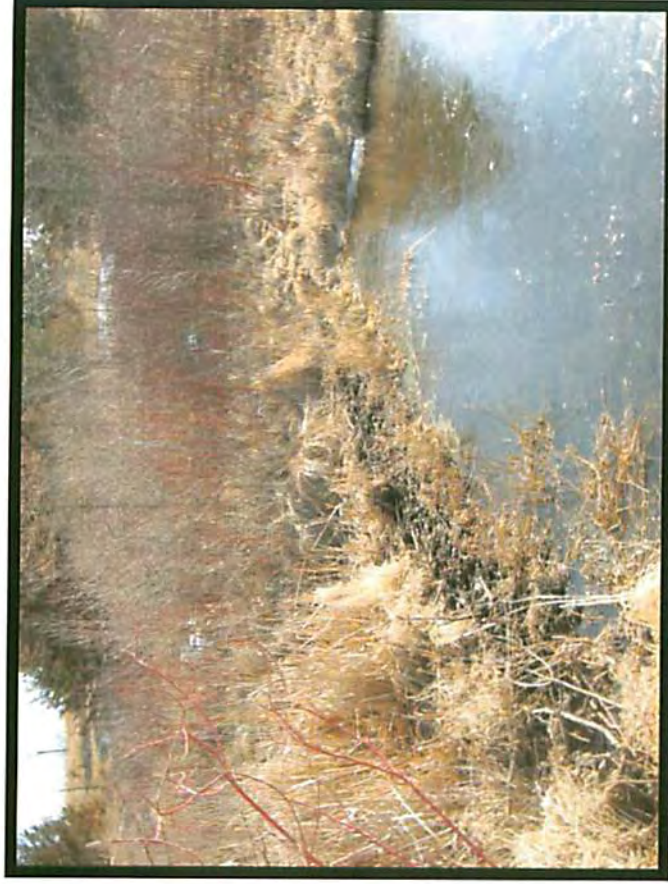
Photo 20-Annandale Wetland Treatment System
Beaver Dam Blocking Flow

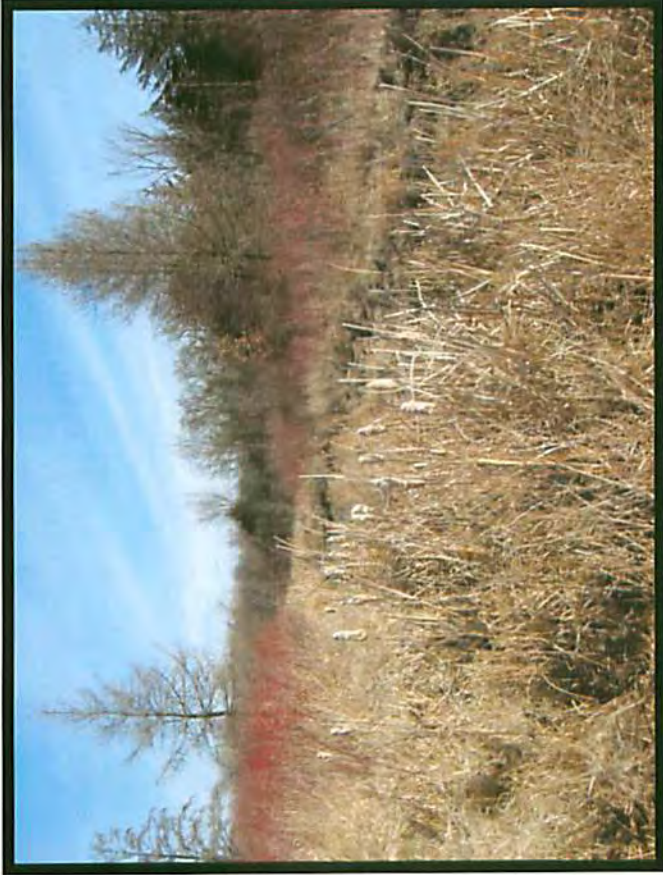
Photo 21-Annandale Wetland Treatment System
Dry Channel Downstream of Beaver Dam

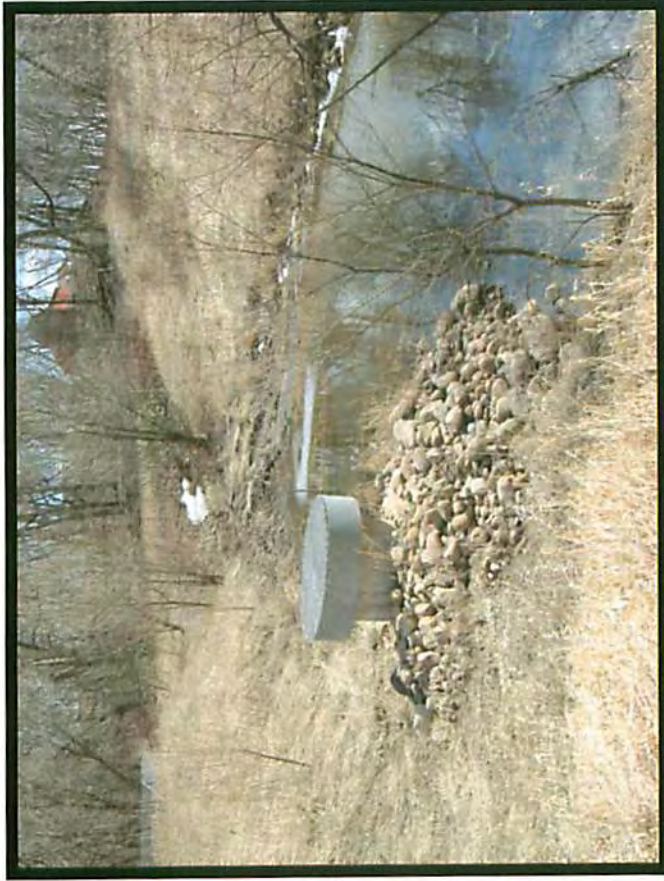
Photo 31-Lake Augusta Erosion Control System
Riser (Cracks in bottom of structure to be repaired
in 2007)

Project	Maintenance			Estimated Cost
	Required	Optional	No Action Now	
Henshaw Lake Outlet (see Photo 24).				
1. Outlet in good condition.			✓	
Swartout Lake Fish Barrier (see Photo 25 & 26).				
1. Fish barrier installed at lake outlet.			✓	
Illsley Ave Fish Barrier (see Photos 27 & 28).				
1. Fish barrier installed in stream near Illsley Ave and Hwy 55.			✓	
Lake Augusta Erosion Control Project (see Figure 6 and Photos 29, 30, 31, & 32).				
1. Sedimentation boxes in good shape.			✓	
2. Riser has crack in bottom of concrete, needs repair.	✓			Repair crack in concrete base: \$4,000
3. Structure outlet in good condition.			✓
