# **2009 Project Inspection Report**

**Clearwater River  
Watershed  
District**

**Wenck File # 0002-132**

**May 2009**

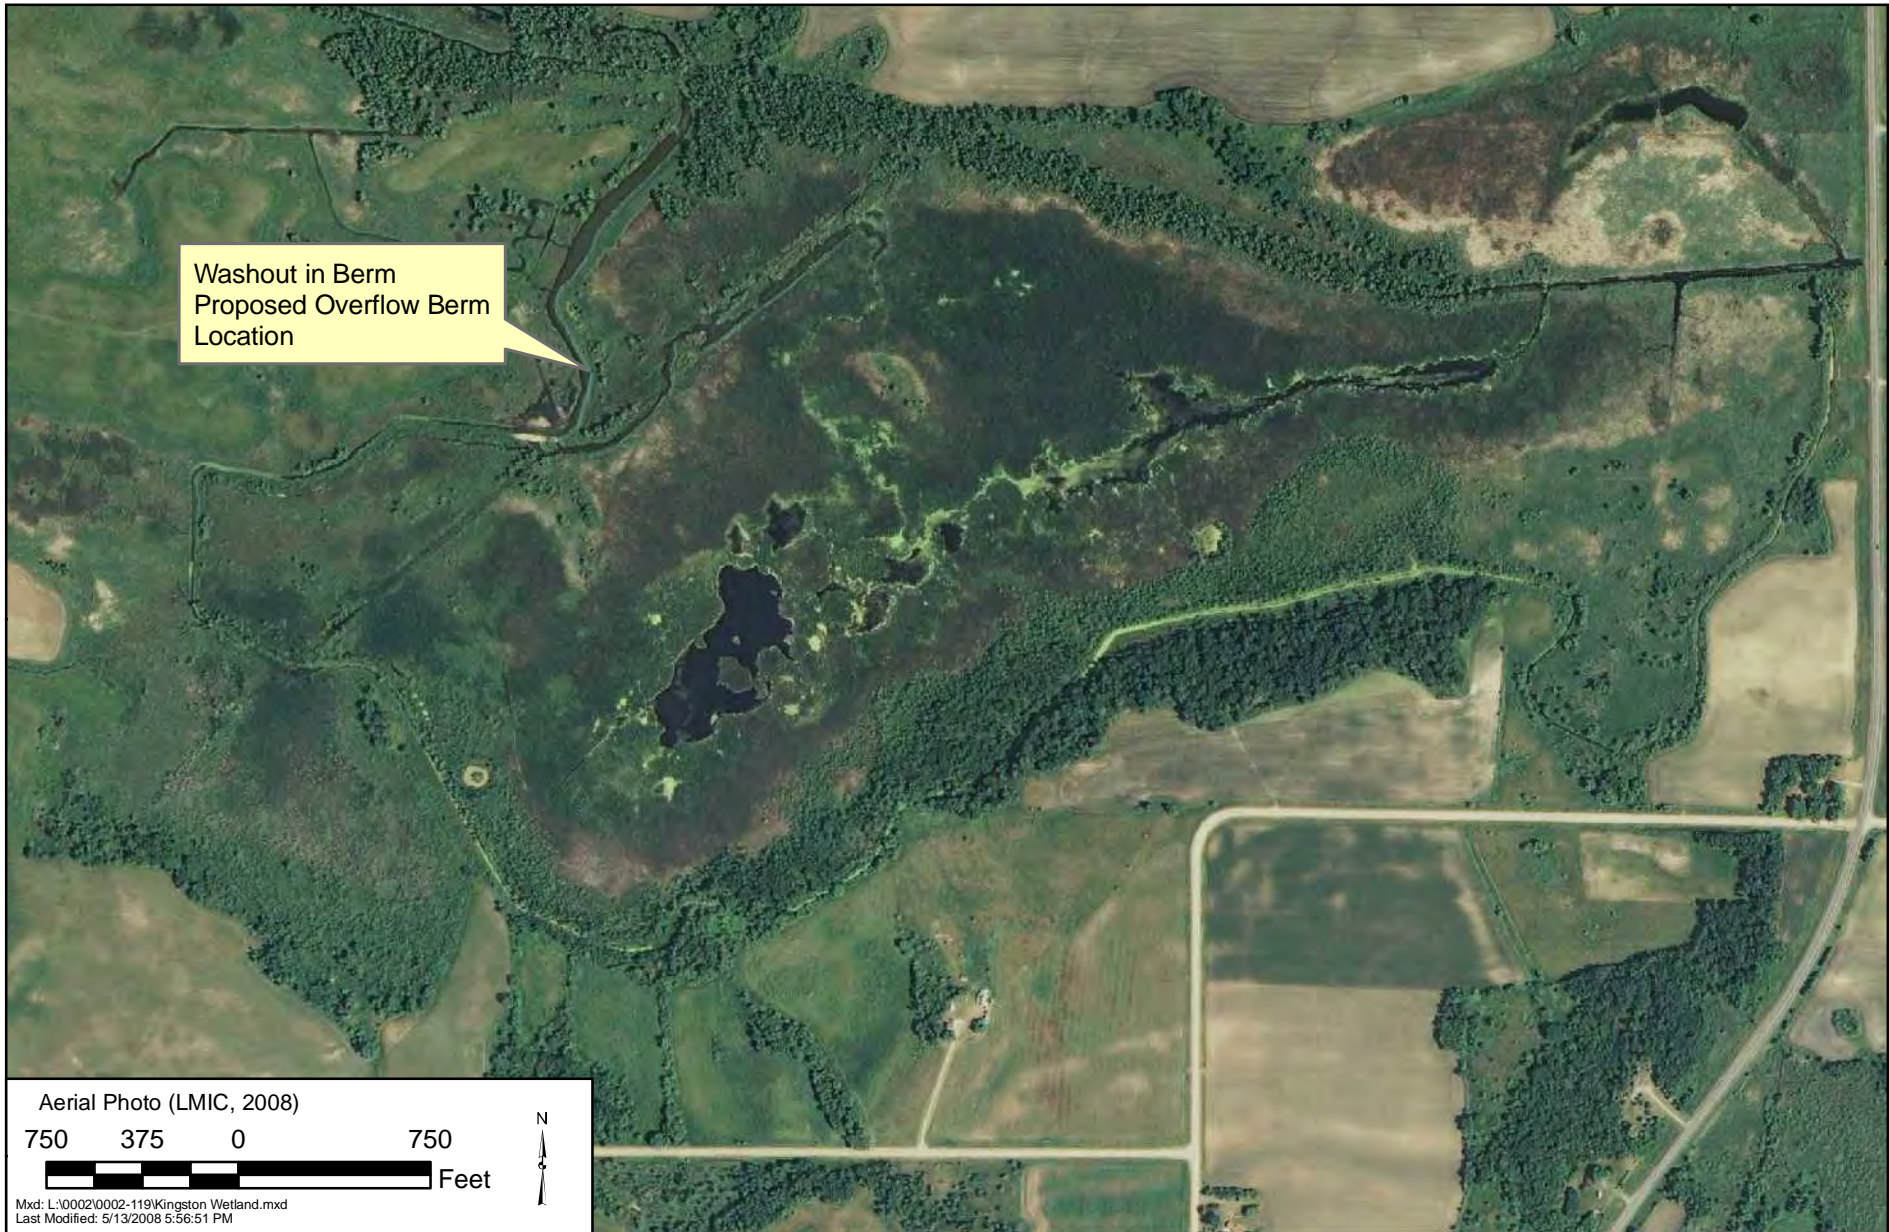
Figure 1

Kingston Wetland Treatment System

1. Repair washout in berm and install rock overflow berm.		✓		\$4,500
2. Water flowing through areas of 2008 sediment removal.			✓	
3. Overflow structure in good condition			✓	
Highway 55 Fish Trap

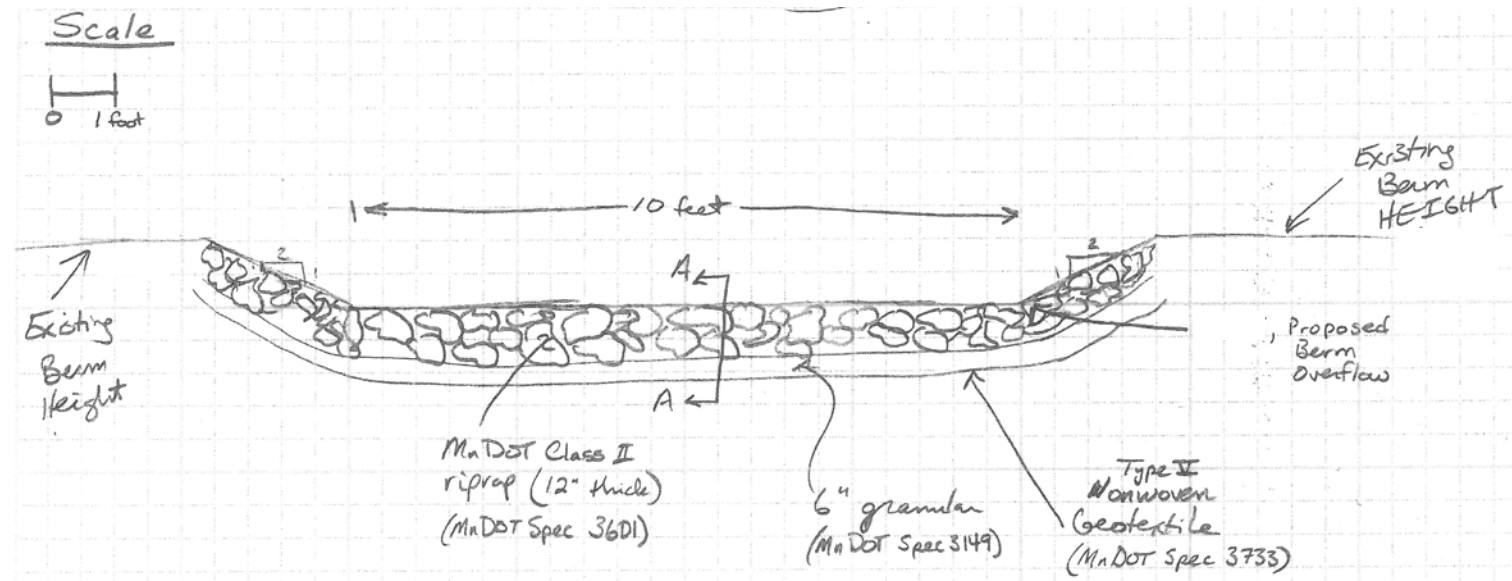
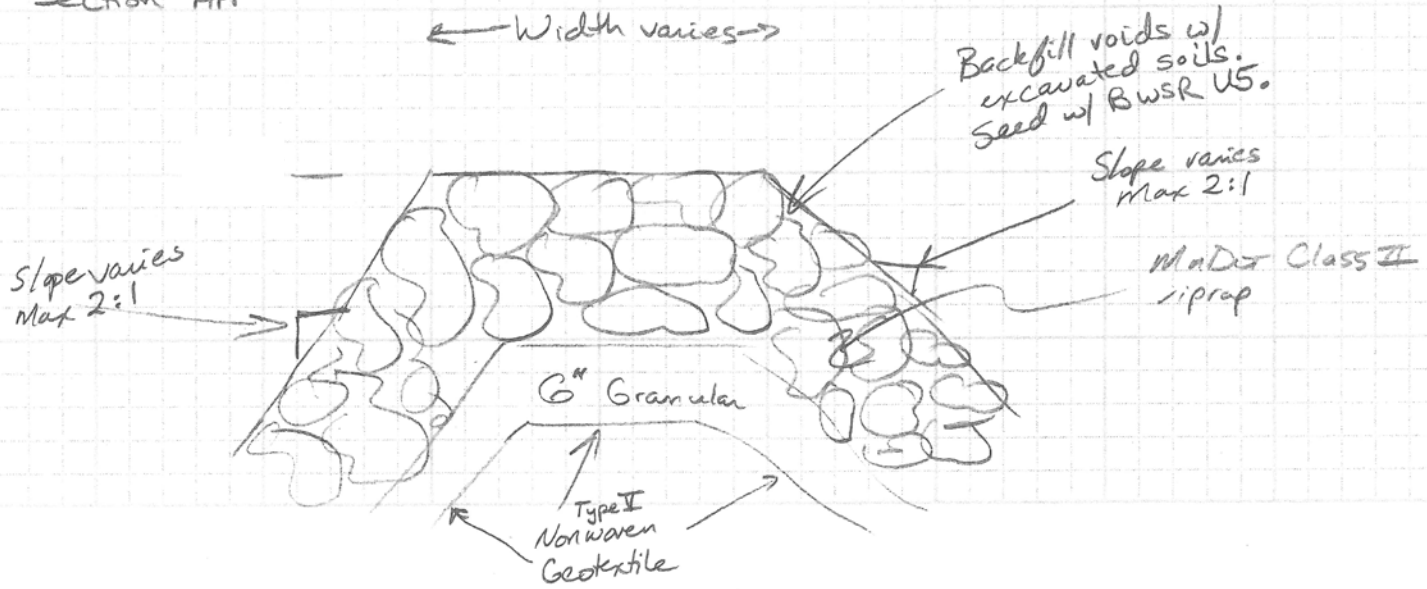
Figure 2

Kingston Wetland Treatment Project-Overflow Berm Design

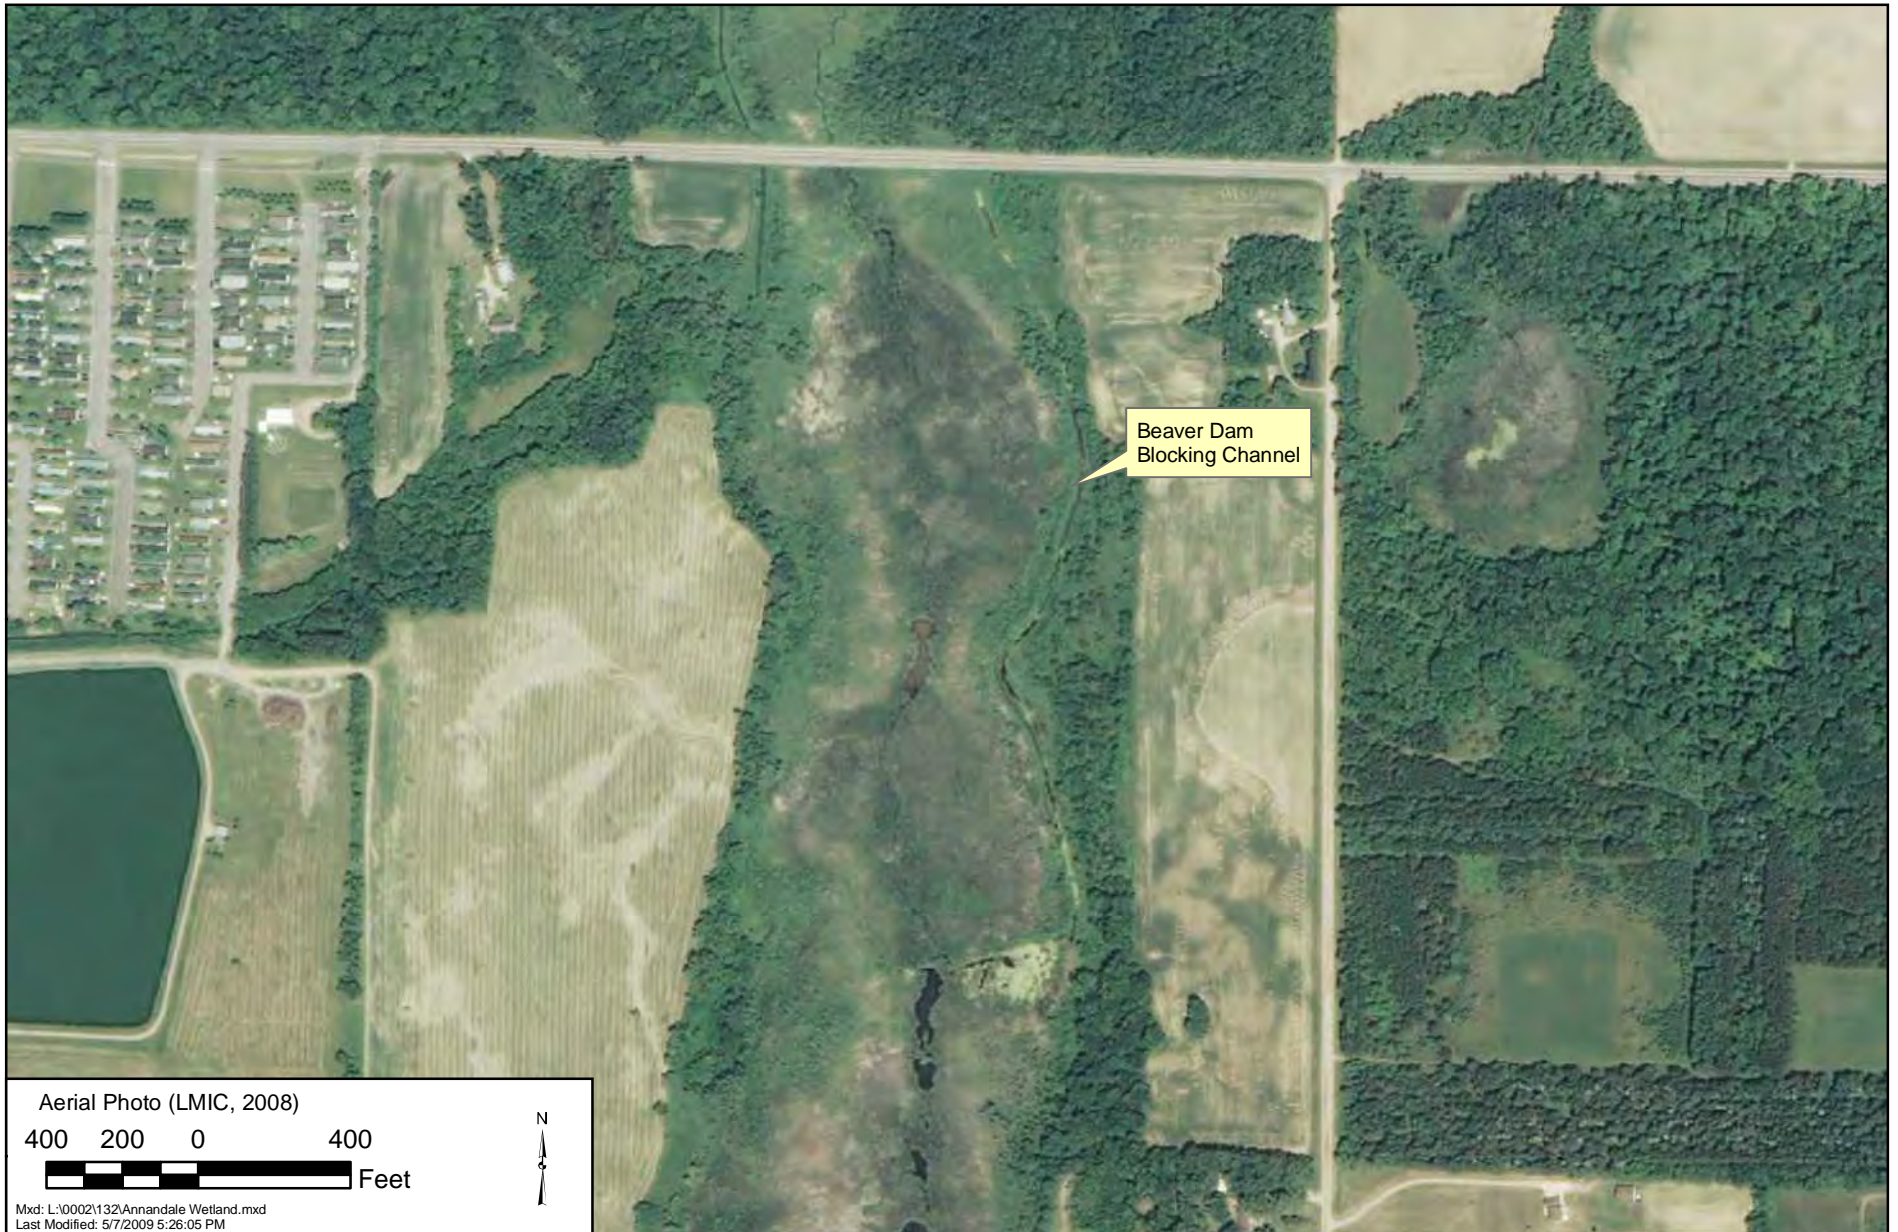
Figure 3

Beaver Dam  
Blocking Channel

1. Beaver dam that is blocking south channel needs to be removed.		✓		Kevin-16 hours + \$300 for equipment
2. Outlet structure in good condition.			✓

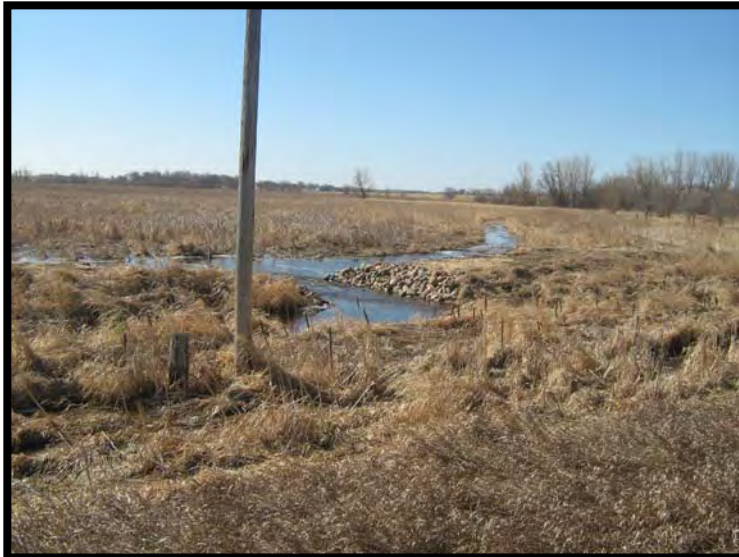
2. Repair otter dugout in berm.	✓			Kevin- 4 hrs + \$200 for equipment
Watkins Wetland Treatment System (South) (see Photos 1 and 2)				
1. New overflow berms operating properly.			✓

Photo 1-Watkins Wetland-North  
Overflow Berm installed in 2008.

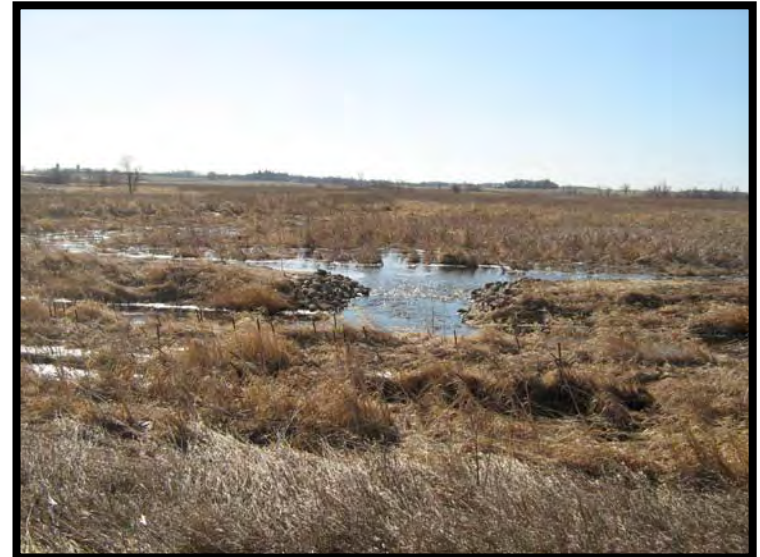
Photo 2-Watkins Wetland-South  
Overflow Berm Installed in 2008

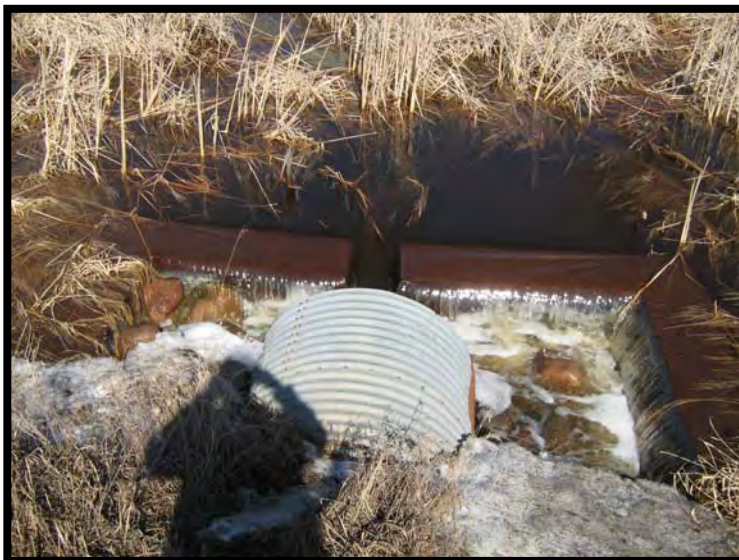
1. Outlet structure in good condition.			✓	
Nistler Sedimentation Basin (see Photo 4).				
1. Sedimentation basin in good condition.			✓	
Kingston Wetland Treatment System (see Figures 1 & 2 and Photos 5 and 6)

Photo 3-Clear Lake V-notch Weir.

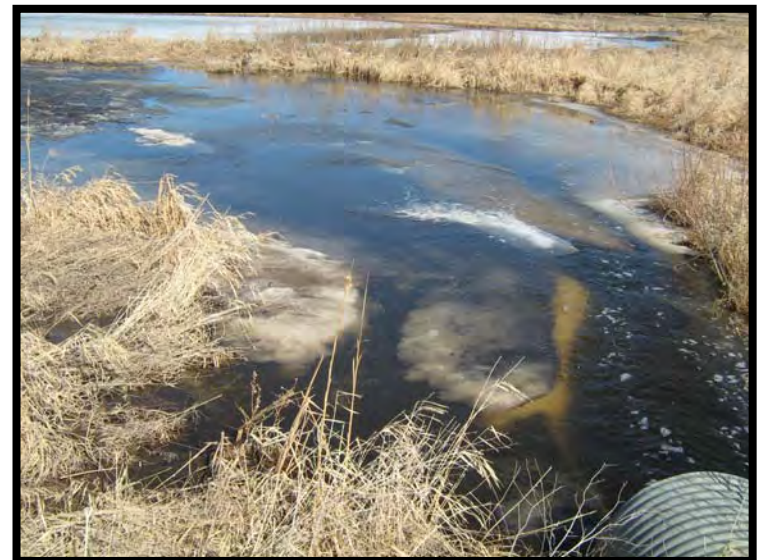
Photo 4-Nistler Sedimentation Basin

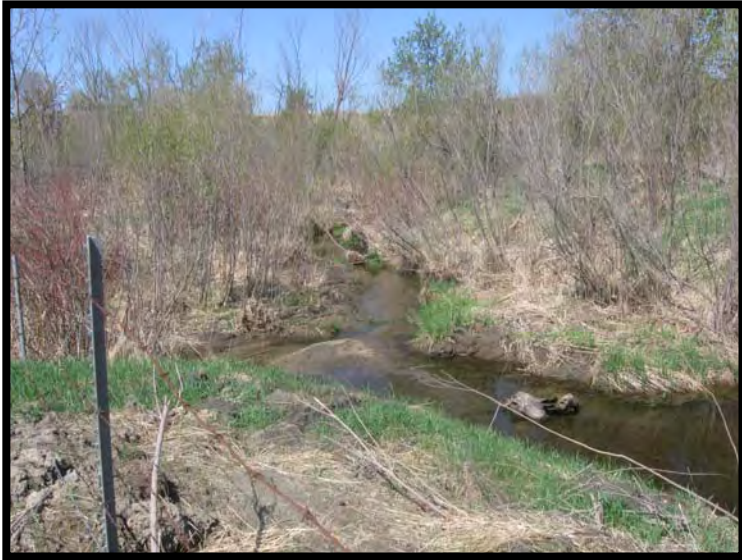
Photo 5-Kingston Wetland-Sediment Removal Area in 2008

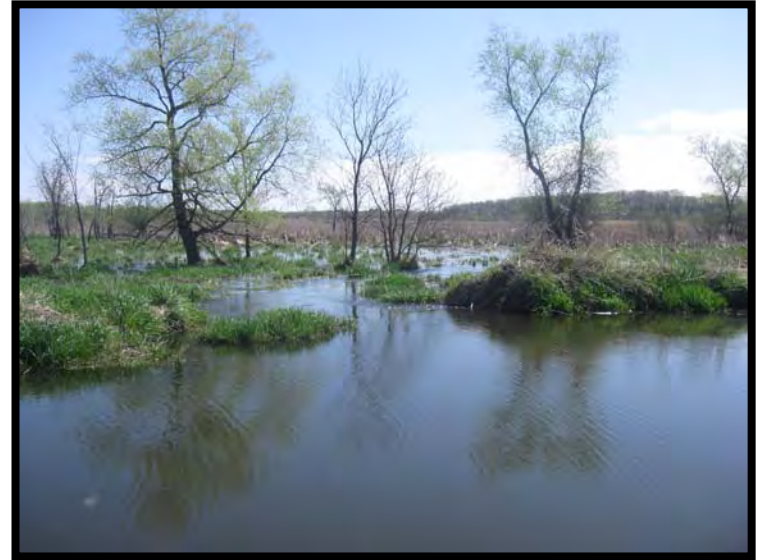
Photo 6-Kingston Wetland Berm Washout

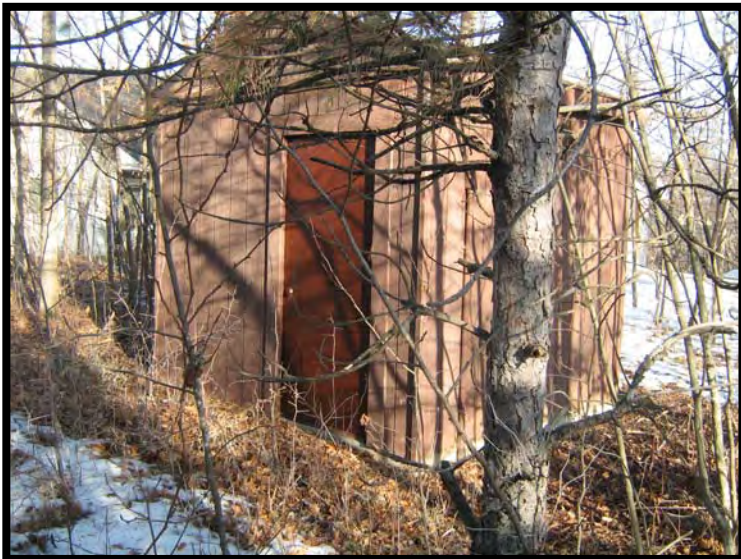
2. Lake Marie- Good condition, no maintenance needed.			✓	
School Section Lake Outlet Project.				
1. Rely on Bob Rocheleau report.			✓	
Rest-a-While Wastewater Treatment System

Photo 7-Lake Marie Aerator Building

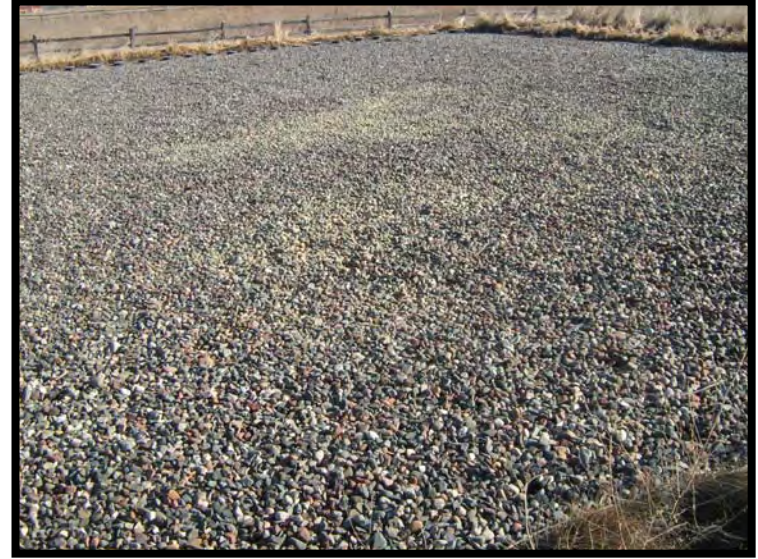
1. Summer weed control	✓			Kevin-8 hrs + \$300 for equipment
2. Pump and sand filter in need of repair.			✓	District has coordinated repairs.
Annandale Wetland Treatment System (see Figure 2 and Photo 9).

Photo 8-Clearwater Harbor Wastewater Treatment System

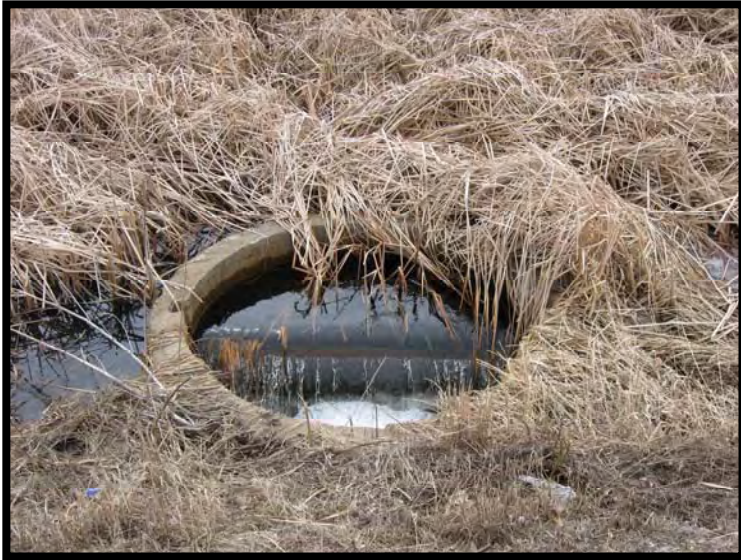
Photo 9-Annandale Wetland Outlet Structure

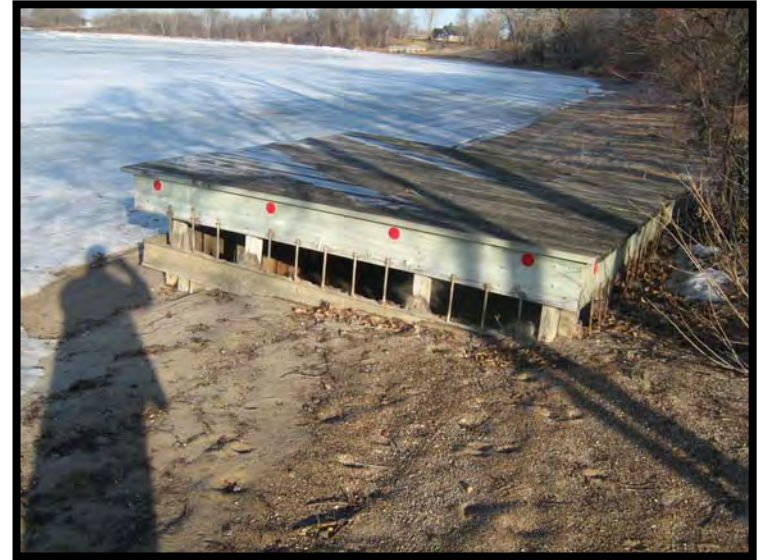
Project	Maintenance			Estimated Cost
	Required	Optional	No Action Now	
Pleasant Lake Outlet Project (See Photo 10)				
1. In good condition, no maintenance needed			✓	
Lake Augusta Erosion Control Project (See Photo 11).

Photo 10-Pleasant Lake Outlet

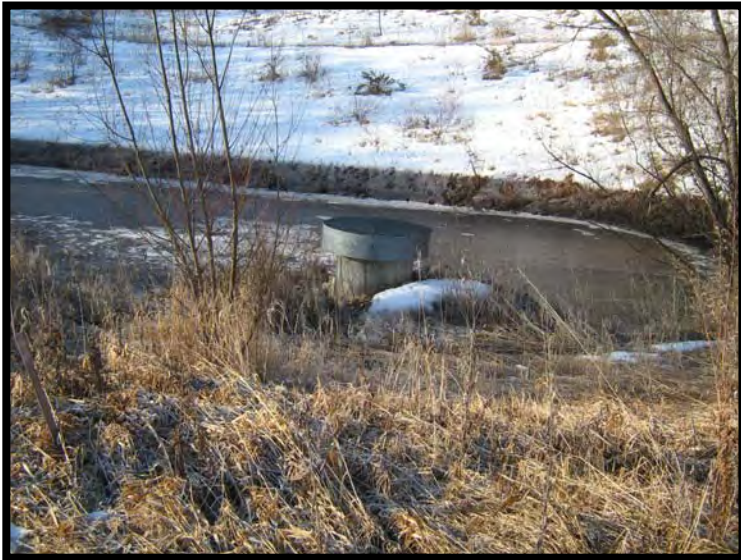
1. Outlet and riser in good condition.			✓	
Norton Ave Sediment Basin (See Photo 12)				
1. Erosion blanket in place.			✓	
Eddie Schultz Buffer (See Photo 13)

Photo 11-Lake Augusta Erosion Control Project Riser Structure

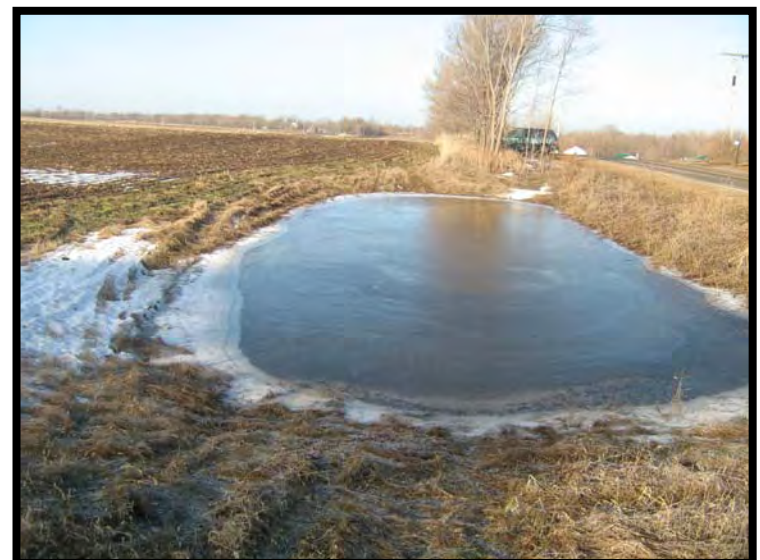
Photo 12-Norton Ave Sedimentation Basin

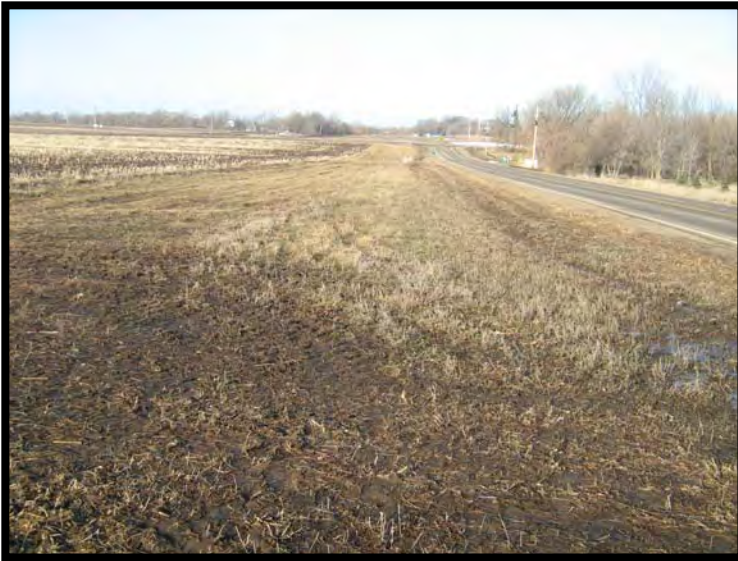
1. No maintenance needed.			✓	
Wandering Ponds Wastewater System				
1. Rely on Miller report.			✓	
Henshaw Lake Outlet (See Photo 14)				
1. Outlet in good condition.			✓

Photo 13-Eddie Schultz Buffer

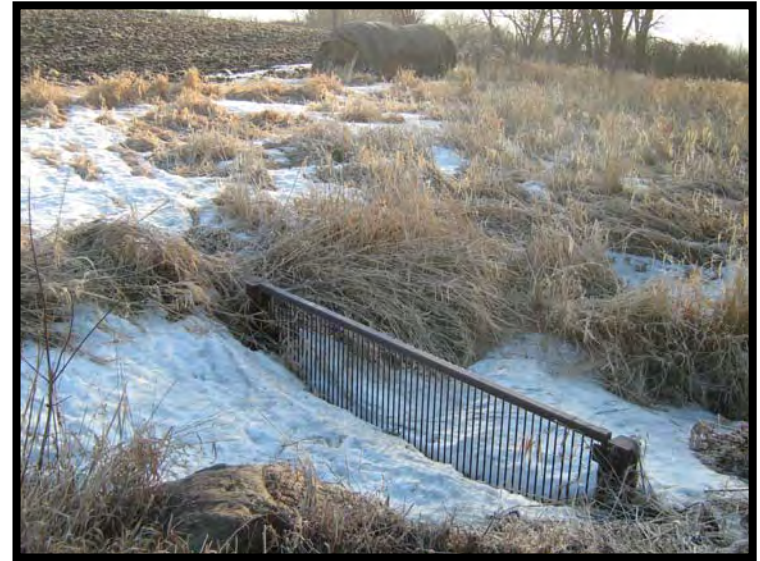
2. Fish barrier operating properly.			✓	
Swartout Lake Fish Barriers (See Photos 15 and 16)				
1. Outlet fish barrier has washout underneath gate.			✓	District has coordinated repair.

Photo 14-Henshaw Lake Fish Barrier

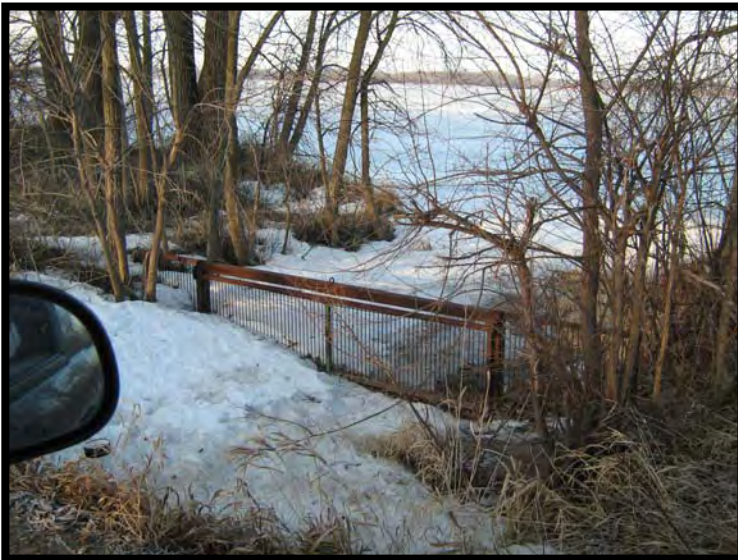
Photo 15-Swartout Outlet Fish Barrier

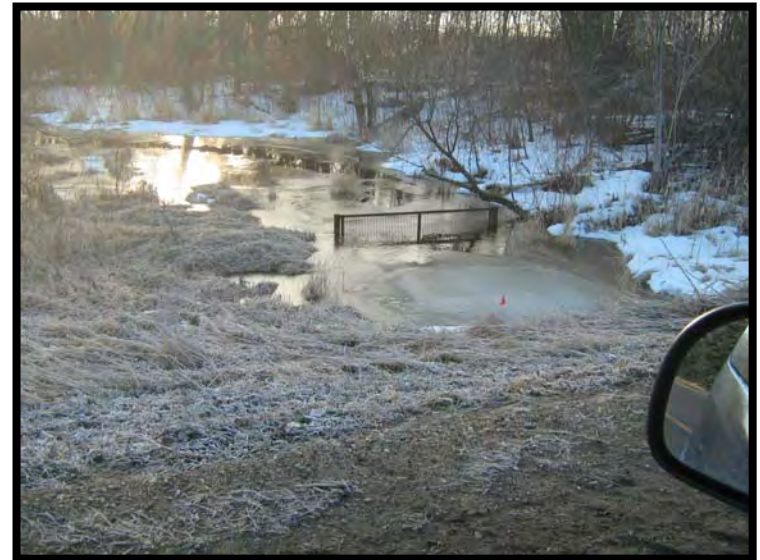
2. Barrier at inlet on southeast side of lake is in need of repair, (Wingwall Installation).			✓	District has coordinated repair.
Illsley Ave Fish Barrier (See Photo 17)

Photo 16-Swartout Inlet Fish Barrier

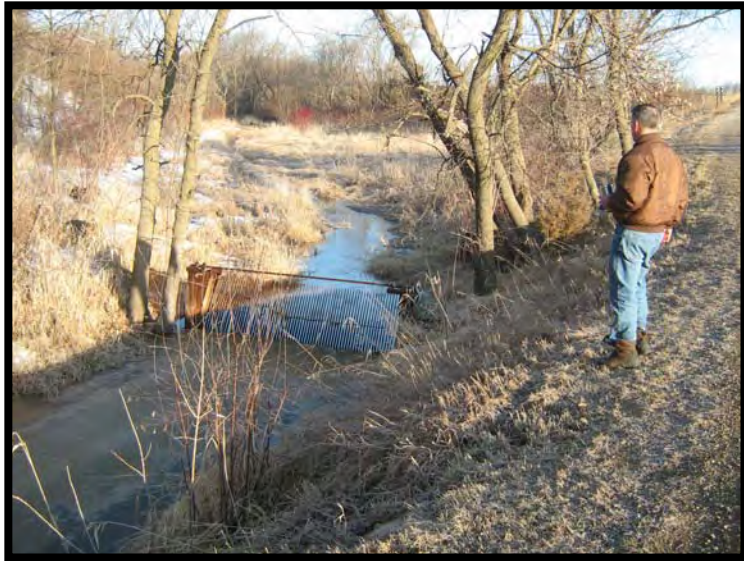
1. Fish barrier in good condition and operating properly.			✓	
Segner Pond (See Figure 3 and Photos 18-20)				
1. Diversion structure operating properly.			✓

Photo 17-Illsley Ave Fish Barrier

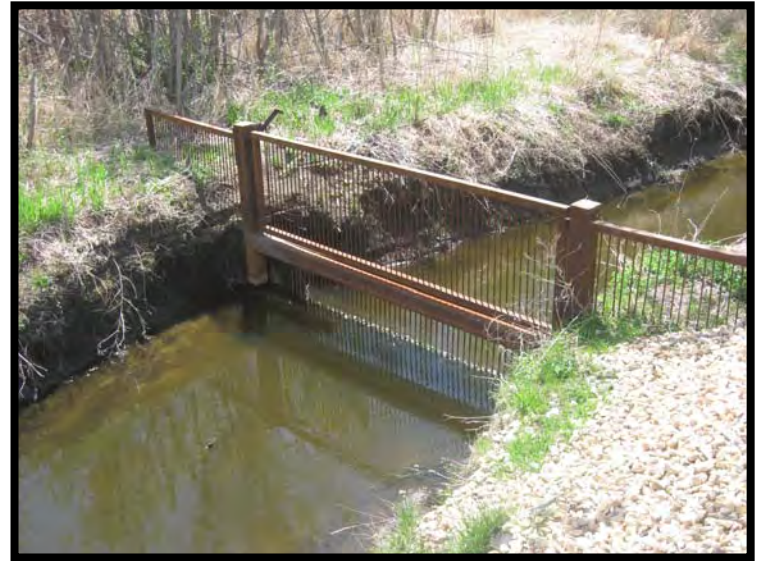
Photo 18-Segner Pond Fish Barrier

2. Add limestone to three low spots in limestone berm.	✓			\$2,000
3. Riprap to repair washout on bank along sides of fish barrier.	✓			\$1,500

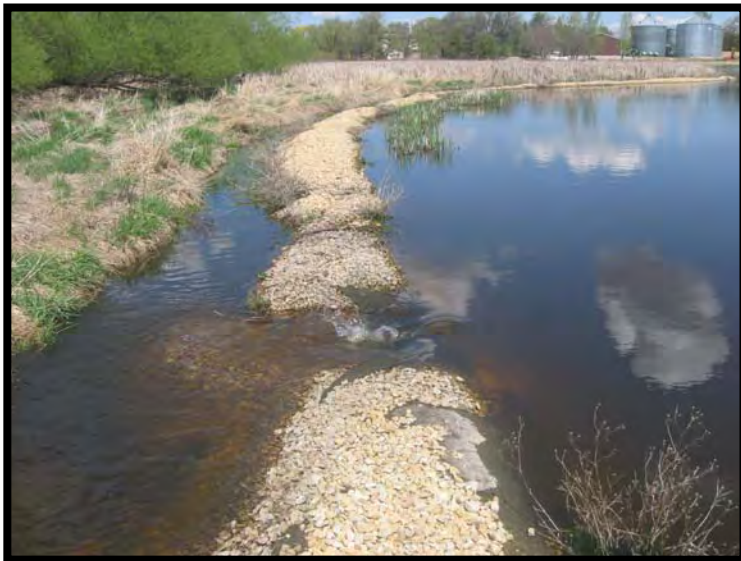
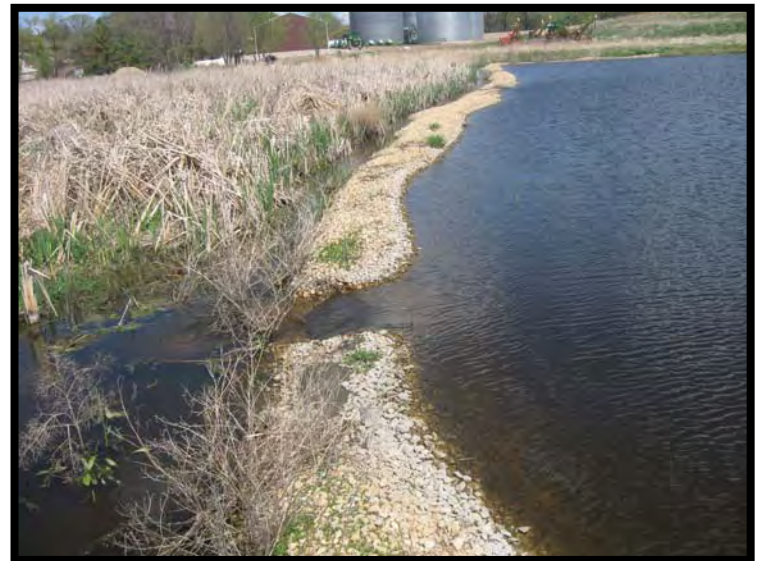
Photo 19-Segner Pond Limestone Berm

Photo 20-Segner Pond Limestone Berm
