Re: 2010 Project Inspection Report
Wenck File # 0002-148

2010 Project Inspection Report

**Clearwater River
Watershed
District**

Wenck File # 0002-148

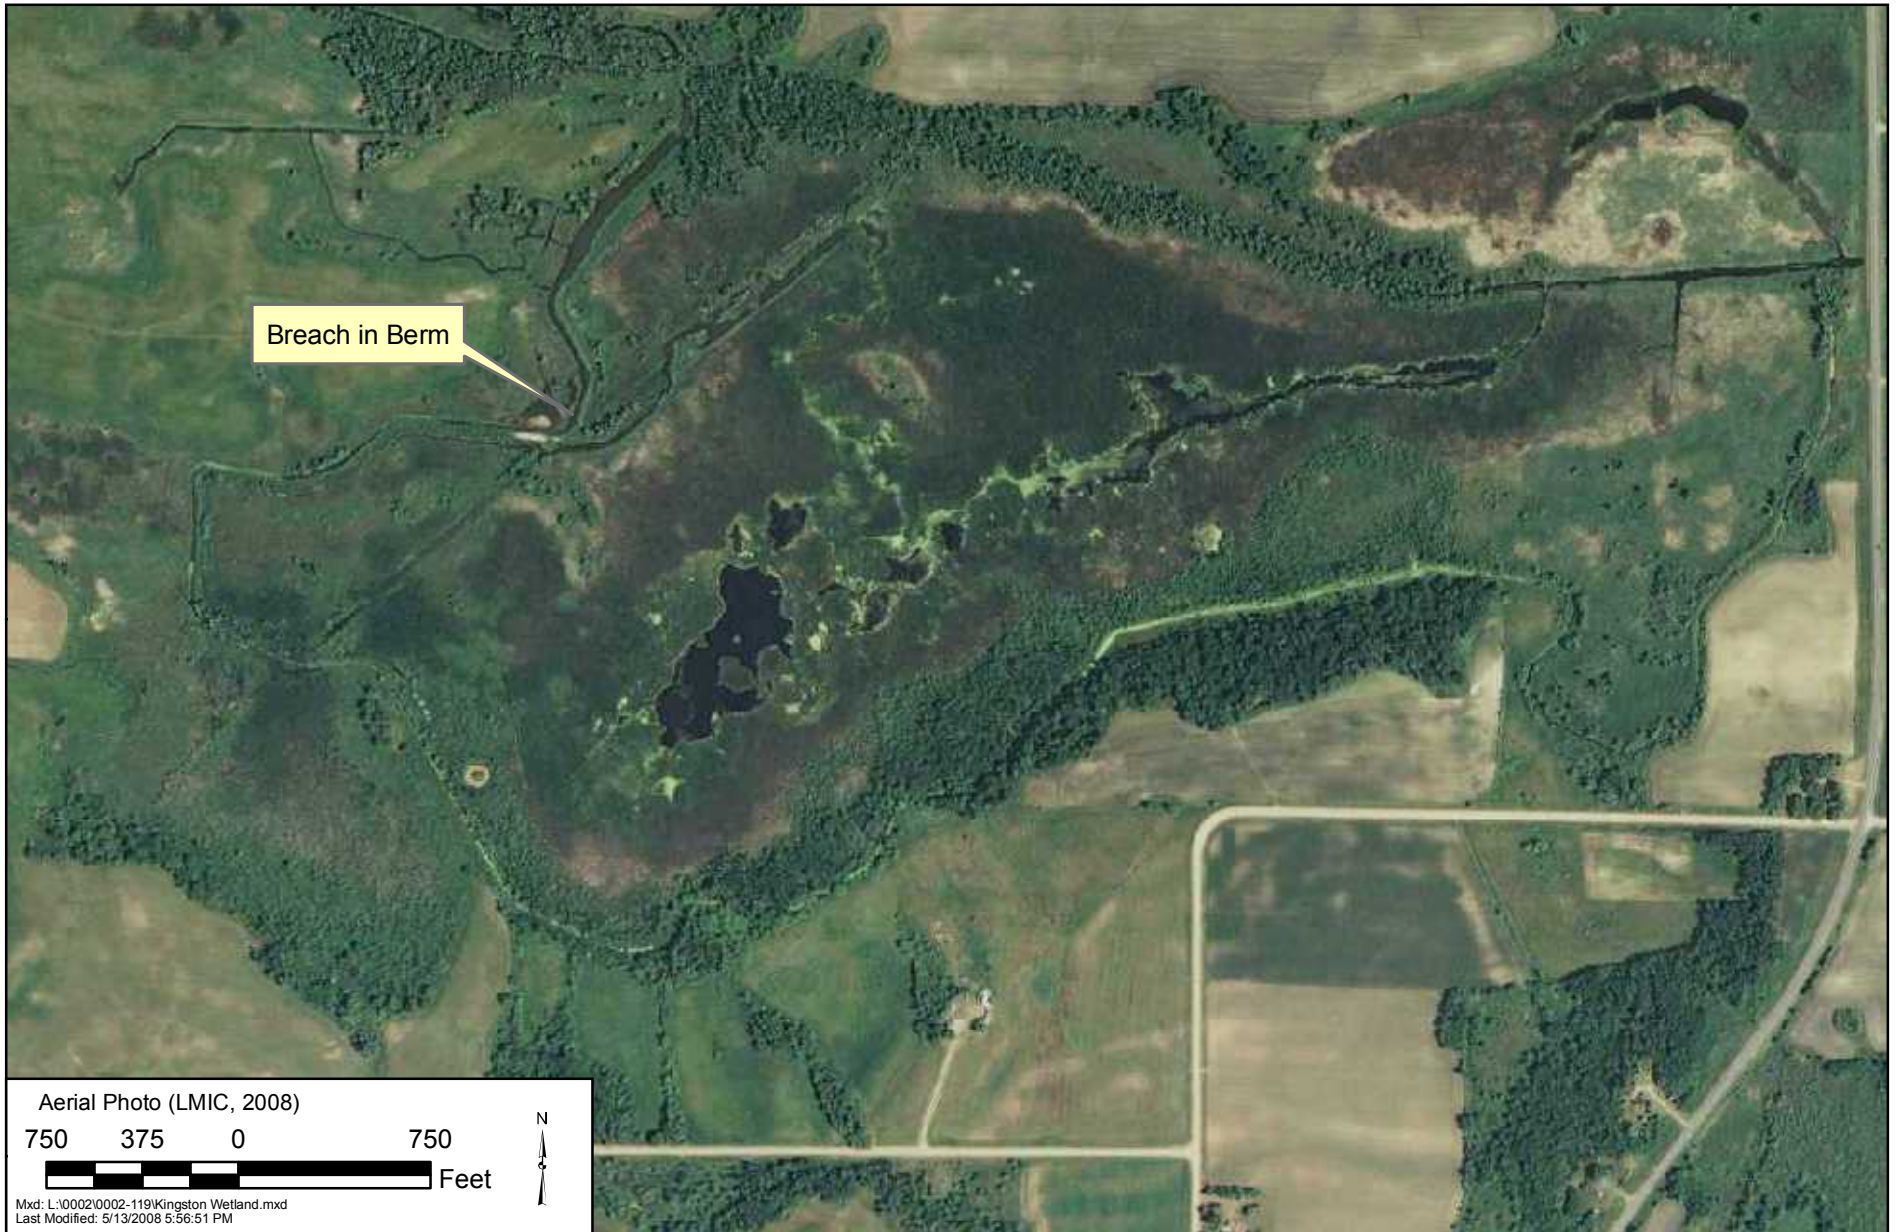
Figure 1

1. Newly installed rock overflow berm installed as designed and operating properly.			✓	
2. Cleanout clogged ports along upstream portion of berm.	✓			District will coordinate repair and plans to use Meeker County Sentenced to Serve crew to assist.

3. Remove beaver dams.	✓			District will coordinate removal of dams in conjunction with port cleanout.
4. Fix breach in berm, install rock overflow, and repair bridge.	✓			\$7,500

Breach in Berm

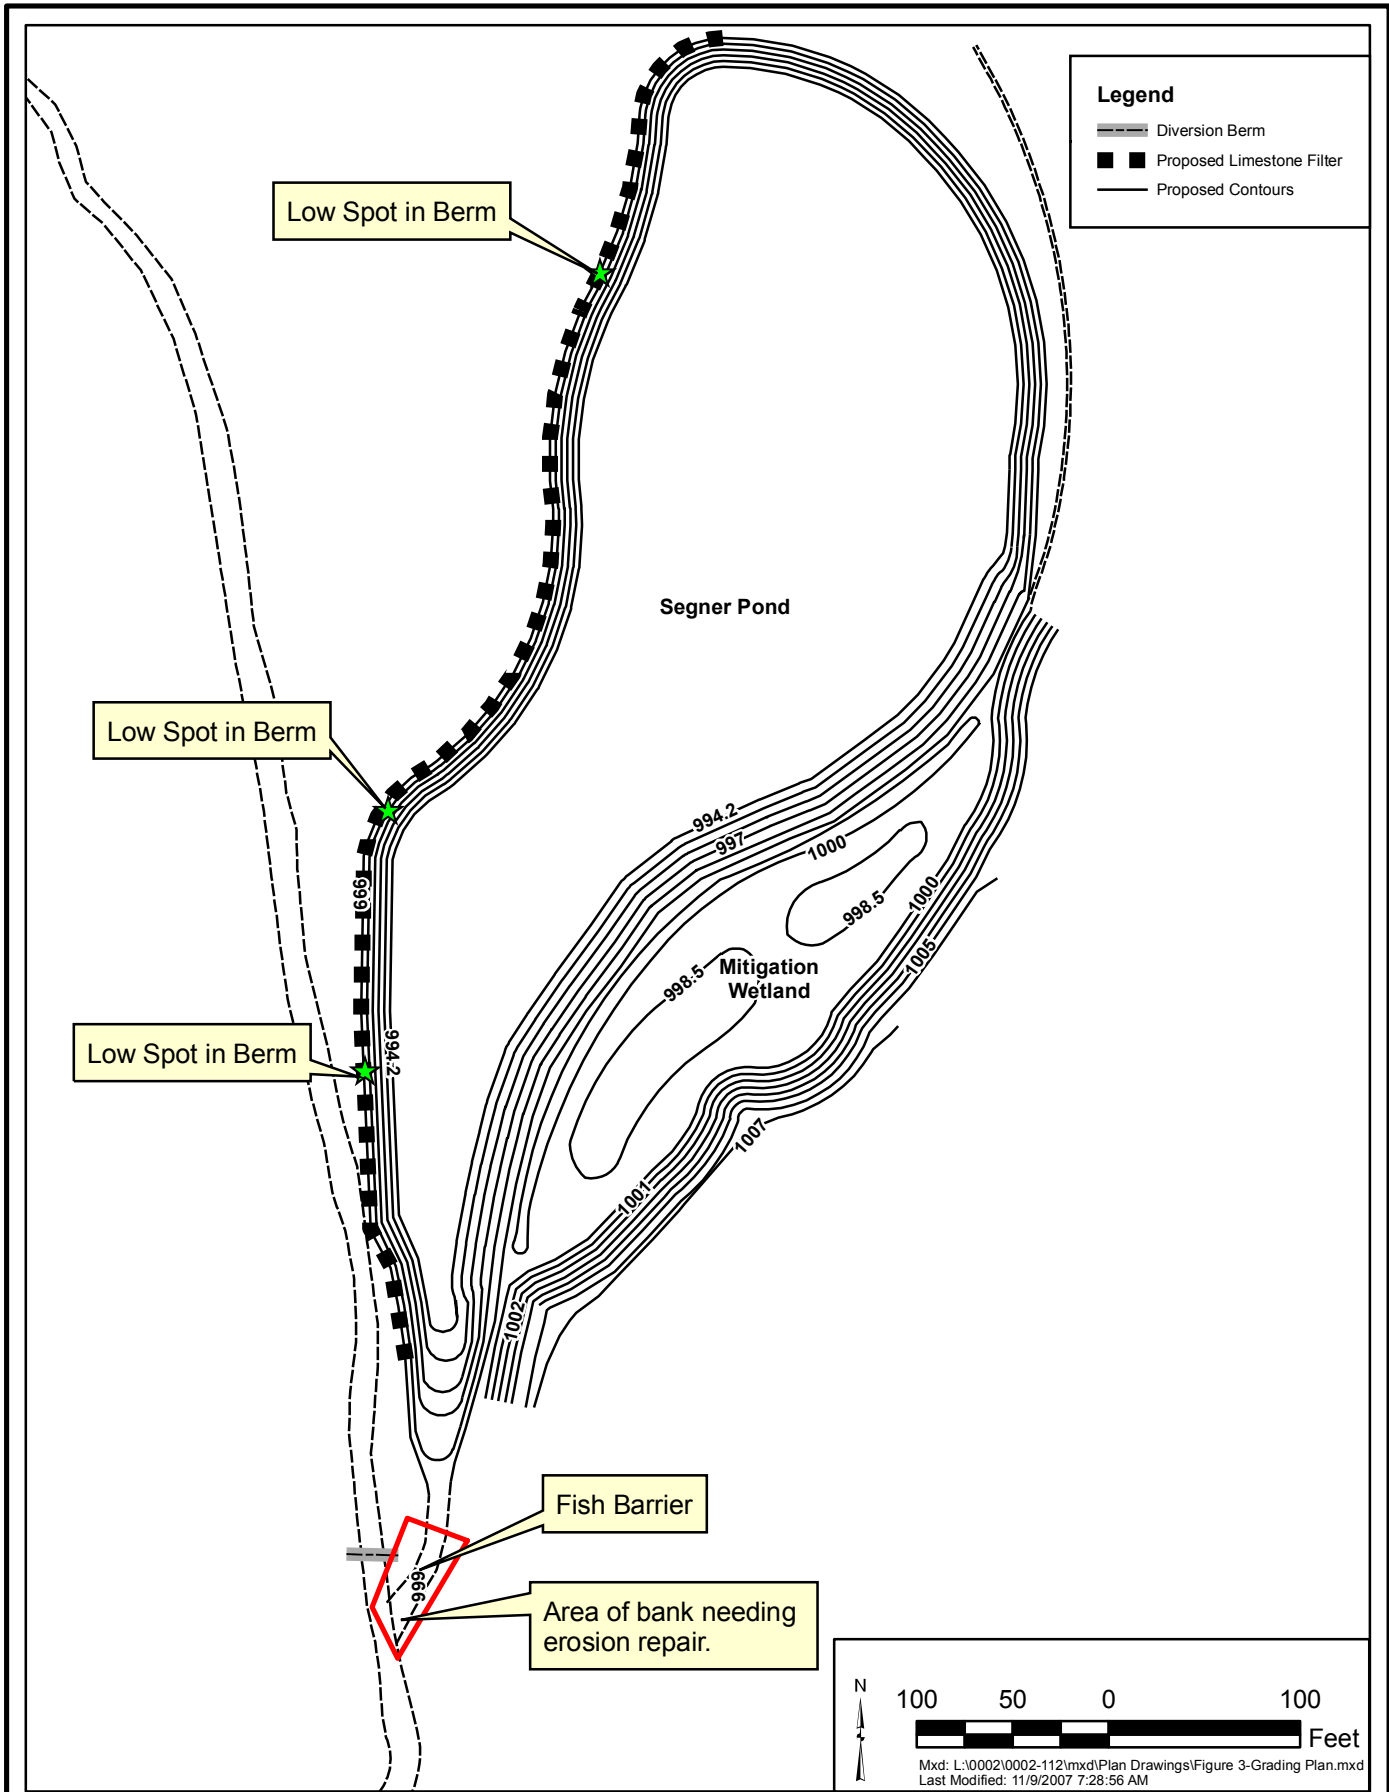
1. Fish barrier in good condition and operating properly.			✓	
Segner Pond (See Figure 2 and Photos 20-22)				
1.Diversion structure operating properly.			✓

2.Add limestone to three low spots in limestone berm.	✓			District will coordinate repair using limestone stockpile on site.
3.Repair bank erosion in diversion channel near fish barrier.	✓			\$8,500

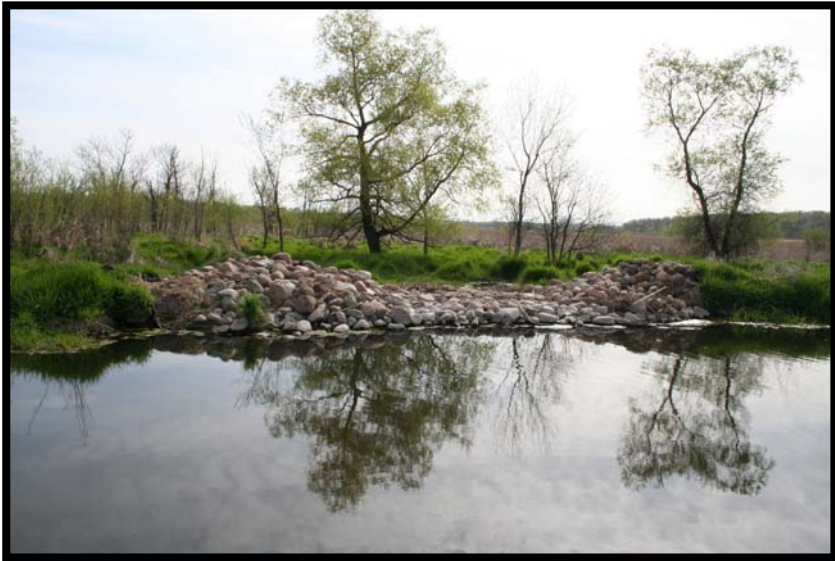
Photo 5-Kingston Wetland Overflow

5. Overflow structure operating properly.			✓

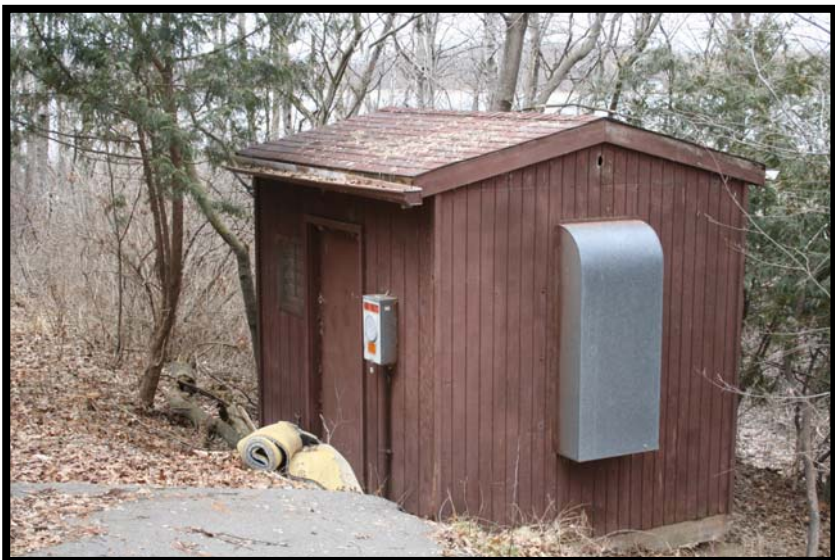
Photo 7-Lake Augusta Aerator Building

1. Lake Augusta-Remove trash and patch woodpecker hole in siding.	✓			District will coordinate repair- not to exceed \$200
2. Lake Marie- Good condition, no maintenance needed.			✓	
School Section Lake Outlet Project (See Photo 9).

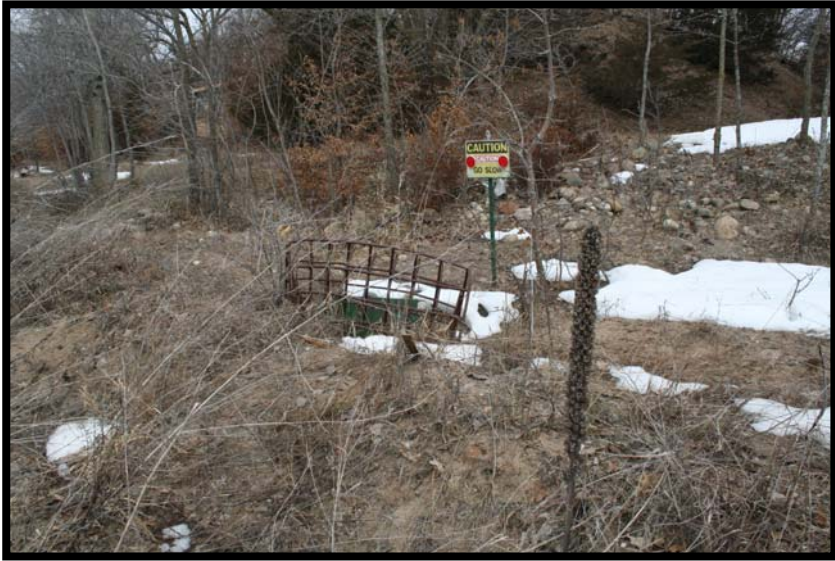
Photo 9-School Section Lake Outlet

1. Outlet is in good condition.			✓	
Rest-a-While Shores Wastewater Treatment System (See Photos 23 and 24)				
1. Pump septic tank.	✓			Contract Pumper: Estimated \$3,000

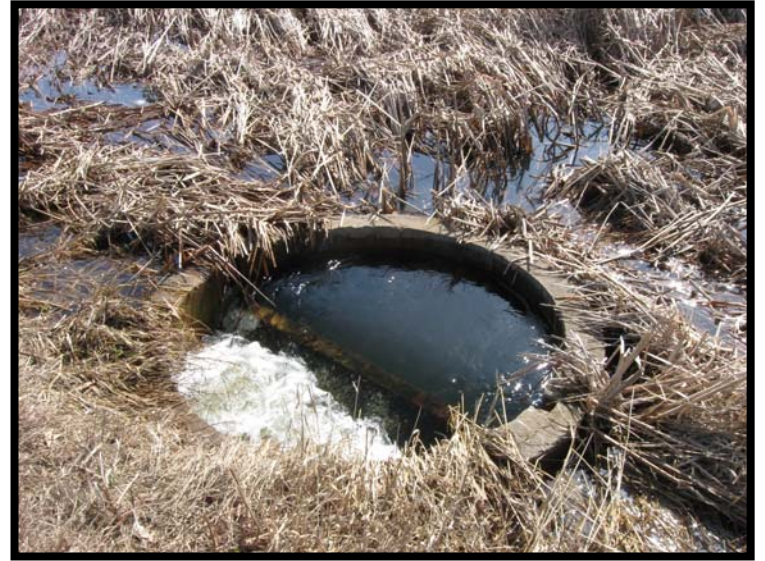
Photo 10-Annandale Wetland
Diversion Structure

1. Summer weed control	✓			Kevin-8 hrs + \$300 for equipment
Annandale Wetland Treatment System (see Photo 10).				
1. Beaver dam that is blocking southeast channel needs to be removed.		✓		Kevin-16 hours + \$300 for equipment

2. Outlet structure in good condition.			✓

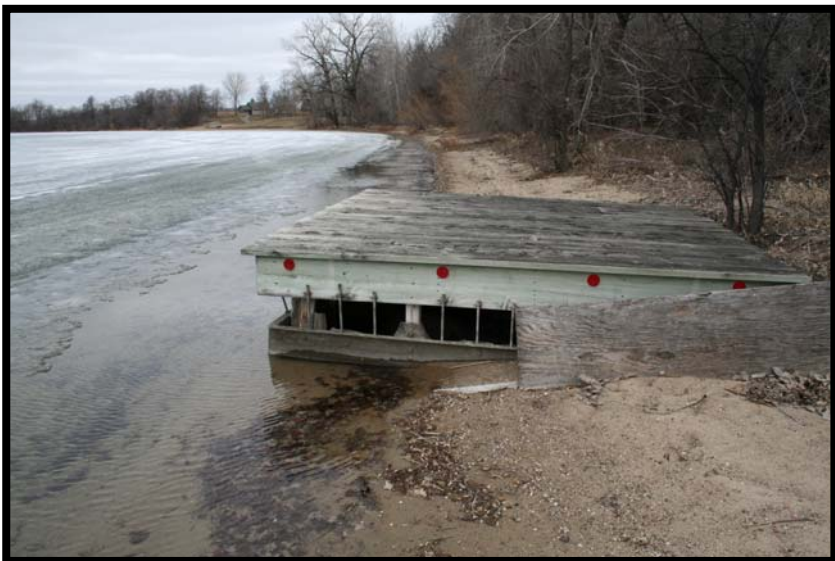
Photo 11-Pleasant Lake Outlet

Project	Maintenance			Estimated Cost
	Required	Optional	No Action Now	
Pleasant Lake Outlet Project (See Photo 11)				
1. In good condition, no maintenance needed			✓	
Lake Augusta Erosion Control Project (See Photos 12 and 13).

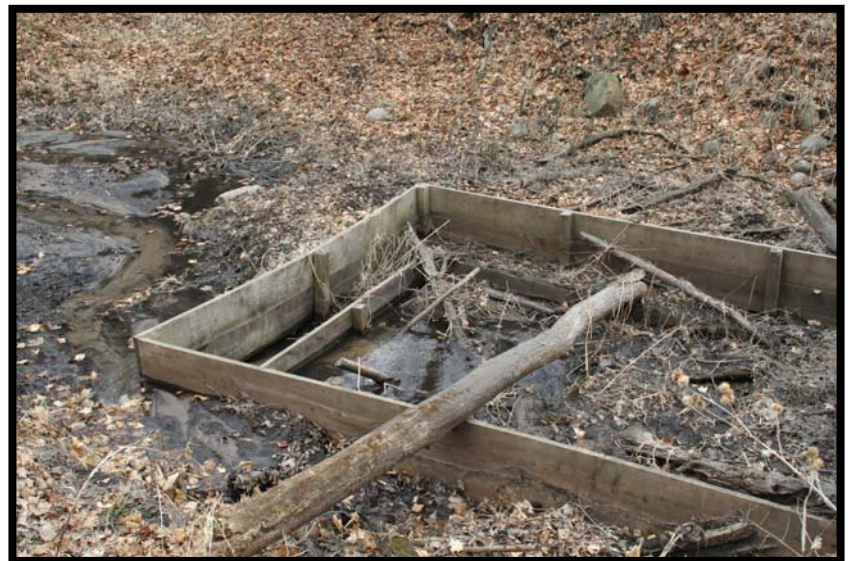
Photo 12-Lake Augusta Sedimentation
Pond Inlet Box

1. Outlet and riser in good condition.			✓	
2. Tree in inlet box.			✓	District staff already removed tree from inlet box.
2. Trim vegetation around fence.			✓	
Norton Ave Sediment Basin (See Photo 14)

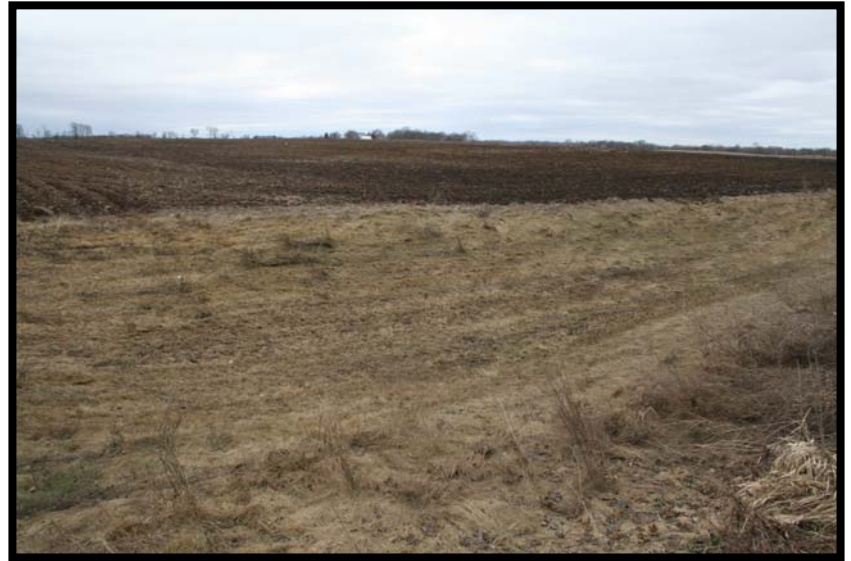
Photo 14-Norton Ave Sediment Basin

1. No maintenance needed.			✓	
Eddie Schultz Buffer (See Photo 15)				
1. No maintenance needed.			✓	
Wandering Ponds Wastewater System				
1. Rely on Bernie Miller report.			✓	
Henshaw Lake Outlet (See Photo 16)

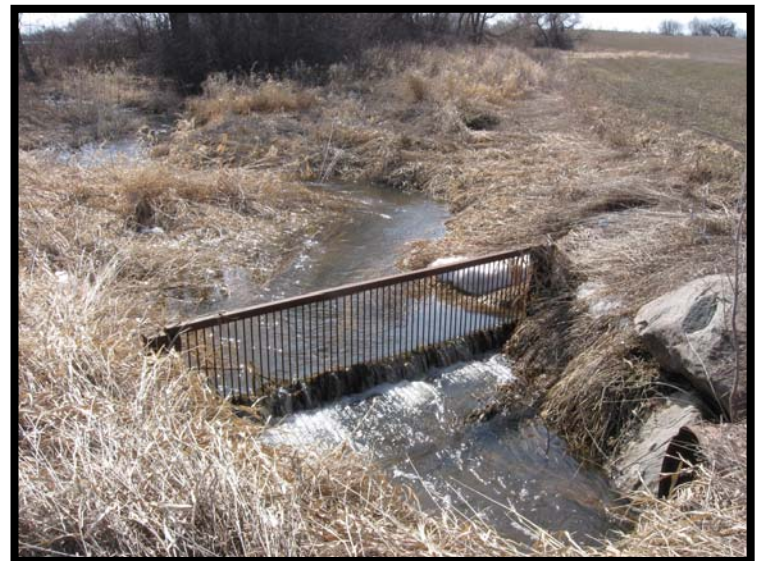
Photo 16-Henshaw Fish Barrier

1. Outlet and fish barrier in good condition.			✓	
Swartout Lake Fish Barriers (See Photos 17 and 18)				
1. Barrier at outlet is in good condition.			✓

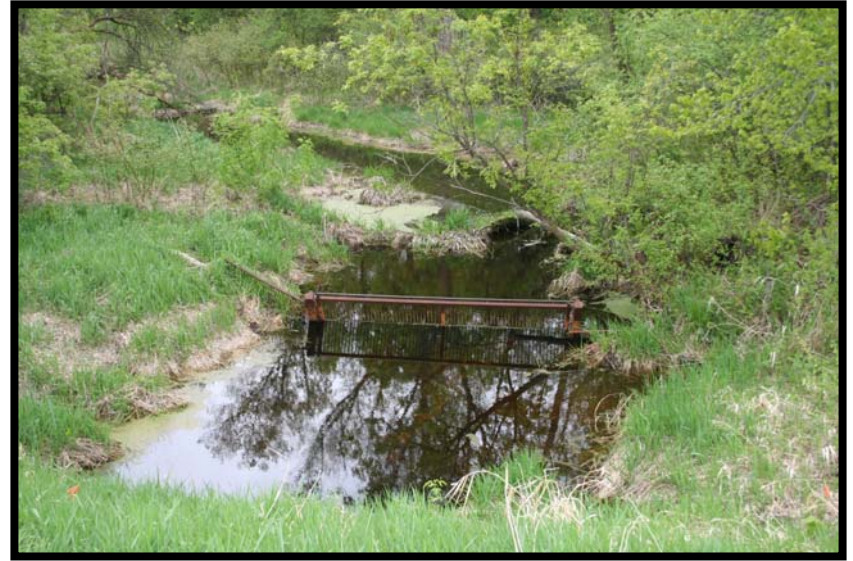
Photo 18-Swartout Inlet Fish Barrier

2. Barrier at inlet on southeast side of lake is in need of repair.	✓			District will coordinate repair-\$1,800
Illsley Ave Fish Barrier (See Photo 19)

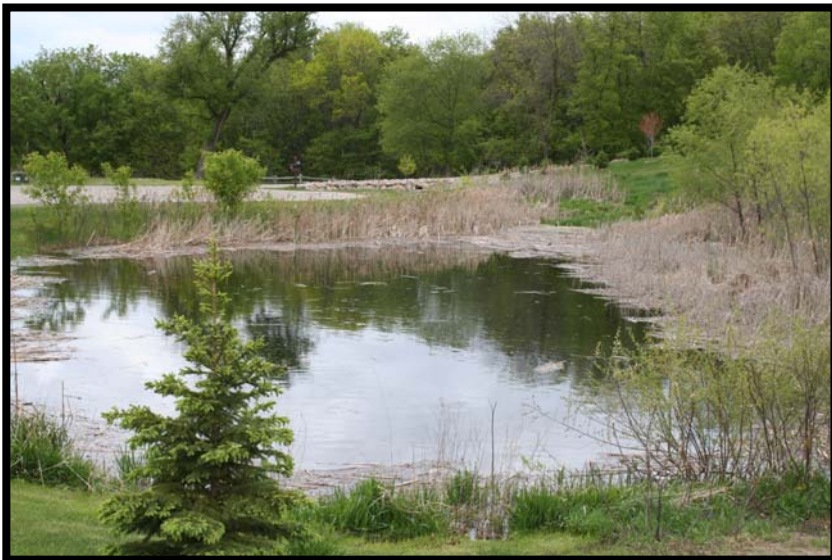
Photo 23-Rest-a-While Sedimentation Basin

2. Repair clogged standpipe in sediment basin.	✓			\$2,000
3. Remove dead trees.	✓			District will coordinate removal of trees - \$200
Hidden River Wastewater Treatment System
