2017

2017 PROJECT INSPECTION REPORT

The mission of the Clearwater River Watershed District is to promote, preserve, and protect water resources within the boundaries of the district in order to maintain property values and quality of life as authorized by MS 103D.

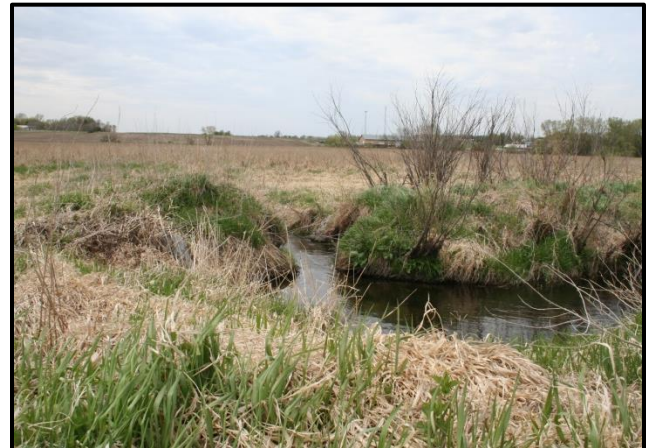
Overall, channel A and corresponding diversion berm are in good condition, with few channel sections where sedimentation has occurred. Channel B has several sections where sedimentation has occurred. Flow seems to not be significantly restricted; however, capacity of the ditch is affected by this sedimentation.

Recommendation: Cleanout of channel sections where sedimentation has occurred is likely needed to return channel to design capacity and mitigation potential drainage concerns of upstream properties.

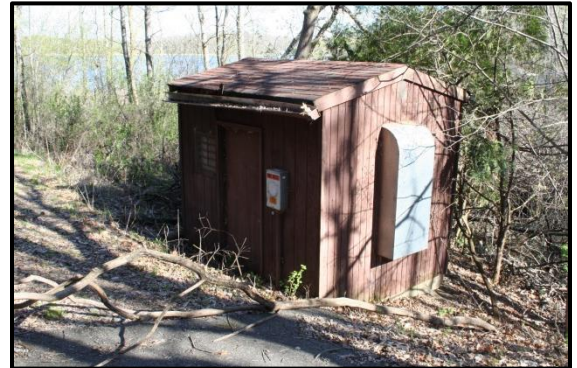
The Lake Marie aerator building is in good condition, except as noted above. The Lake Augusta aerator building is in need of a new coat of paint, as well as work to its soffits, eaves, and potentially its foundation. In addition, recent work on the lake access road located adjacent to the building has resulted in a large amount of dirt and debris pushed against the lake Augusta aerator building. The CRWD Board has its attorney drafting an opinion on how to proceed with O&M for these buildings.

Recommendation: The CRWD should consider whether this building should continue to be maintained or abandoned, considering the amount of time that has transpired since the aerators were active.

If the CRWD wishes to continue to maintain, the soffits and eaves of the Lake Augusta building should be repaired. A more in-depth review of this building’s foundation should be conducted in the next year or so to determine whether it needs repair work.

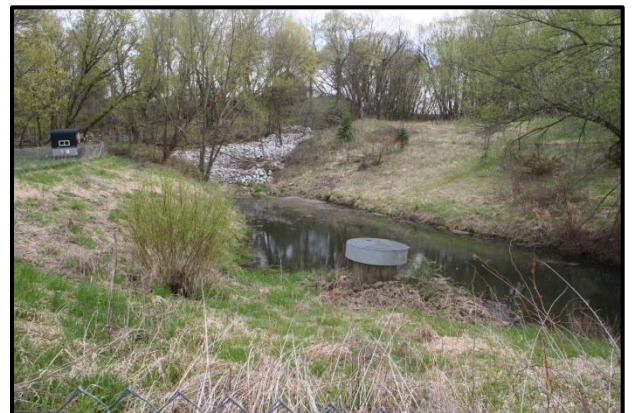
Site inspection was conducted April 29, 2017. The southern drop structure has multiple repair needs. The tile that drains local groundwater in an effort to stabilize the ravine is clogged. The drop structure's lid has been damaged and needs to be reset. Significant erosion has occurred around the bottom of the culvert at the base of the ravine such that the anti-seepage collar is exposed. Multiple trash guards are in need of repair.

The western drop structure is in need of repaired trash guards. Both ravines would likely benefit from tree thinning to promote ground cover. Several trees need to be cut down within the basin fence in order to protect underground culverts from damage. The southern and western inlets are in good working order.

Recommendation: Continue to work on request for quotes to complete noted repair items.

Recommendation: Cut select trees within basin fence to protect infrastructure; treat stumps.

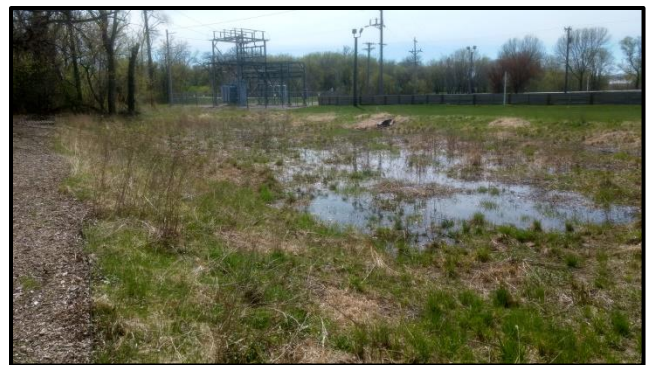
Raingarden and Agri-drain: Water level in rain garden low due to agri-drain being in fully open position per O&M plan. Agri-drain baffles slide easily after last year's maintenance. Trash removed from rain garden. Minor sediment accumulation in rain garden and corresponding inlet was noted, likely source is flow from contributing watershed. Sediment load is expected to decrease due to recent paving of nearby parking lot.

City of Kimball should be contacted to inspect upstream sump to see if vacuuming is warranted. Native plantings may need additional work; this should be determined by vegetation maintenance vendor. Riprap missing from outlet; after speaking with City staff, determined to be not an issue at this time, but needs to be monitored.

- Monitor riprap around outlet
- Speak with City of Kimball on checking upstream sump to see if vacuuming is needed
- Set agri-drain baffles to winter condition in late fall, grease as needed

- Work with vegetation contractor to see if additional work outside current contract is warranted

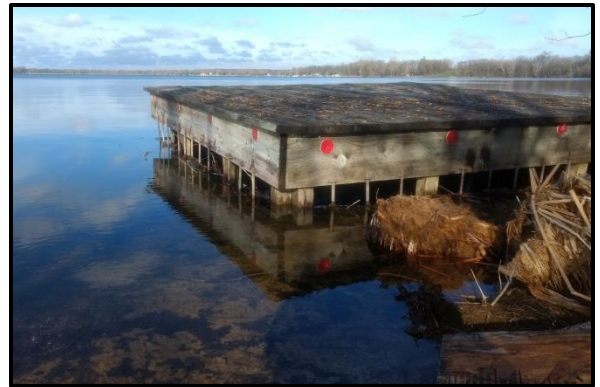
Overall, the outlet control structure is in fair condition. The rebar trash guards on the front of the structure are missing. One board on top of the structure is loose. One hinge on door access is broken, and the door is missing its lock. Last year it was noted the outlet guillotine valve does not completely close so as to make a watertight seal.

Recommendations: The rebar trash guards should be repaired, hinge and lock should be replaced, and the loose board should be tightened. In addition, the guillotine valve should be greased by maintenance personnel to promote ease of operation.

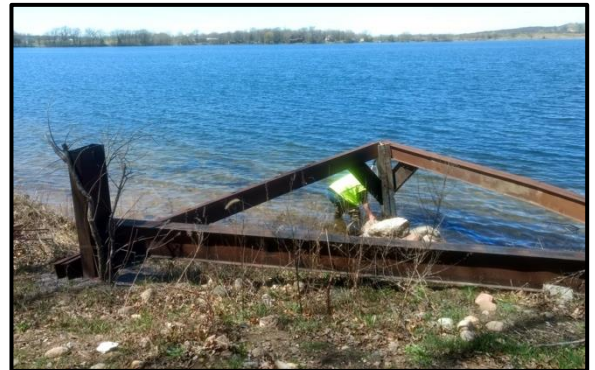
The lake outlet pipe has sand and debris in it that has caused a partial blockage to occur. It will need to be cleared in order to return the outlet to operational effectiveness.

Recommendations: Either a vendor should be brought in to clear the blockage or the blockage should be addressed as part of the ice barrier replacement planned for 2017.

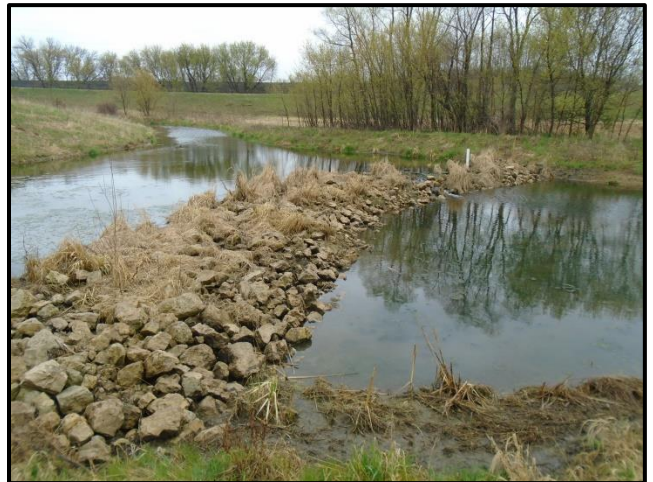
Slight erosion is occurring around tile outlet and around limestone swale on the northeastern side of the low flow channel. Low flow channel in good condition.

Recommendations: Smaller limestone rock should be brought in to fill voids in the swale. Rock should be brought in to stop erosion around tile outlet.

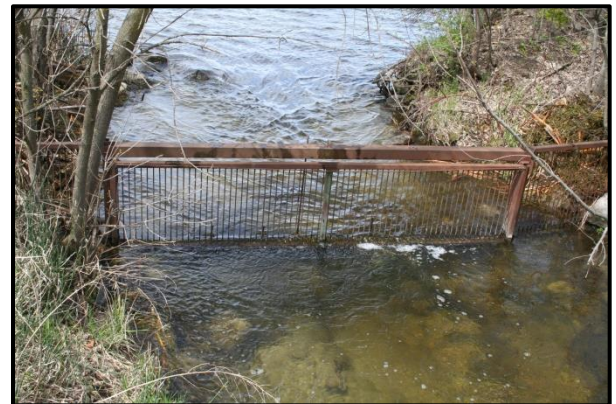
Swartout Outlet: temporary fish bars are planned to be deployed in May. The barrier is operating, but in order to cut down on maintenance, modifications to this barrier should be considered. One option would be to work with the road authority to integrate a fish barrier into the road culvert.

Recommendation: Partner with Wright County to integrate a fish barrier into the replacement culvert.
