2005 Project Inspection Report

**Clearwater River
Watershed
District**

Re: 2005 Project Inspection Report
Wenck File #0002-72

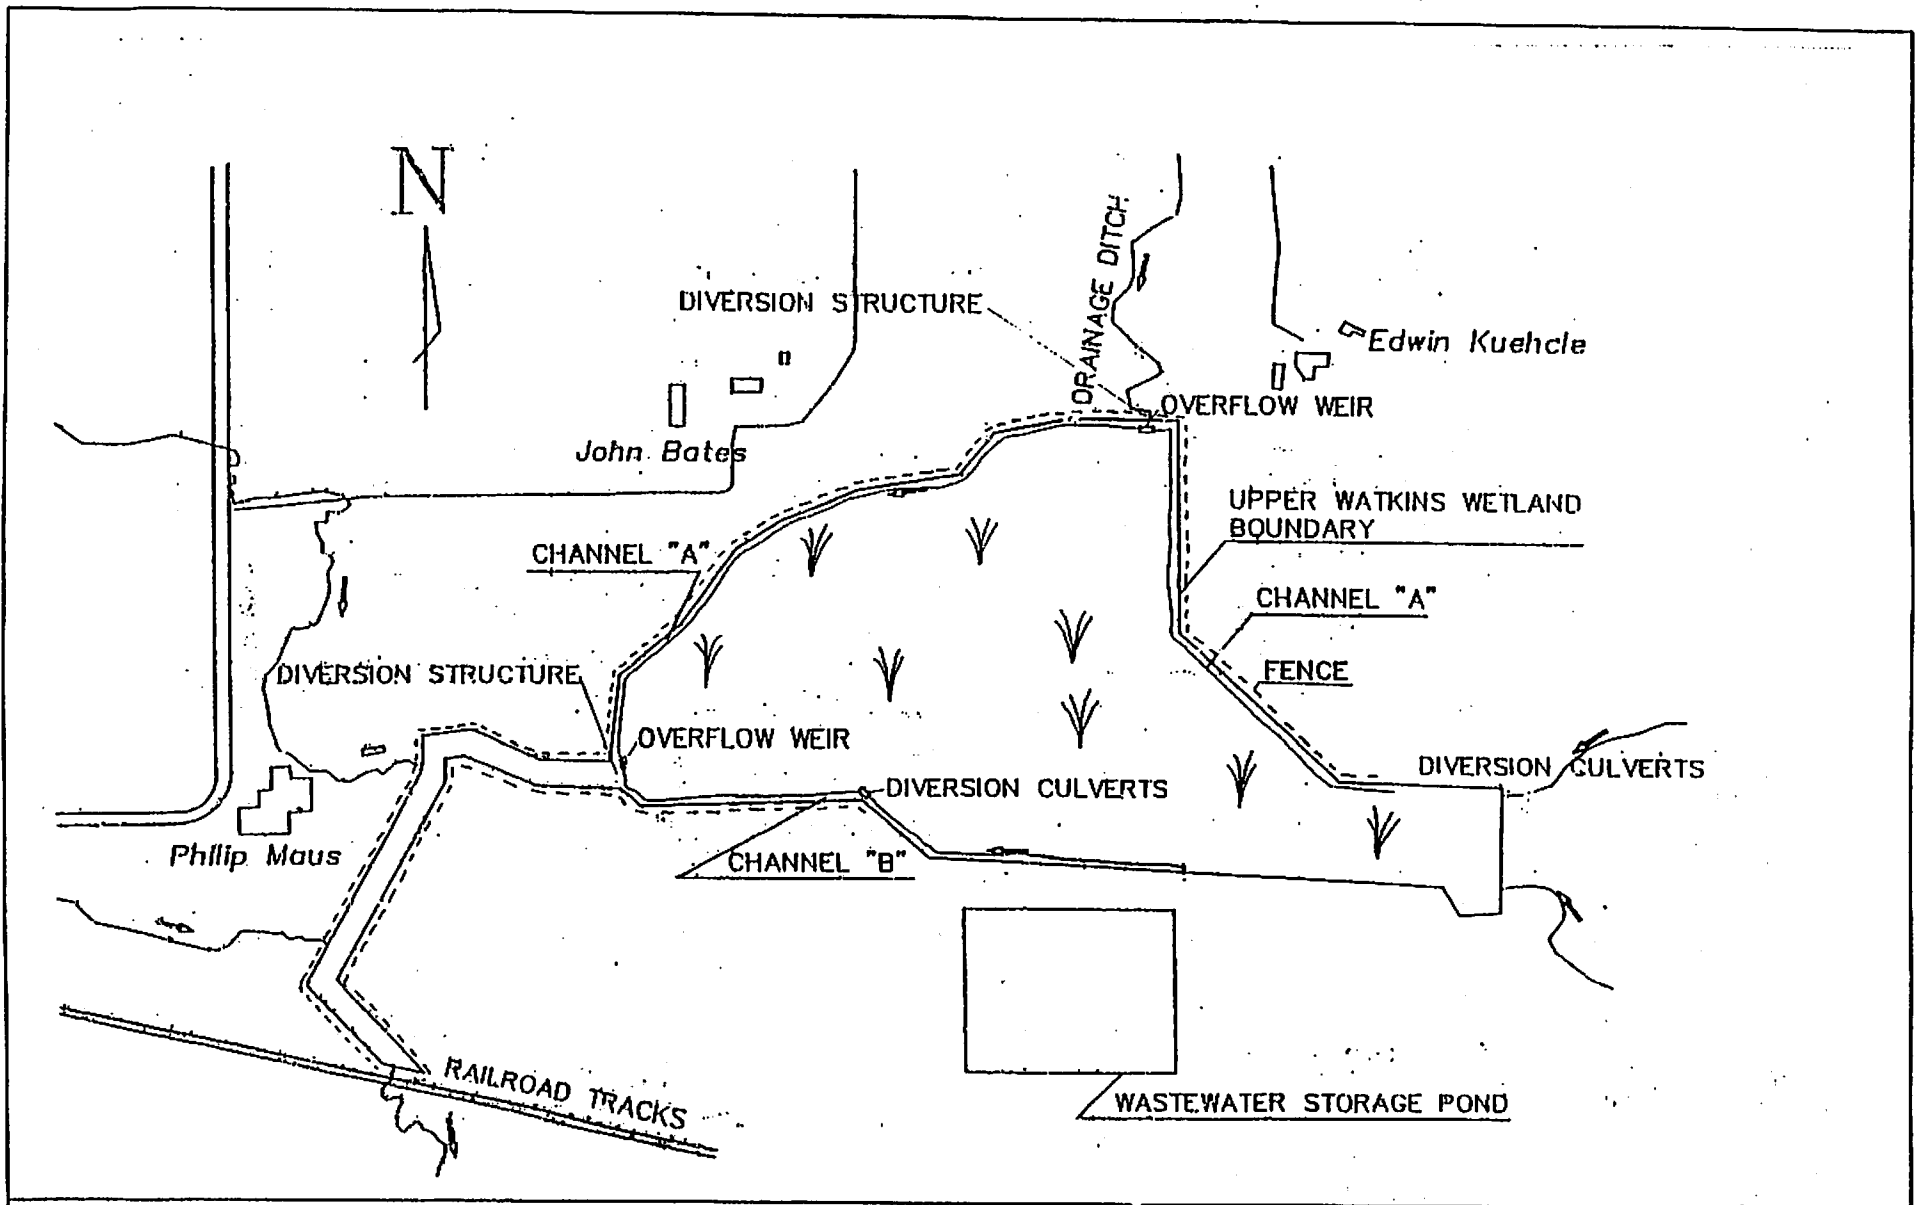
Figure 2

2. East side (Channel B) flowing normal, channel ports open.			✓	
3. East side water quality monitoring for phosphorus before and after wetland.	✓			\$980
Upper Watkins Wetland Isolation Project (north) (see Figure 2).				
Closer inspection needed at a later date.				
Annandale Wetland Treatment System (see Figure 3 and Photos 3 and 4).

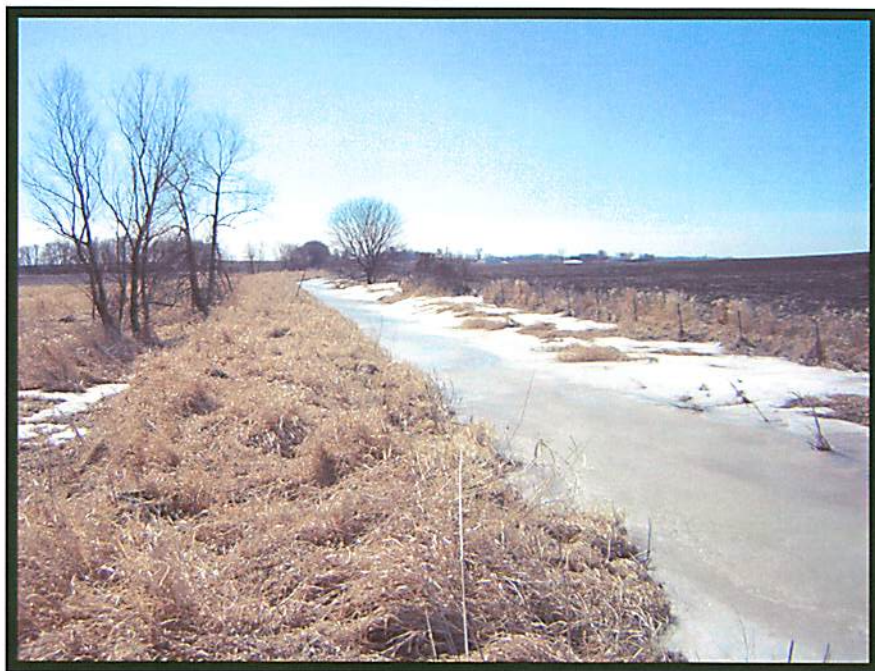
Photo 1

Project	Maintenance			Estimated Cost
	Required	Optional	No Action Now	
Watkins Wetland Treatment System (south) (see Figure 1 and Photos 1 and 2).				
1. West side (Channel A) washout south of pipe outlet	✓			\$3500

Watkins Wetland Treatment System,
west ditch

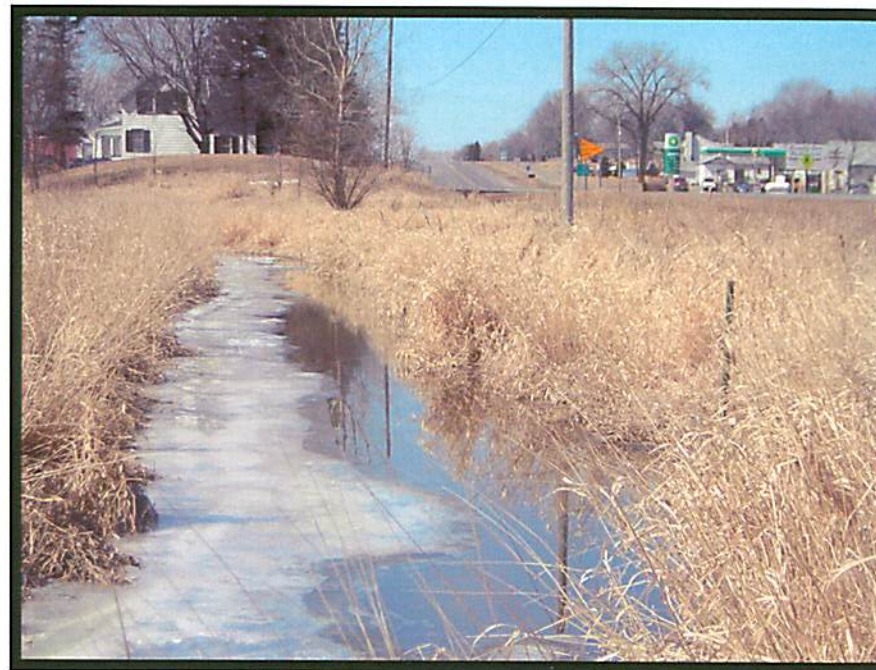
Photo 2

Watkins Wetland Treatment System,
north ditch along Hwy 55

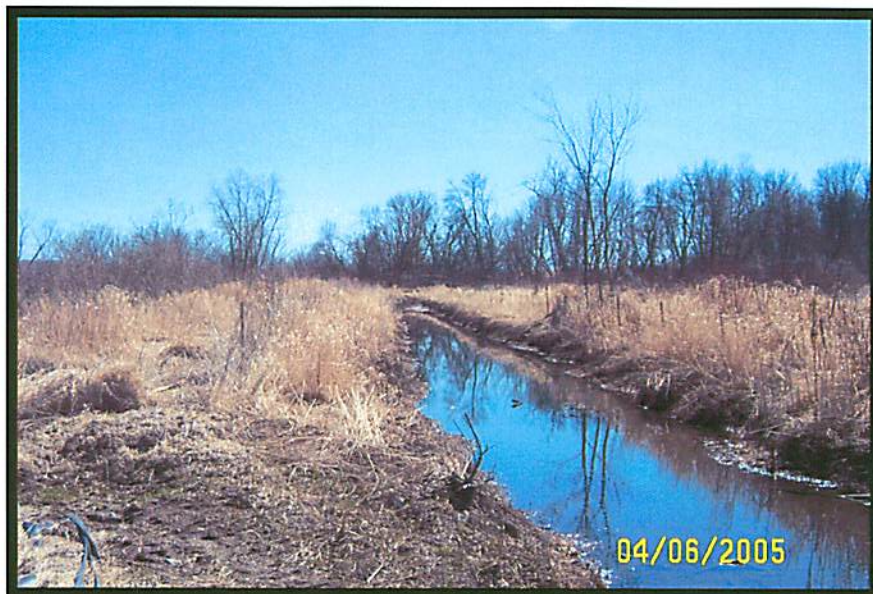
Photo 3

1. Washout of berm north of Hemlock Street	✓			\$3500
2. Fence needs repair and tightening	✓			Kevin 24 hrs.
School Section Lake Outlet Project (see Photo 5).

Annandale Wetland Treatment System,
west ditch

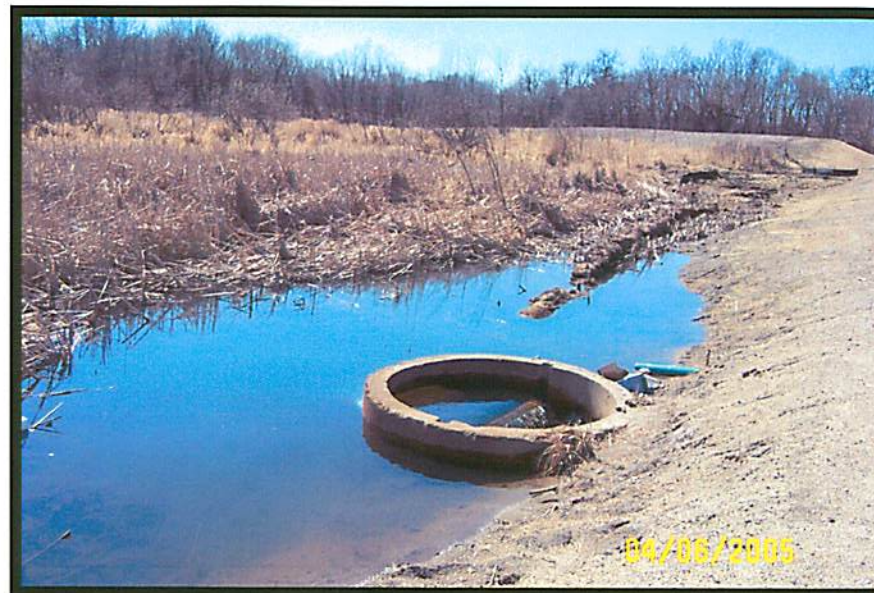
Photo 4

Annandale Wetland Treatment System,
overflow structure

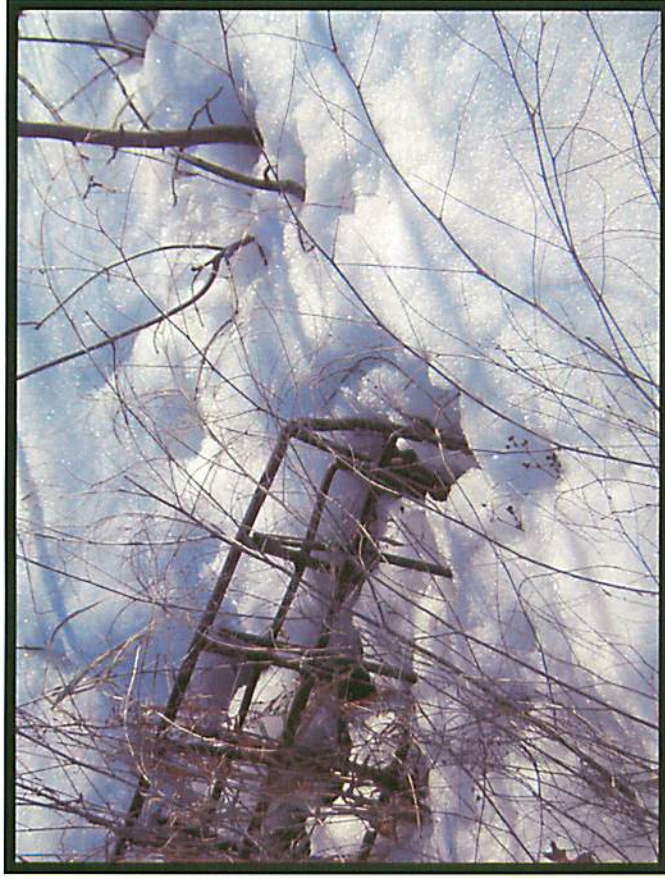
Photo 5

1. Outlet structure and culverts in good condition.			✓	
2. Downstream culvert and structures in good condition.			✓	
Pleasant Lake Outlet Project (see Photo 6).

School Section Lake Outlet Project

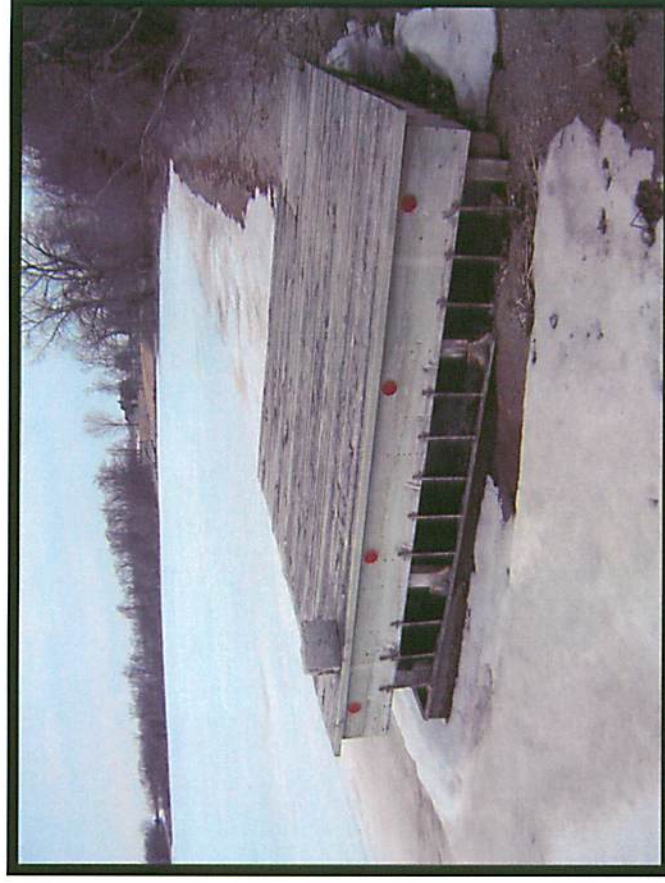
Photo 6

1. Outlet structure in good condition.			✓	
Kingston Wetland Treatment System (see Figure 4 and Photos 7 and 8).				
1. Ditches and channel ports open.			✓

Pleasant Lake Outlet Project

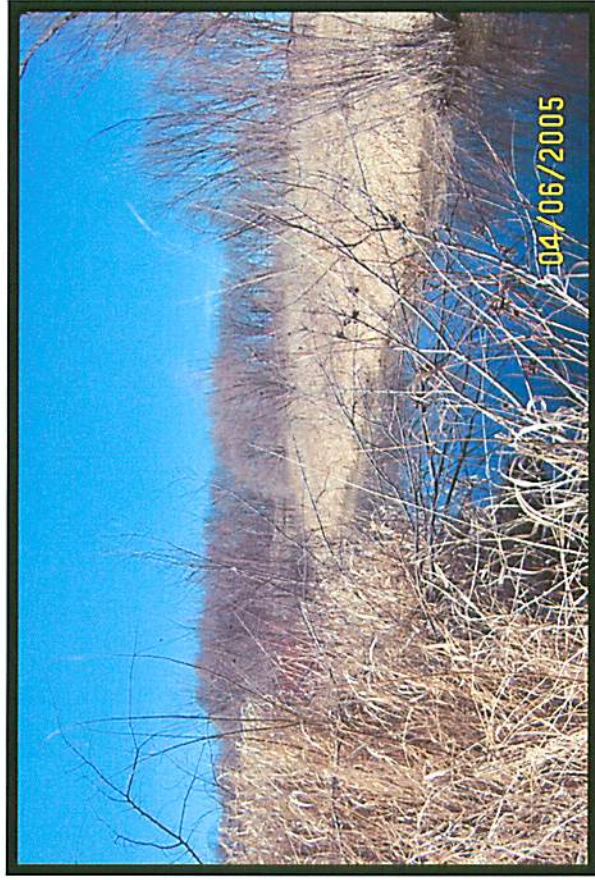
Photo 7

Kingston Wetland Treatment System

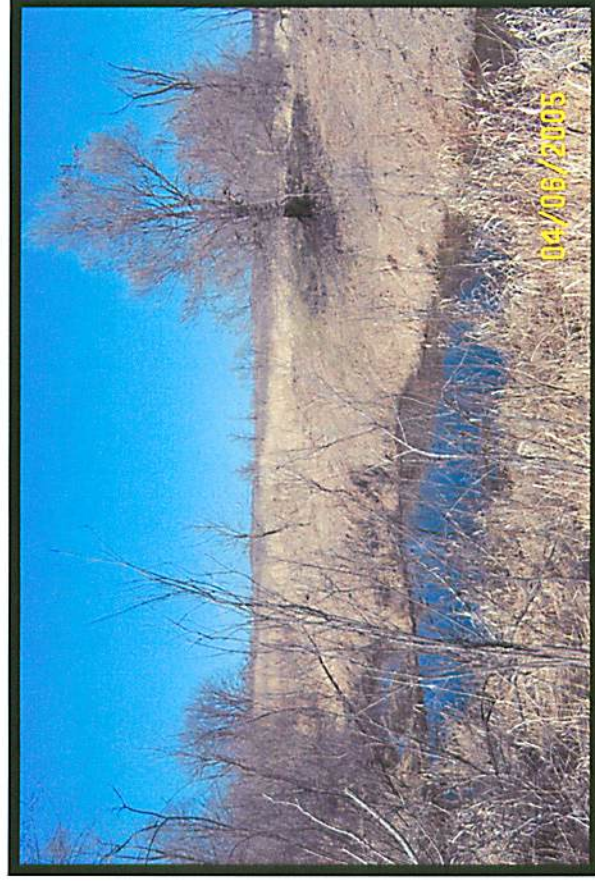
Photo 8

2. Washout in berm south of first overflow.	✓			\$7000
Aerator Buildings (see Photo 9).				
1. Lake Augusta – replace downspout.	✓			Kevin, 1 hr plus materials

Kingston Wetland Treatment System,
southeast berm

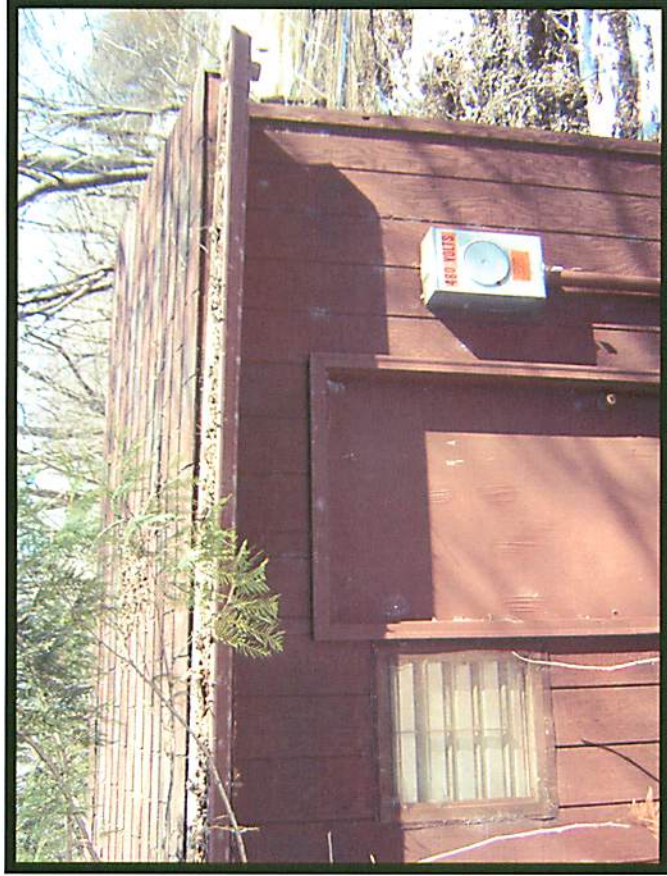
Photo 9

Lake August Aerator Building

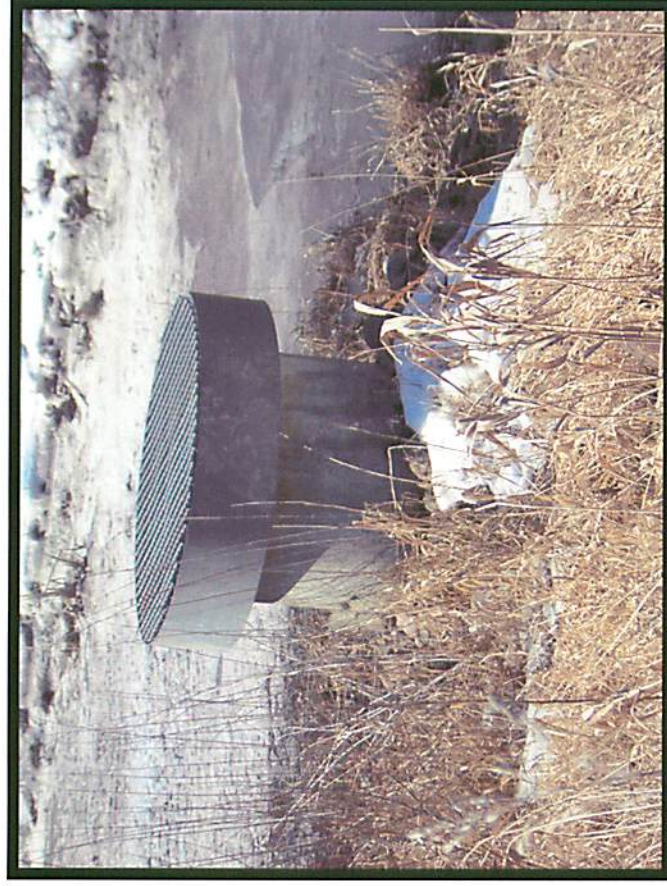
Photo 10

Project	Maintenance			Estimated Cost
	Required	Optional	No Action Now	
Lake Augusta Erosion Control Project (see Figure 5 and Photos 10 and 11).				
1. Sedimentation basin in good condition.			✓

Lake August Erosion Control Project,
control structure

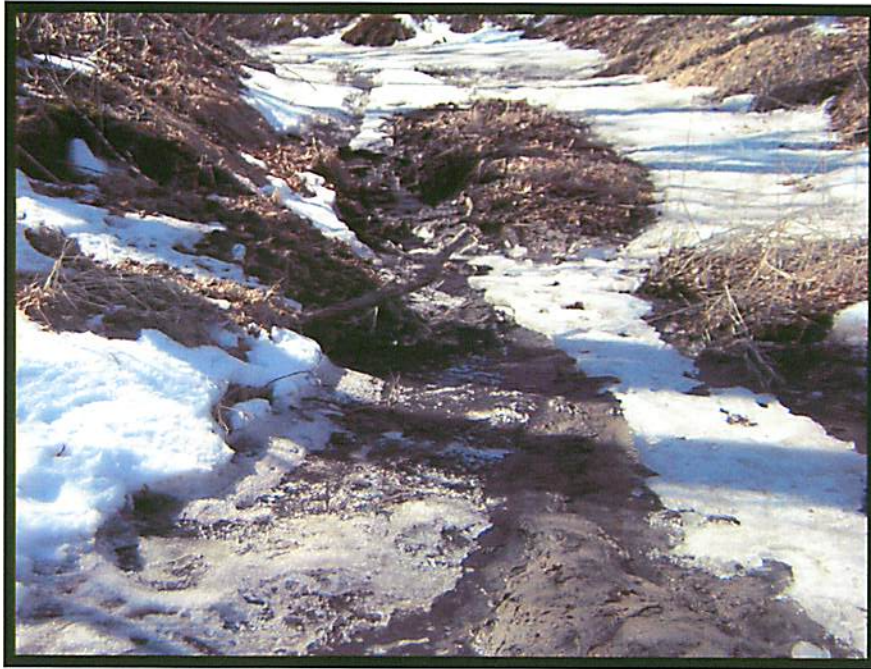
Photo 11

2. West drop inlet structure is in good condition.			✓	
3. Clean out sediment above south box	✓			\$2500
4. Install two rock check dams above south box. (20'x3'x2')		✓		Consider community service sentence-to –serve manpower. Plus materials
Clear Lake Sedimentation Basin (south) (see Photo 12, 13, and 18).

Lake August Erosion Control Project,
area above south box

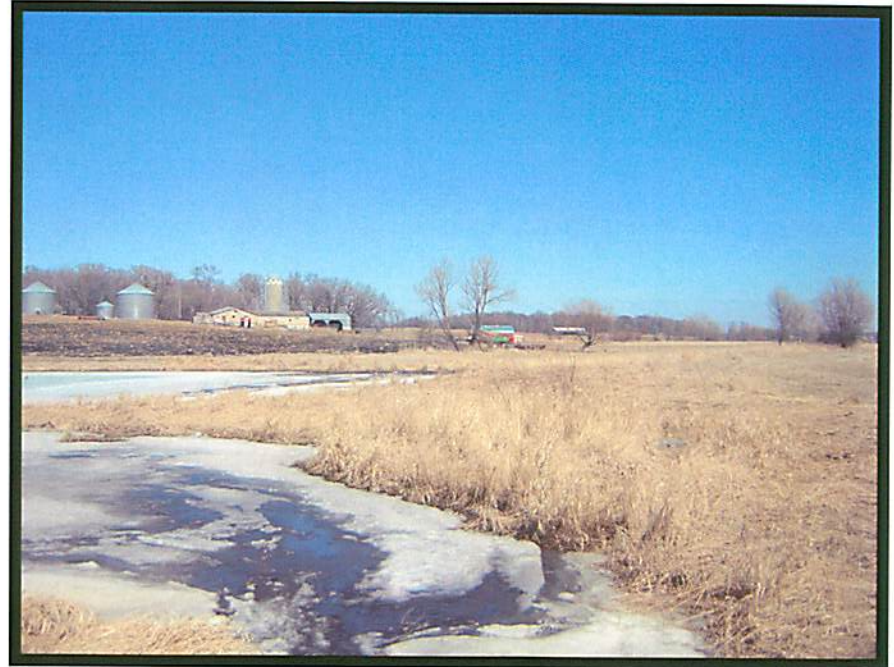
Photo 12

1. Sedimentation basin in good condition.			✓	
Clear Lake (northeast) Wetland Outlet Structure (see Photo 14).				
1. Outlet structure in good condition.			✓	
Hidden River Sewage Treatment Facility (see Photo 15).

Clear Lake Sedimentation Basin

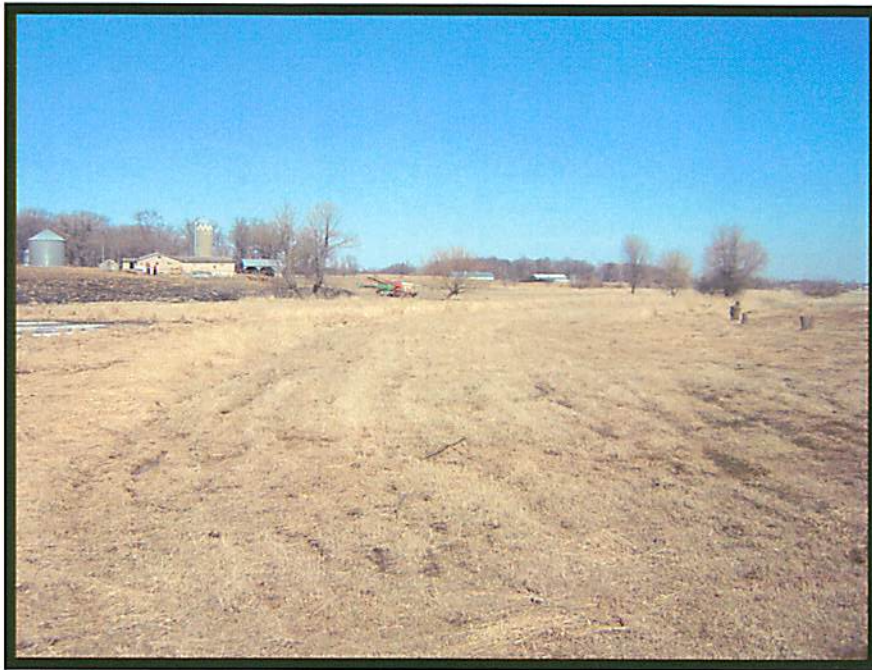
Photo 13

Clear Lake Sedimentation Basin,
expansion

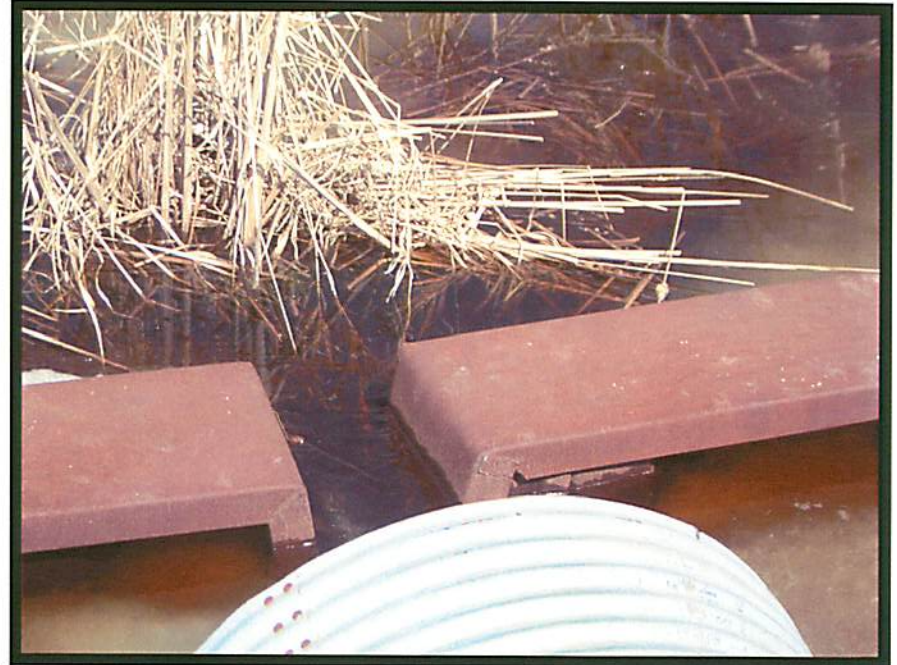
Photo 14

Clear Lake Wetland Outlet
Structure (northeast)

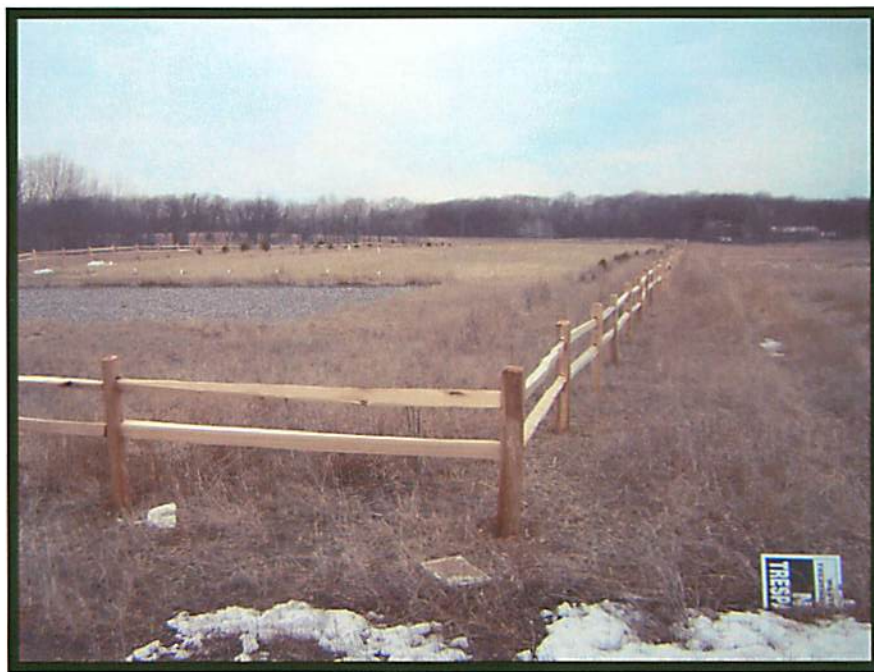
Photo 15

1. Treatment facility in good condition.			✓	
2. Remove debris along driveway and south fence	✓			Kevin, 1 hr
3. Inspect screens, filters, manholes, and mains.	✓			Bill, 2 hr

Hidden River Sewage Treatment
Facility

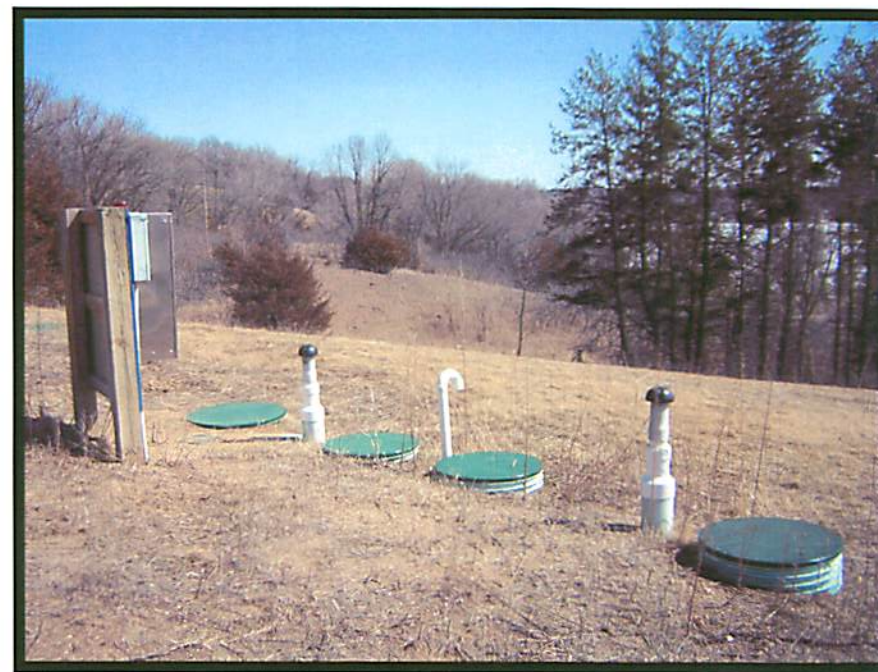
Photo 16

4. Schedule tank pumping	✓			Merle 1hr
Rest A While Sewage Treatment Facility (see Photos 16 and 17).				
1. Treatment facility in good condition.			✓	
2. East Sediment Basin Erosion has been corrected.			✓

Rest A While Sewage Treatment
Facility

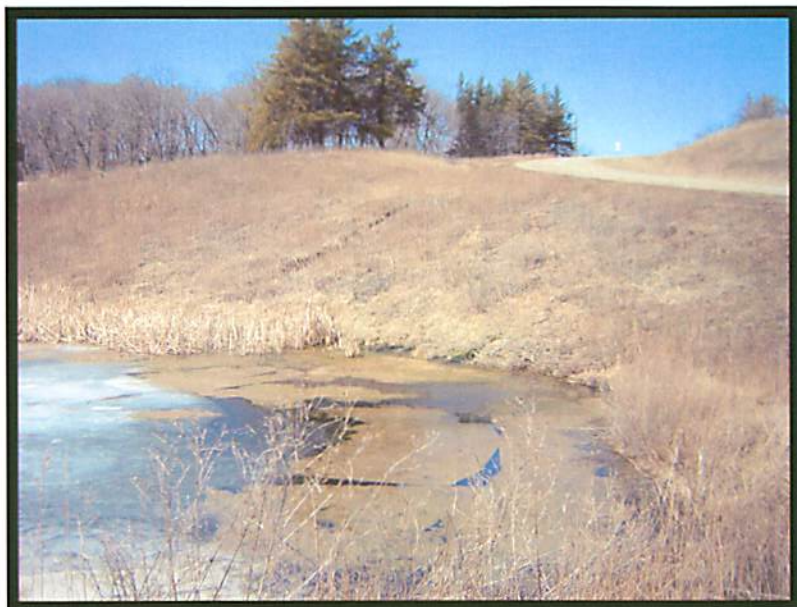
Photo 17

3. West Sediment Basin small gully screen and filter cleaning.	✓			Kevin, 4 hours

Rest A While Sewage Treatment Facility,
west sediment basin

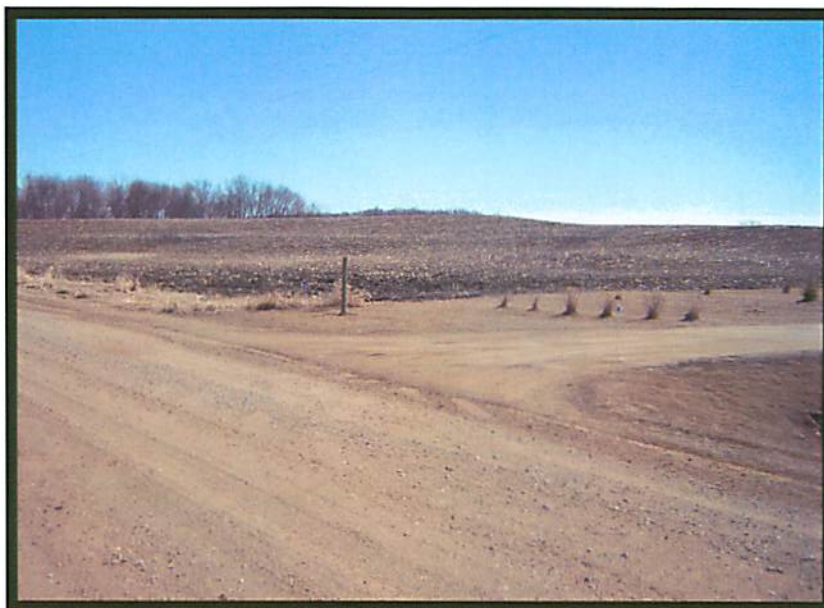
Photo 18

Clear Lake Sedimentation Basin;
farm field needs erosion control
