# 2015

## **2015 PROJECT INSPECTION REPORT**

The mission of the Clearwater River Watershed District is to promote, preserve, and protect water resources within the boundaries of the district in order to maintain property values and quality of life as authorized by MS 103D.

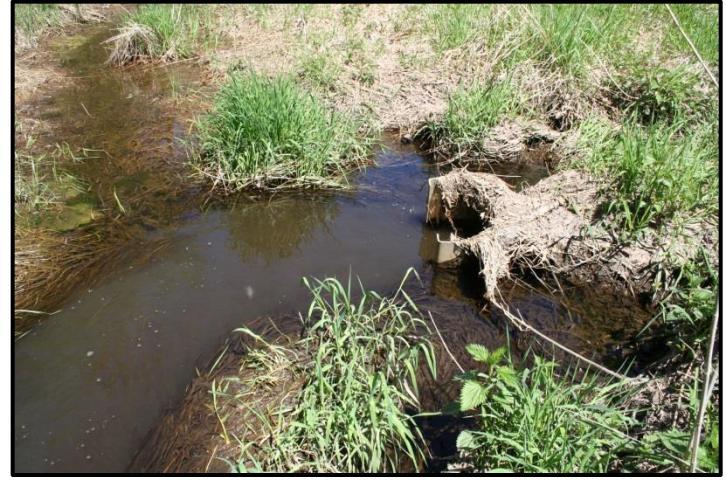
The last major site inspection was conducted May 22, 2014 (see 2014 Project Inspection Report). In 2015, only the center diversion structure was inspected, and found to be in working order.

The District Board of Managers has tentatively scheduled the District engineer firm to conduct an in-depth analysis and review of this wetland treatment system in 2015. The goal of this analysis is to determine: 1) the current operational effectiveness of the wetland, with comparison to original design effectiveness, 2) remaining life expectancy of system components, 3) whether the system is still needed, and 4) any specific maintenance and repairs needed to maintain the project's operational effectiveness.

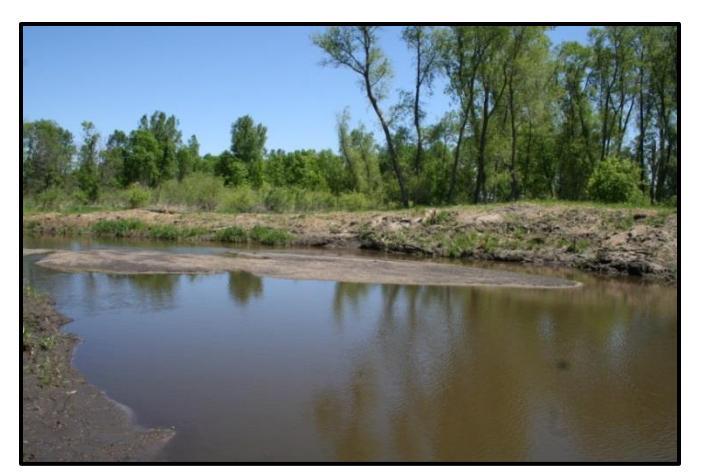
Site inspection was conducted May 30, 2015. The existing ports in the high flow channel & berm have not been maintained for operational capacity (the overflow structures serve that function); as such, they are no longer inspected. The pool at the end of the river channel near State Hwy. 55 was not examined due to being underwater.

Visual inspection indicated the re-meandered low-flow channel was in good condition; its shape seems to be very stable,

and vegetation is established. The limestone filter berm and rock riffle structure were underwater and not inspected. Fencing is missing or damaged in numerous sections. The high flow channel & berm and overflow structures were not inspected in order to cut down on field time.

The recent sediment basin cleanout work completed in early 2015 is holding well. Both the basin proper and the forebay are in good condition. New sediment deposits in the basin were noted (see picture), but the newly created space in the basin should provide a few more years of sediment removal.

Staff recommends: 1) the pool near State Hwy. 55 be surveyed via boat in 2016 to determine its sedimentation rate, 2) the high flow channel & berm and overflow structures be inspected in 2016 to assess stability, and 3) the limestone filter berm, and rock riffle structure be inspected in low-flow conditions later in the year to determine their status.

In addition, the Board should decide how the high-flow channel and berm will be maintained in the future; this will determine future inspections of this component. Also, staff recommends the Board develop an agreement with the adjacent property owners to provide for future sediment removal, as piling excavated sediment on the berm may not be a viable option in the future due to lack of space.

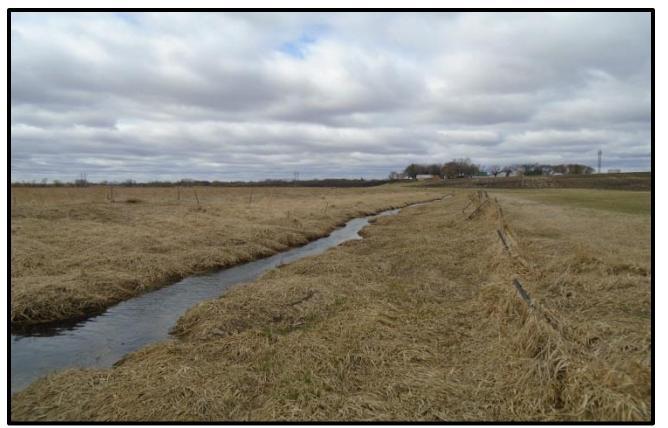
While much of the berm has been cleared of woody vegetation, clearing is still needed on several segments. The small breach on the northern end of the berm remains (noted in last year's report), but has not grown larger. Currently water

is flowing into, not out of, the wetland at this location. This breach should be repair. A couple of other low spots were noted; overall, the berm seems to be in good condition.

The wooden weir structures are in good condition. Woody vegetation around the weirs should be cleared. The diversion channel seems to be in good condition. The upper culvert crossing is in good shape. Fencing around the Isolation Project is in good condition in most area; a few spots the fencing is broken, missing, or overgrown.

Staff recommends: 1) repairing the small breach in the berm, 2) removal of woody vegetation along the berm, 3) removal of woody vegetation from the wooden weirs, and 4) treatment of noxious weeds (mainly thistles). Weed treatment should occur in the summer to minimize interference with neighboring farm fields. Berm repairs should be conducted in the winter to allow access with heavy machinery. Woody vegetation removal can occur in the fall.

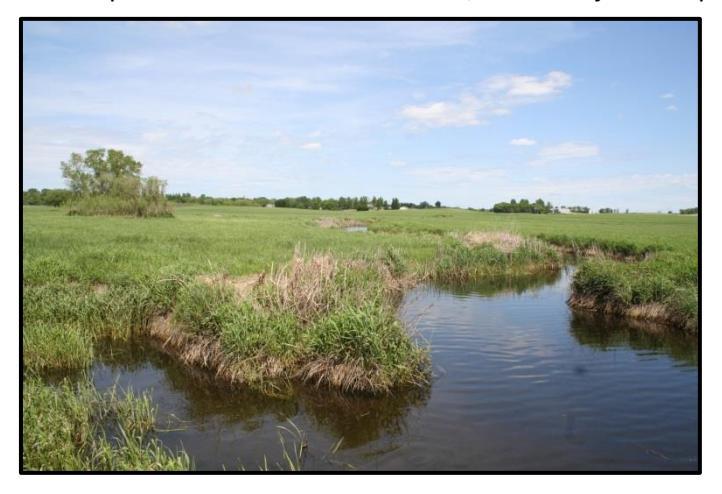
Site inspection was conducted June 1, 2015. Project components viewed included the diversion berm and outside

Both the diversion berm and channel are in good condition. Woody vegetation needs to be cleared from several berm sections. Some of the individual ports are clogged and in need of cleaning. Large sections of fencing are either missing, damaged, or overgrown. The overflows are in good condition.

Staff recommends: 1) clearing woody vegetation from the diversion berm, 2) cleaning individual ports to allow flow to enter the wetland, 3) noxious weeds (mainly thistles) are treated to minimize their interference with neighboring farm

fields. As an optional item, staff recommends decision on whether to begin repairs to fencing, or if placement of signage might be a feasible alternative.

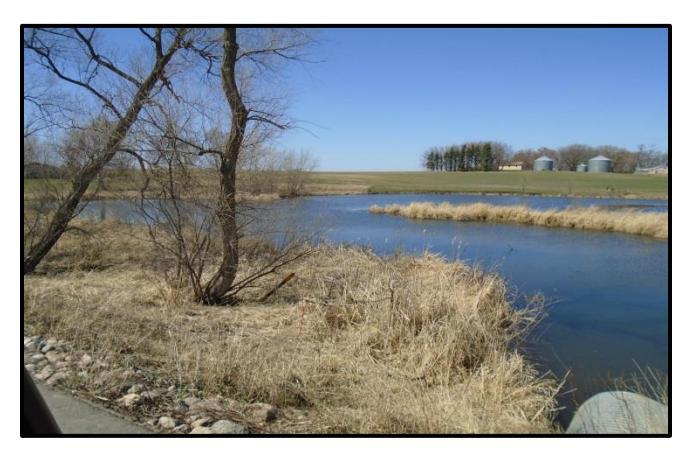
Site inspection was conducted April 14, 2015. Project is a two-cell sedimentation basin. No depth survey was taken of the basin this year. Last survey was conducted in 2012, and indicated a slight buildup of sediment in the northern cell of

the basin. Staff recommends Board consider a five-year depth survey schedule, and survey the basin again in 2017. Overall, basin seemed to be in good condition. No further action is needed.

Other items to note: 1) the placement of the notch weir above the inlet to the basin should lead to less sediment entering the basin, increasing the basin's useful life, 2) the source of the delta that formed on the southwestern end of the southern cell has been rectified due to the District cooperative effort with Forest Prairie Township in improving the road ditching and drainage above that location.

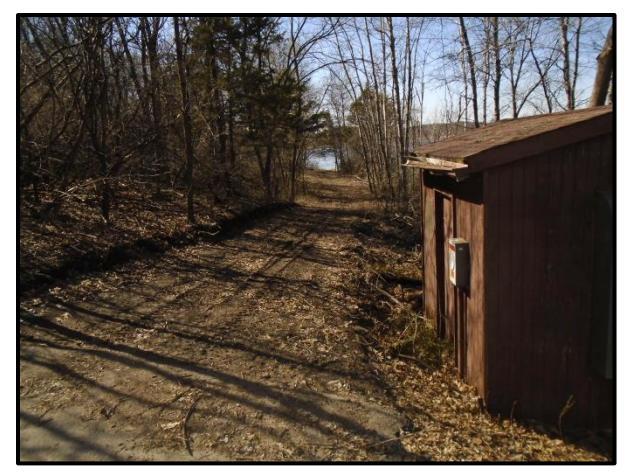
The Lake Marie aerator building is in good condition. The Lake Augusta aerator building is in need of a new coat of paint, as well as some work to its soffits, eves, and potentially its foundation. In addition, recent work on the lake access road located adjacent to the building has resulted in a large amount of dirt and debris pushed against the lake Augusta aerator building.

Staff recommends repairing the soffits and eves. A more in-depth review of the building's foundation should be conducted in the next year or so. An optional item would be to conduct a legal survey to clearly delineate the easements for each of these projects on a drawing and in current geospatial terms.

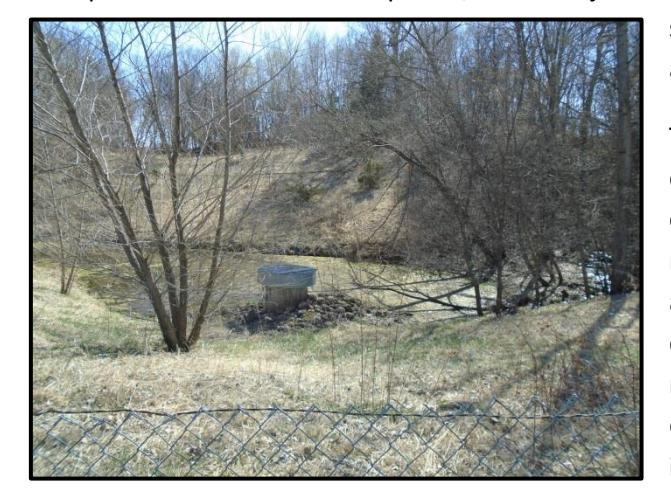
The Lake Augusta Erosion Control Project is in good condition overall. The riser is in good condition. The inlet boxes are in okay condition. The outlet is in good condition, with riprap slowing moving into channel as natural soughing occurs. The fencing around the basin is in need of minor repair (excess vegetation cleared from fence, straightening bent portions of fence). These repairs are considered optional. A depth survey of the basin to determine the amount of sedimentation and need for cleanout is scheduled for later this summer.

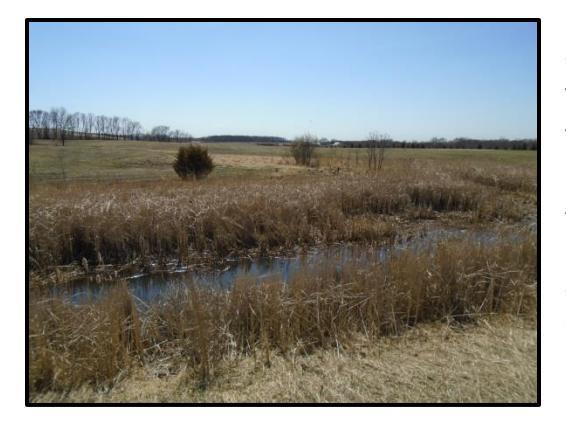
Site inspection was conducted April 14, 2015. Project is a basin with a berm to impound water and a tile outlet to release water at a slow, uniform rate, thereby eliminating gully expansion downstream. Visual inspection indicated all three components seemed to be in good working condition. No further action is needed.

Staff noted the immediate area around the basin has been mowed and cleared by some other party; the District will want to watch this closely to ensure future actions near the basin do not affect the basins operation.

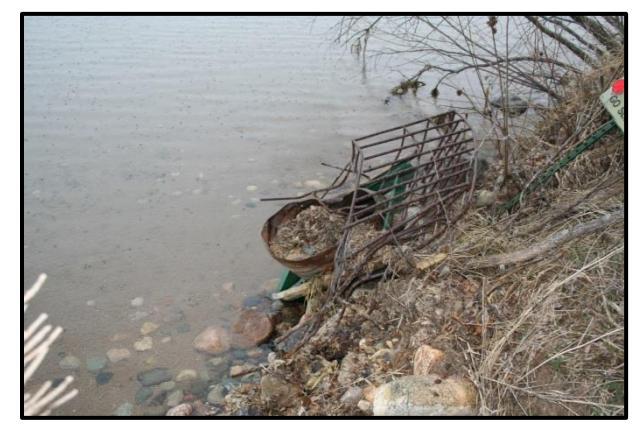
The lake outlet structure has significant damage due to ice and is not operable. Because of this, the whole outlet works is no longer functional. Work is needed to repair the outlet such that operations can occur.

The Board of Managers for the CRWD is already aware of this issue, and is planning repairs. As such, no further recommendations were made as part of this report.

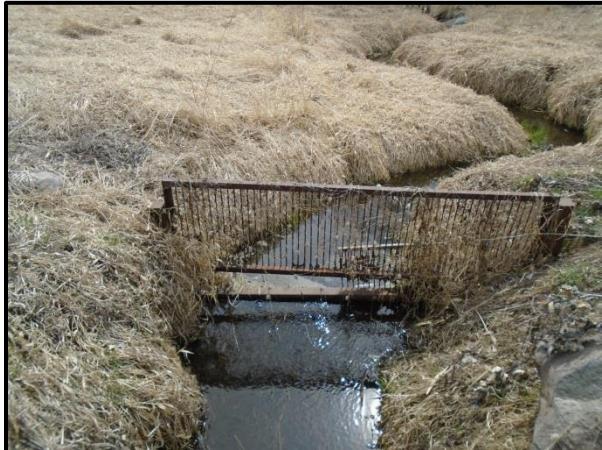
<u>Henshaw:</u> due to the large amount of filamentous algae being produced in Henshaw Lake, the barrier was left partially open to minimize risk of barrier failure and cut down of maintenance. Staff recommends this barrier be replaced with another method, such as a velocity tube. The culvert just below the barrier is experiencing significant erosion. Staff recommends the District partner with the MN DNR to evaluate the placement of a velocity tube at the eroding culvert.

- Swartout Inlet: this barrier has failed, but is slated to be replaced in 2015 as part of the Cedar Lake Watershed Protection & Improvement Project.
- 3. <u>Swartout Outlet:</u> temporary patches were put in place in May to block holes due to undercutting. The barrier is operating, but it will need significant modification in the future to remain operationally reliable. One option would be to work with the nearby road authority to integrate a fish barrier into the road culvert. The county road is slated to be replaced in the next couple of years. Staff recommends partnering with Wright County when this road is replaced to integrate a fish barrier into the replaced culvert.

- 4. Illsley Avenue: additional riprap was placed in late May to address erosion around the wings of the barrier. The barrier is in good working order. No further work is needed.

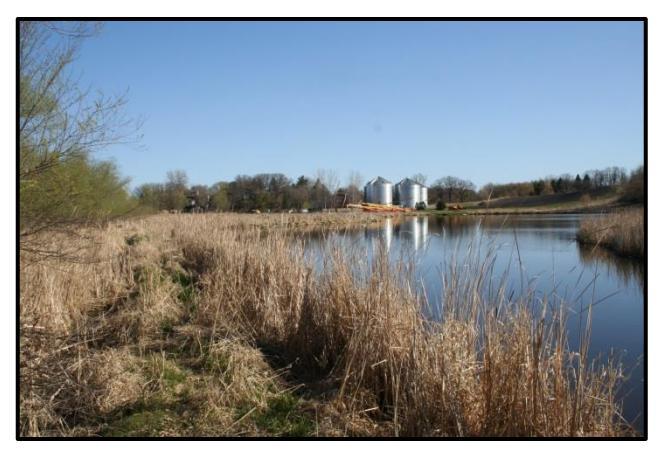
The diversion berm and inlet channel was noted to be in good condition. The limestone berm was survey with GPS equipment on May 1, 2015; low spots noted from that survey were corrected on May 22, 2015. The pond did not undergo a depth survey, but visually seemed to be in good condition. The mitigation wetland was in good condition.

Staff recommends the Board consider a five-year depth survey schedule, and survey the pond next year. No other work was noted as necessary.
