[2013 PROJECT INSPECTION REPORT]

This 2013 Project Inspection Report serves to provide an overview of existing District projects and their operational and maintenance needs. The projects were inspected by Dennis Loewen and Cole Loewen in May and June of 2013.

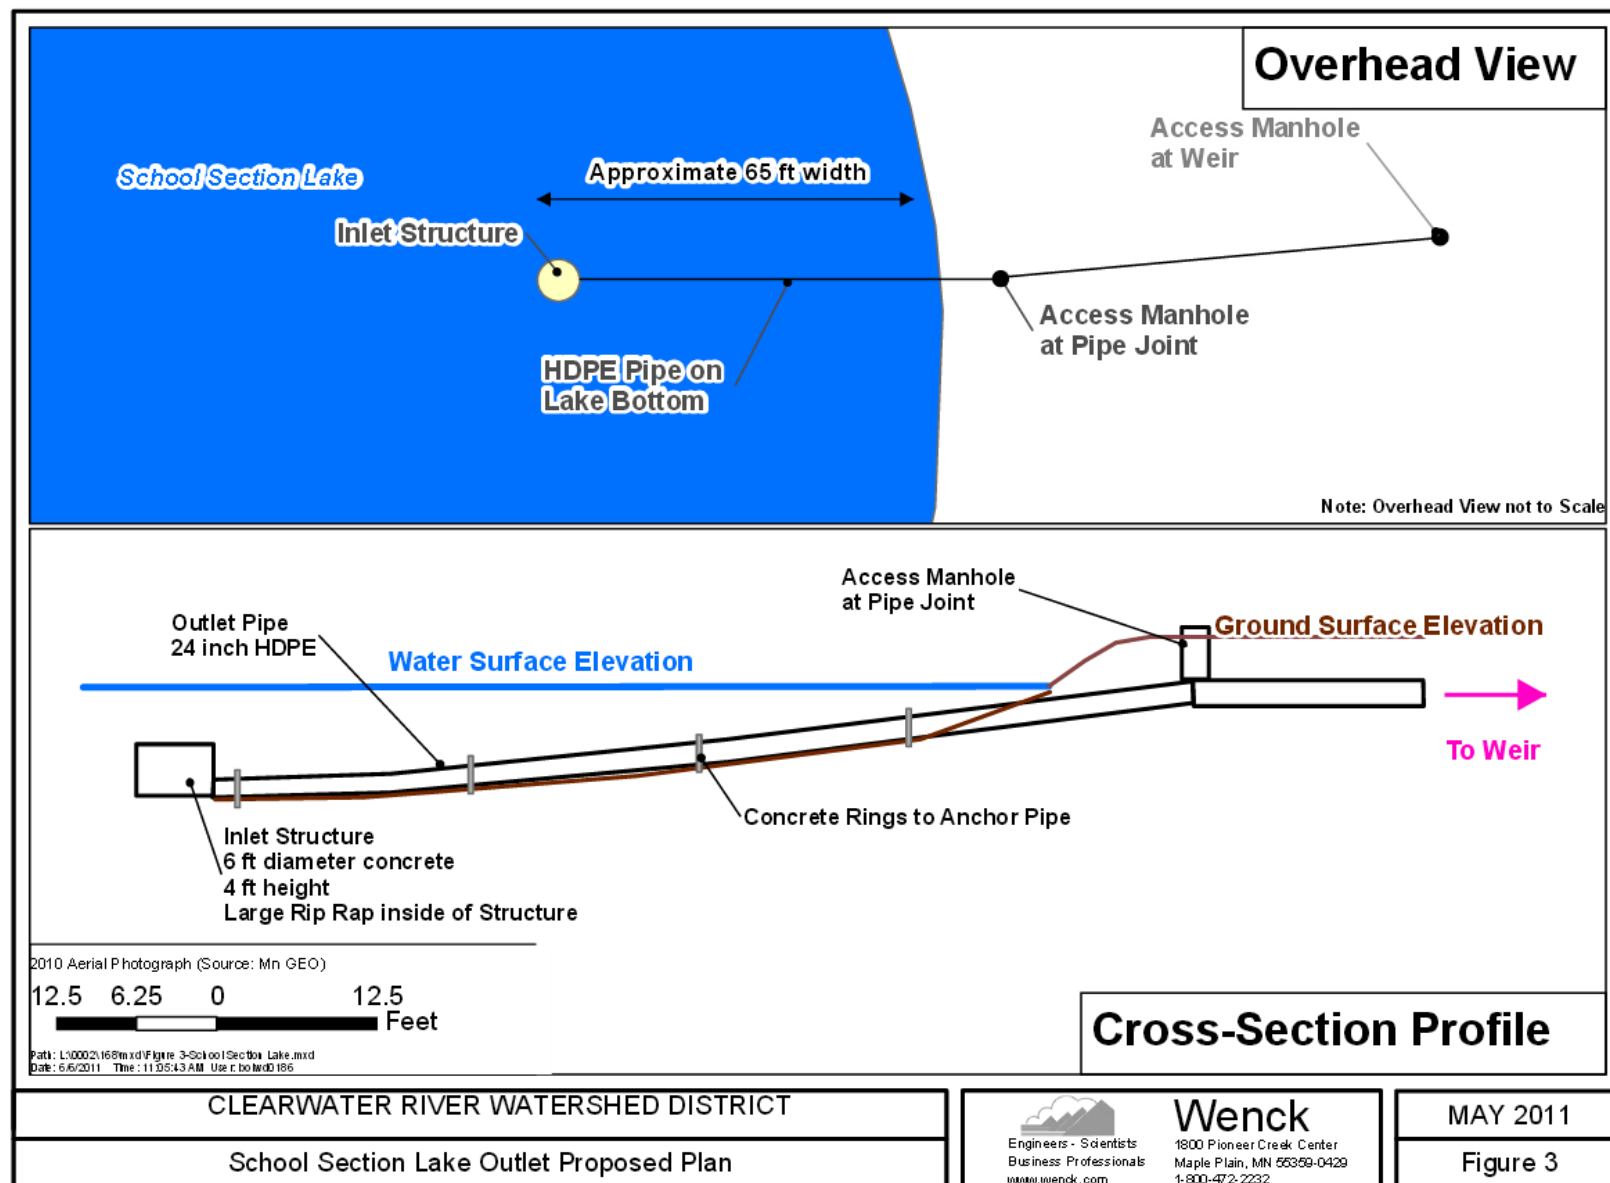
1. Notch weir outlet structure in good condition			✓	
2. Sand-Iron Filter in good condition			✓	
School Section Lake Outlet Project (See Photo 10 and Figures 2 and 3).

1. Proposed alterations to outlet		✓		\$30,000

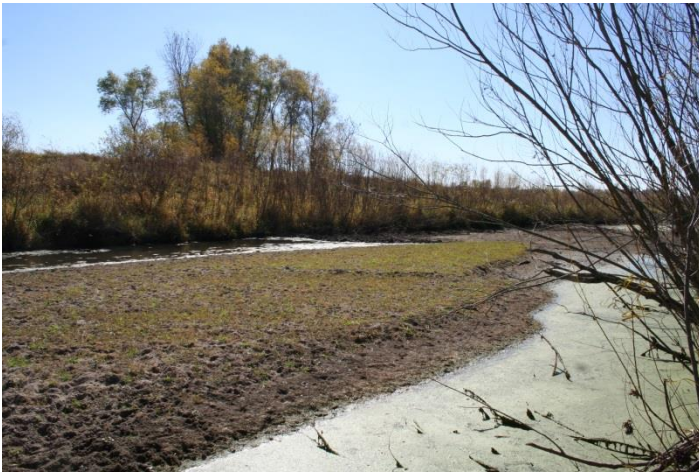
1-Sediment in Kingston Wetland Diversion Channel Basin

1. Remove sediment in diversion channel basin	✓			\$8,000
2. Existing Berms are operating properly			✓	
3. Major O&M work recently completed			✓	
Upper Watkins Wetland Isolation Project (North) (See Photo 2)

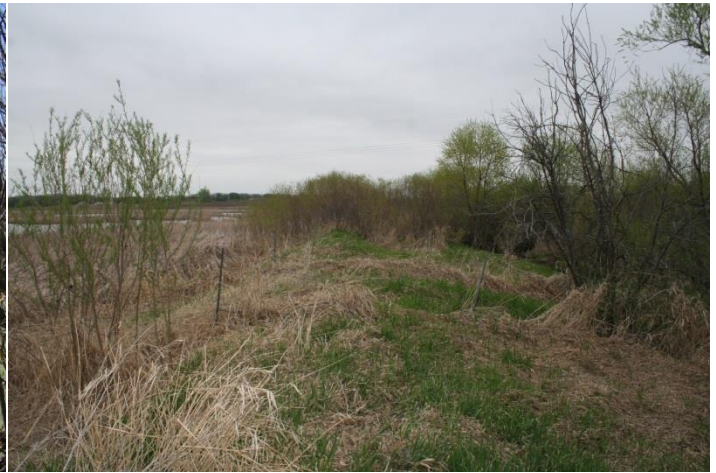
2-Brush/Trees on Berm at Watkins Isolation Project

1. Berms are in good condition			✓	
2. Wood isolation structures are in good condition			✓	
3. Clear brush/trees growing on and around berms		✓		Maintenance -24 hours + \$300 materials

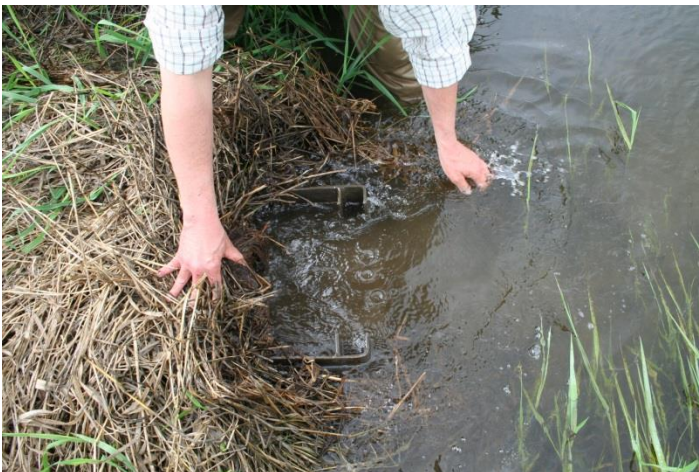
3-Example of Port at Watkins Wetland Treatment System

4. Treatment of noxious weed (as needed)	✓			Maintenance - 12 hours + \$300 materials
Watkins Wetland Treatment System (South) (see Photos 3-5)				
1. Clean debris from ports	✓			Maintenance -24 hours + \$300 materials

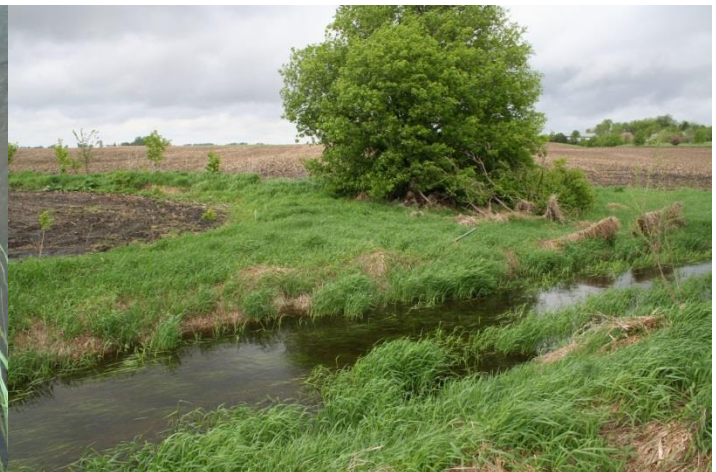
4-Missing Portions of Fence at Watkins Wetland Treatment System (TS)

2. Berms are in good condition			✓	
3. Repairs needed in fencing	✓			Maintenance -24 hours + \$500 materials
4. Clear brush/trees growing on and around berms		✓		Maintenance -32 hours + \$400 materials

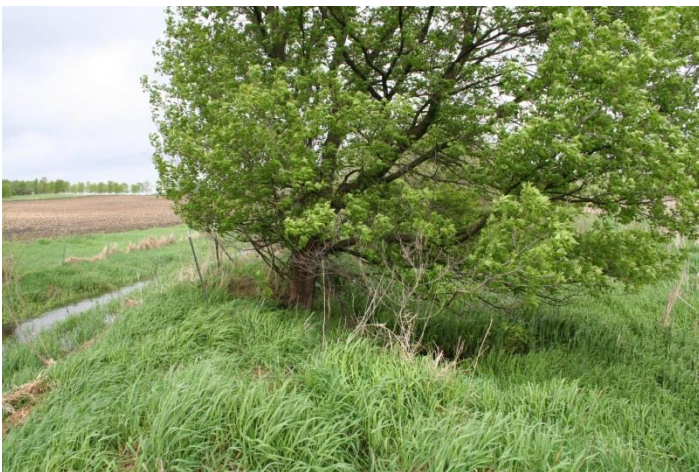
5-Brush/Trees on Berm at Watkins Wetland TS

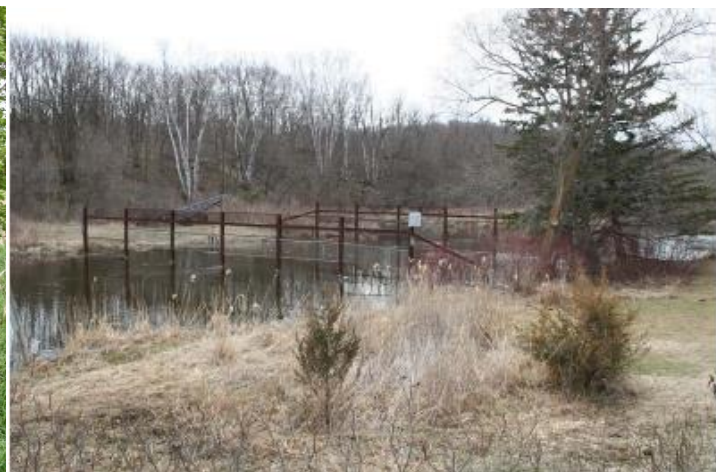
6-Highway 55 Fish Trap

1. Improvements to fish trap		✓		District will coordinate with commercial fisherman
Aerator Buildings (See Photos 7-8)				
1. Lake Augusta-Repair to soffits and eaves	✓			District will coordinate repair-approximately \$1,500

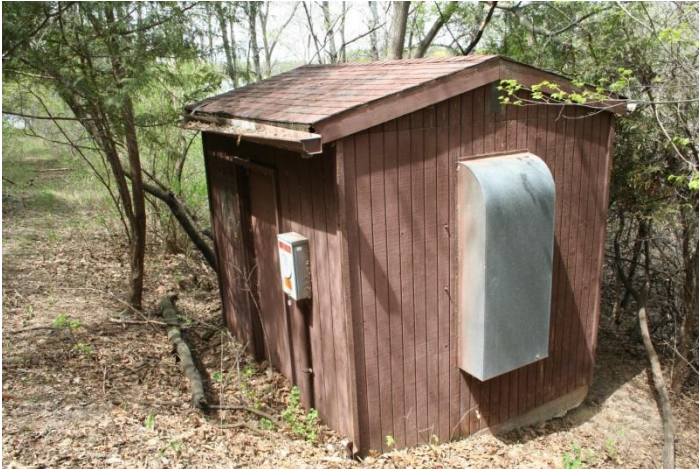
7-Lake Augusta Aerator Building

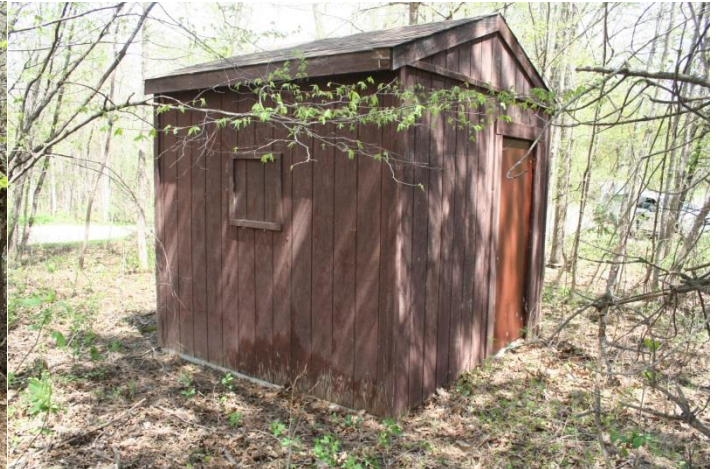
8-Lake Marie Aerator Building

2. Lake Marie- New coat of paint	✓			Maintenance - 4 hrs. + \$100
Lake Augusta Erosion Control Project (See Photo 9).				
1. Outlet and riser in good condition (slight lean in riser)			✓

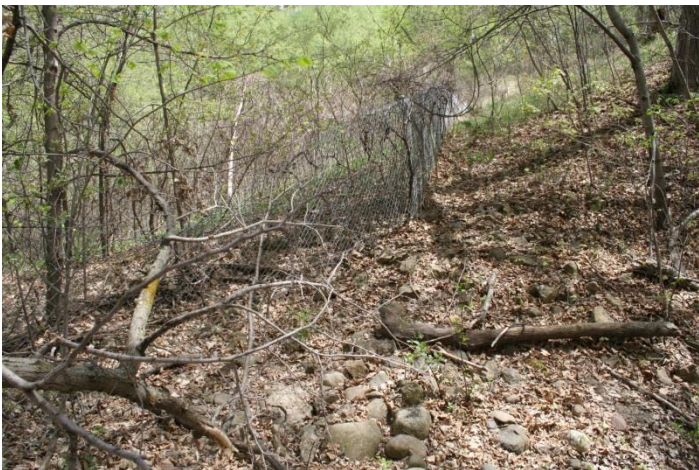
9-Bent Fencing at Lake Augusta Erosion Control Project

2. Inlet boxes are in okay condition			✓	
3. Repair bent portions of fence, clear brush/trees from fence		✓		Maintenance - 6 hrs + \$300 for materials
Norton Ave Sediment Basin

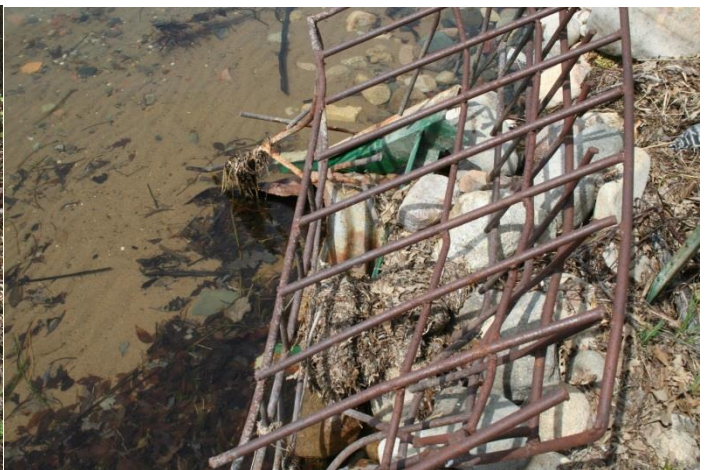
10-School Section Lake Outlet Damaged by Ice

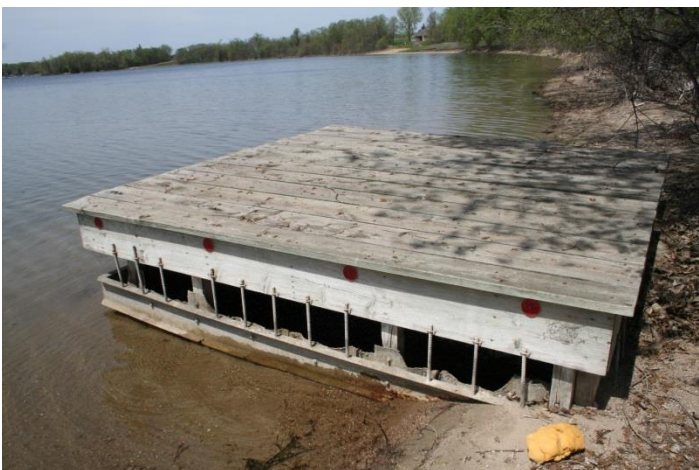
11-Pleasant Lake Outlet Control Structure

Project	Maintenance			Estimated Cost
	Recommended	Optional	No Action Now	
Pleasant Lake Outlet Project (See Photo 11)				
1. Repairs to wood structure		✓		Maintenance - 6 hrs + \$300 for materials
Kimball Stormwater Phase I

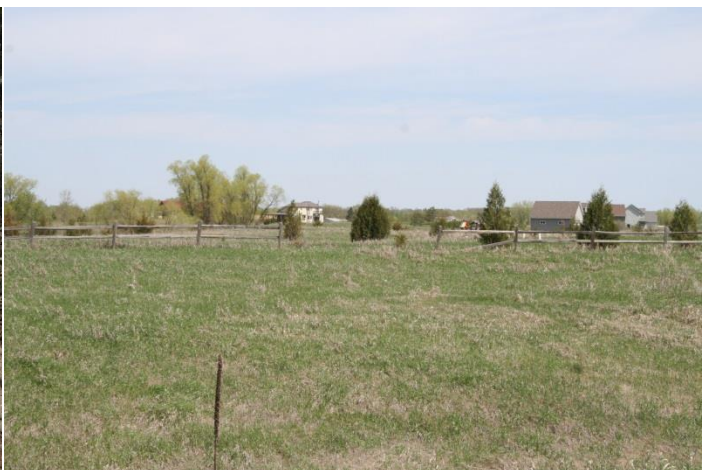
12-Broken Fence at Hidden River Sewer System

3. Remove brush/trees growing inside fence	✓			Maintenance- 4 hrs + \$300 for equipment
4. Repair broken sections of fence	✓			Maintenance- 4 hrs + \$200 for materials
Rest-a-While Shores Wastewater Treatment System (See Photos 13-14)

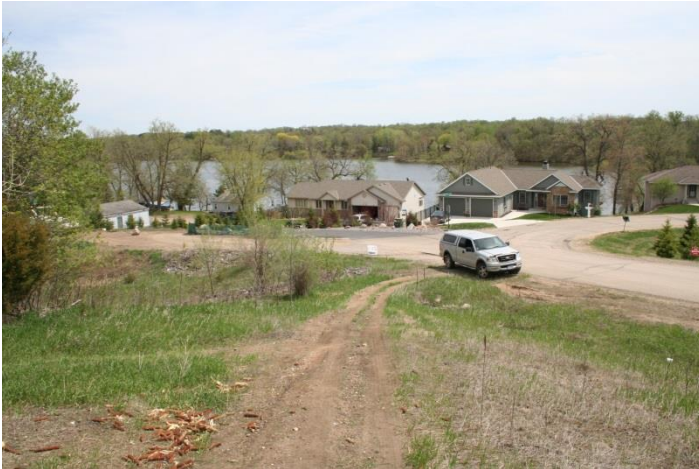
13-Eroding Hillside "Trail" at Rest-A-While Shores Sewer System

1. Fence off eroding hillside "trail," seed grass, place additional "No Trespassing" signs	✓			Maintenance - 8 hours + \$300 materials
2. Remove debris piled on property		✓		Maintenance - 6 hours + \$500 for hauling
Clearwater Harbor Wastewater Treatment System

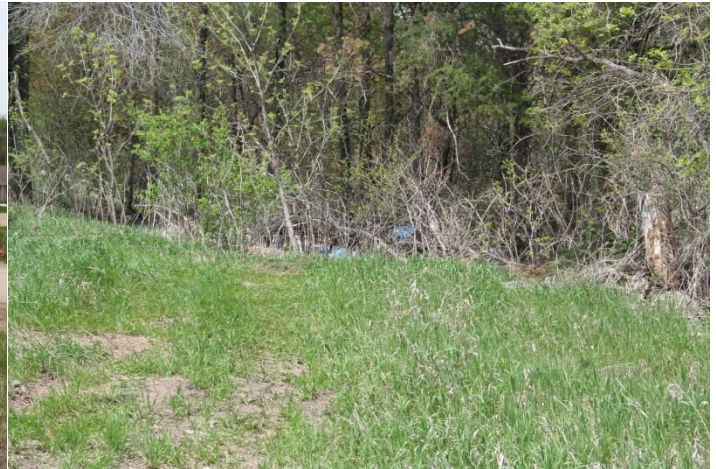
14-Debris Pile on Property inside Tree Line

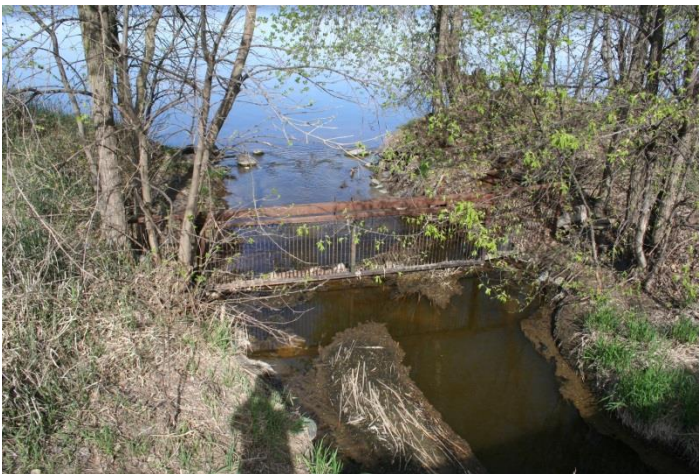
15-Swartout Lake Outlet Fish Barrier

1. Barrier at outlet has undercut, needs to be repositioned due to change in outlet dam	✓			District will coordinate repairs with grant work later this year

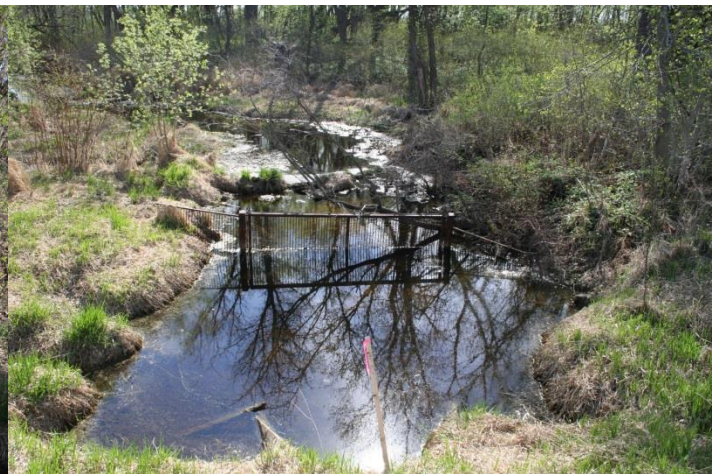
16-Swartout Lake Inlet Fish Barrier

2. Barrier at inlet needs to be repositioned	✓			Maintenance - 16 hrs + \$1,500 for equipment
3. Make alterations to fish barrier.		✓		Maintenance - 16 hrs + \$1,000 for materials
Illsley Ave Fish Barrier (See Photos 17-18)

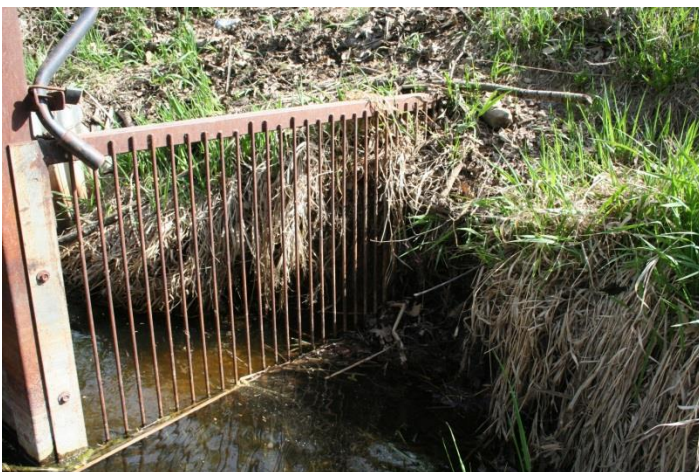
17-Eroding Bank at Illsley Ave Fish Barrier

1. Place rip rap on wings of barrier to stop erosion of banks, replace temporary repair on western wing	✓			Maintenance - 12 hrs + \$500
Segner Pond (See Photos 19-20)

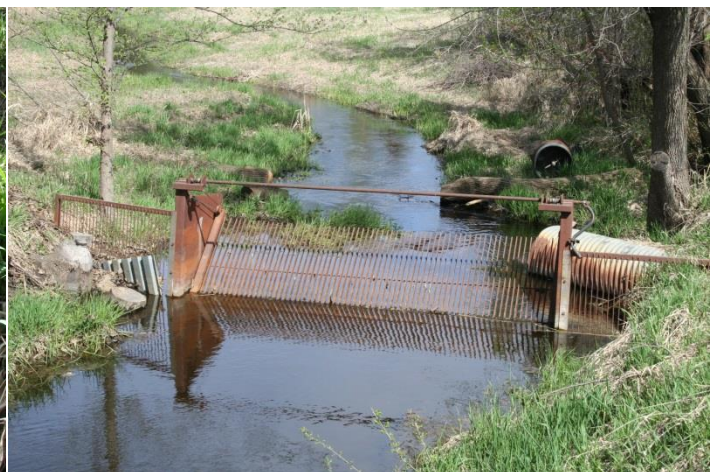
18-(Left) Temporary Repair at Illsley Ave Fish Barrier

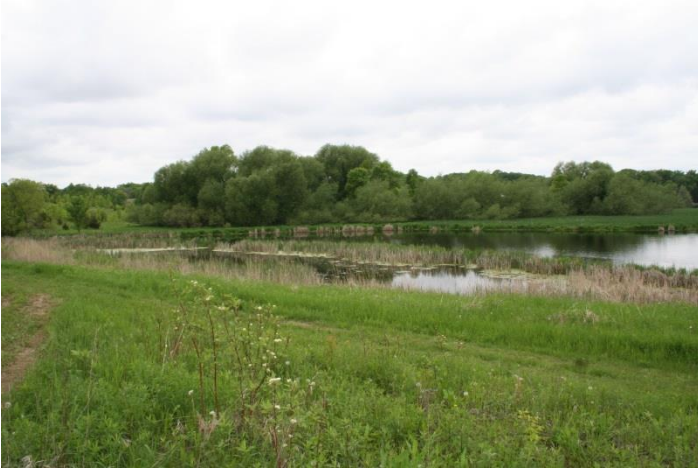
19-Segner Pond

1.Diversion structure operating properly			✓	
2.Add limestone to low spots in limestone berm	✓			Maintenance - 16 hrs + \$2,000 for materials
3. Make alterations to fish barrier		✓		Maintenance - 16 hrs + \$1,000

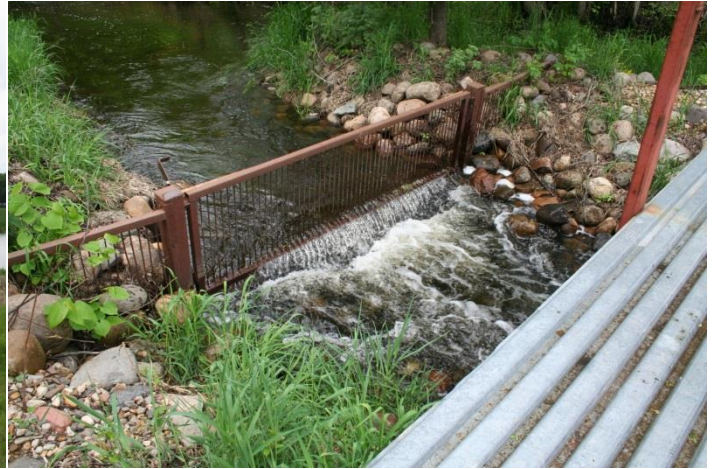
20-Segner Pond Fish Barrier
