METHODS FOR DETERMINING VEGETATION & FISH HEALTH

ALBION LAKE

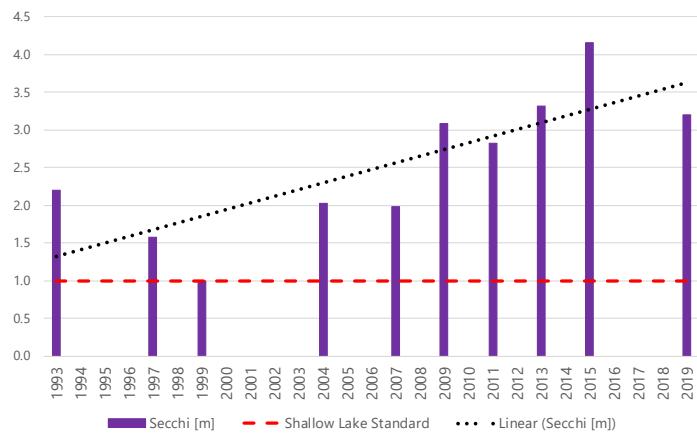
School Section - Historical Secchi Depth [m]
