METHODS FOR DETERMINING VEGETATION & FISH HEALTH

ALBION LAKE

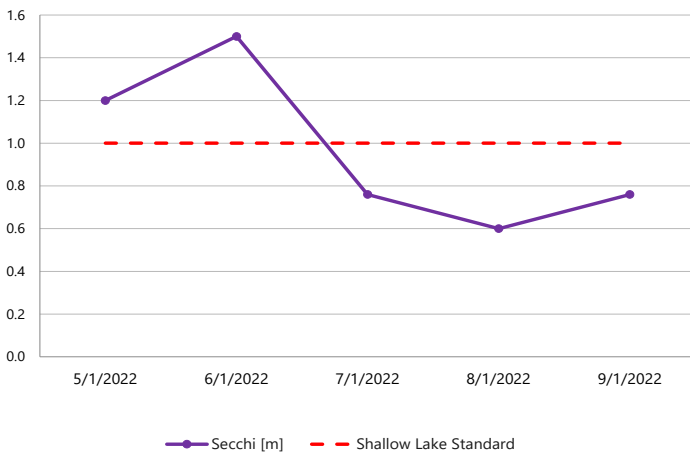
Clear - 2022 Secchi Depth [m]

Secchi [m] Shallow Lake Standard

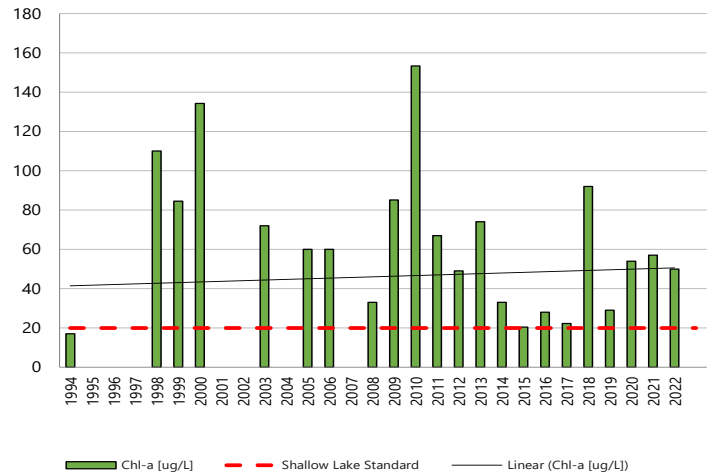
Clear - Historical Chl-a [ug/l]

Chl-a [ug/L] Shallow Lake Standard Linear (Chl-a [ug/L])

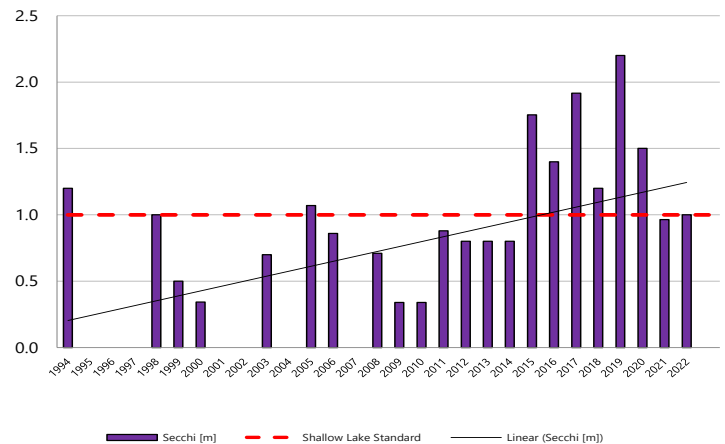
Clear - Historical Secchi Depth [m]

Secchi [m] Shallow Lake Standard Linear (Secchi [m])

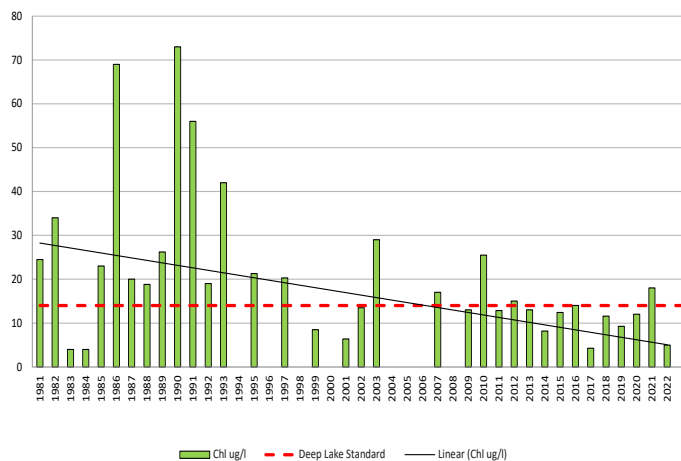
Augusta - Historical Chl-a [ug/L]

■ Chl ug/l - - - Deep Lake Standard — Linear (Chl ug/l)
