2012 Water Quality Monitoring and TMDL Implementation Status Report

CLEARWATER RIVER WATERSHED DISTRICT

WENCK ASSOCIATES, INC.

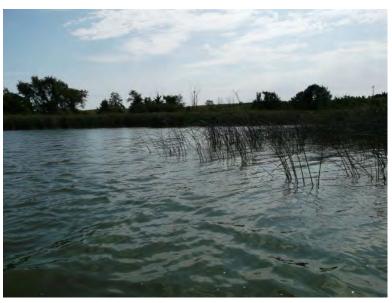
Emergent Vegetation in Albion Lake

An aquatic vegetation survey conducted in September 2012 found aquatic vegetation at 23 of 62 survey points, as shown in Figure 4.2. Curly-leaf pondweed, flatstem pondweed, and elodea were the most common species of submergent vegetation observed in the lake. A fringe of emergent vegetation dominated by hardstem bulrush was also observed in portions of the lake. Curly leaf pondweed was especially prevalent in the lake as turions and young plants were collected at several monitoring points and observed floating in many other areas of the lake.

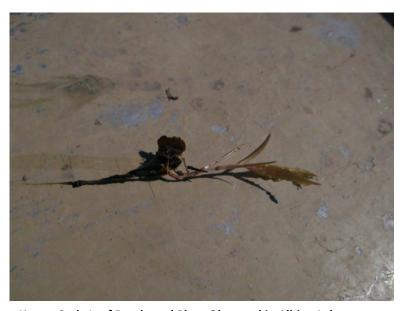
Young Curly Leaf Pondweed Plant Observed in Albion Lake

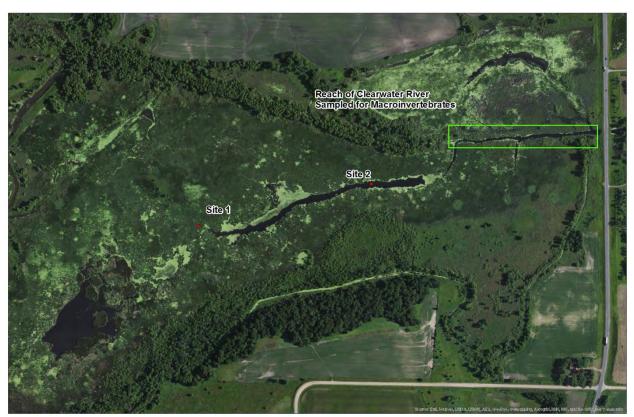
Figure 5.1 Kingston Wetland Sediment and Macroinvertebrate Sample Locations

Macroinvertebrate samples and sediment cores were collected in 2012 as shown in Figure 5.1.
