2013 Water Quality Monitoring and TMDL Implementation Status Report

Wenck File #0002-203

CLEARWATER RIVER WATERSHED DISTRICT
Box 481
Annandale, Minnesota 55389

January 2014

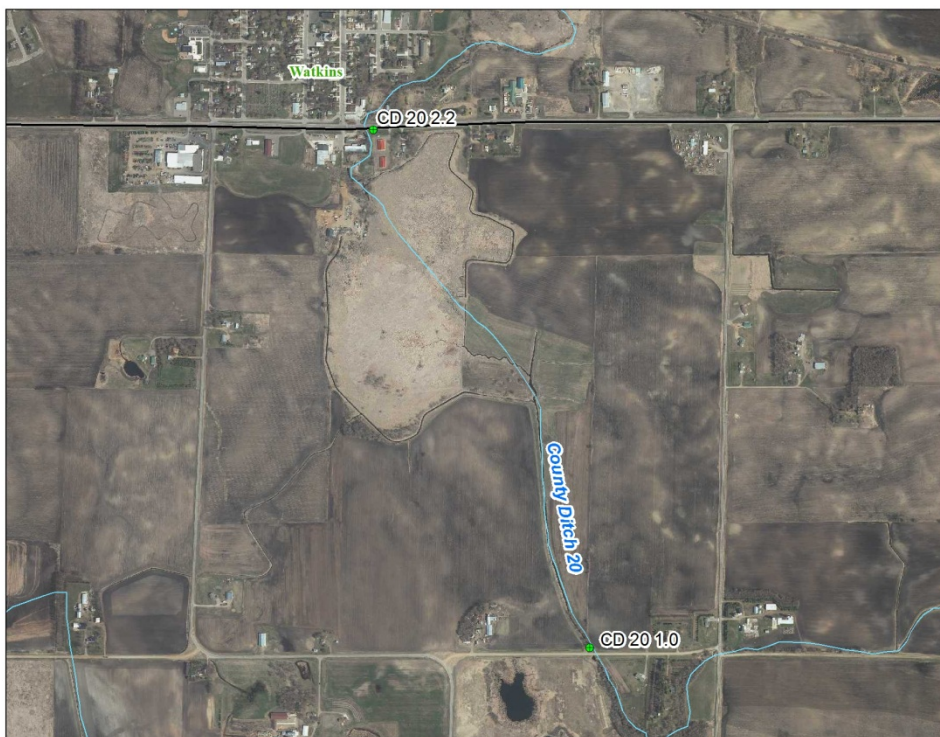
Figure 3.6 County Ditch 20 Monitoring Locations

As shown in Figure 3.6, County Ditch 20 was also monitored in 2013 at two locations upstream and downstream of the Watkins wetland. As shown in Table 3.4, total phosphorus concentrations were similar and high at both sites with slightly higher concentrations observed at downstream station CD 20-1.0. The phosphorus load was over twice as high at the downstream monitoring location. The proportion of total phosphorus comprised of soluble phosphorus was very high at both sites, indicating potential export of soluble phosphorus from wetlands in this subwatershed as a significant source of phosphorus.

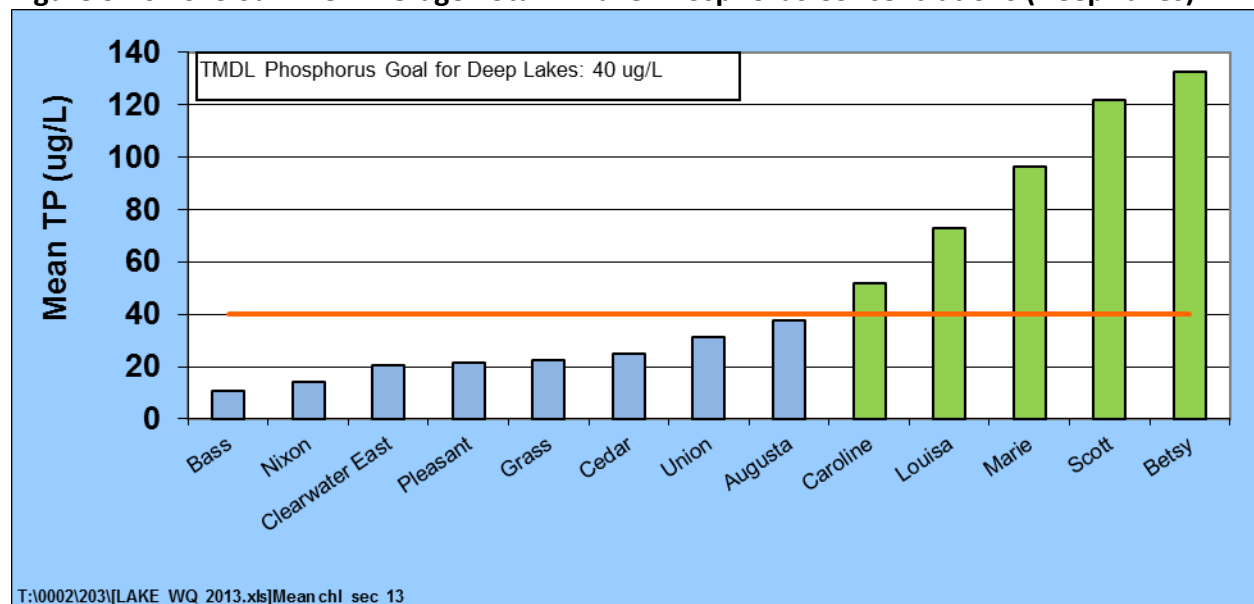
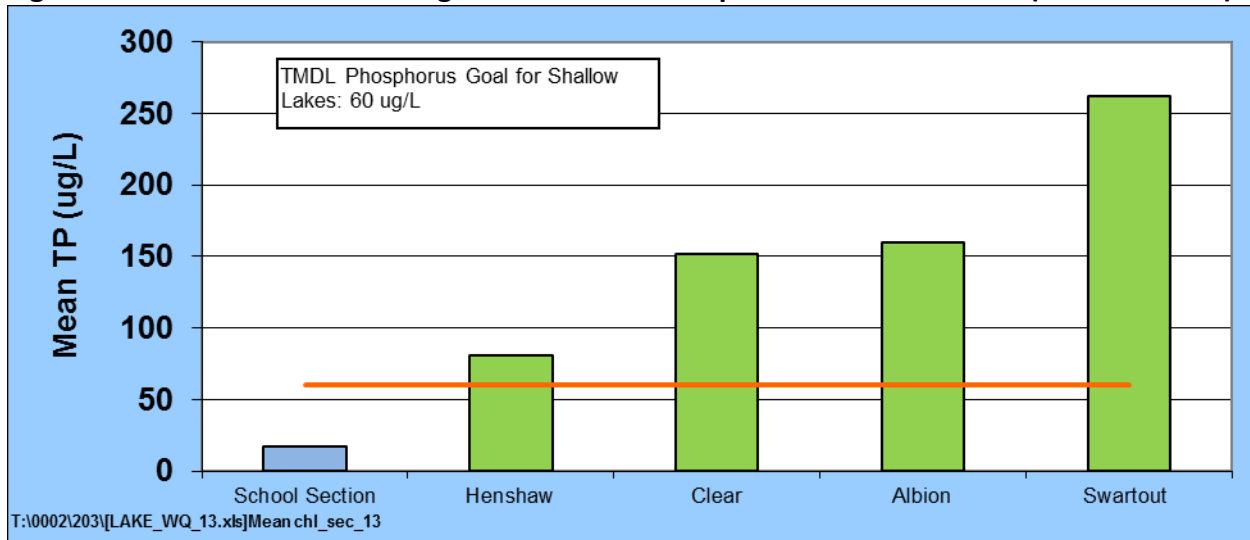
Figure 3.10 2013 Summer Average Total In-Lake Phosphorus Concentrations (Deep Lakes)

Figure 3.11 2013 Summer Average Total In-Lake Phosphorus Concentrations (Shallow Lakes)

In general, phosphorus concentrations were lower in most lakes in 2013 in comparison to recent years due to decreased runoff and loading from the watershed, with a few exceptions. Based on the 2013 monitoring data for each lake Caroline, Betsy, Louisa, Scott, Marie, Henshaw, Clear, Albion, and Swartout were above the TMDL goal for total phosphorus. Although phosphorus concentrations did not meet TMDL goals in these lakes, concentrations were dramatically improved in Caroline, Henshaw, Louisa, Marie, and Swartout Lakes. Phosphorus concentrations increased in Clear Lake in 2013.

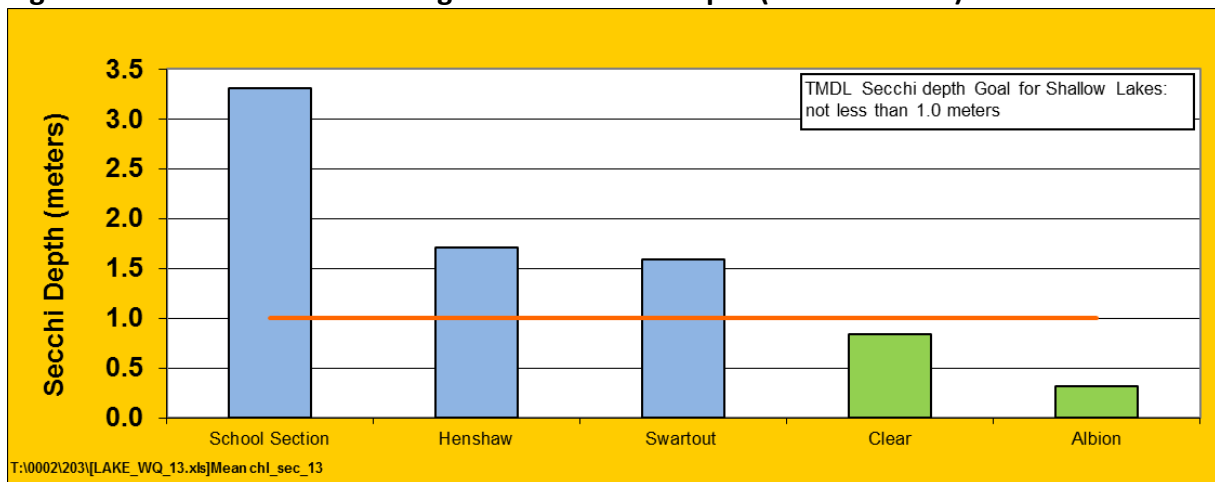
Figures 3.14 and 3.15 compare the 2013 Secchi disk depth for CRWD lakes to the appropriate Secchi TMDL goal. Water clarity was good in the District lakes in 2013, as the TMDL goal was met for all lakes except for Albion and Clear.

Figure 3.14 2013 Summer Average In-Lake Secchi Depth (Deep Lakes)

Figure 3.15 2013 Summer Average In-Lake Secchi Depth (Shallow Lakes)

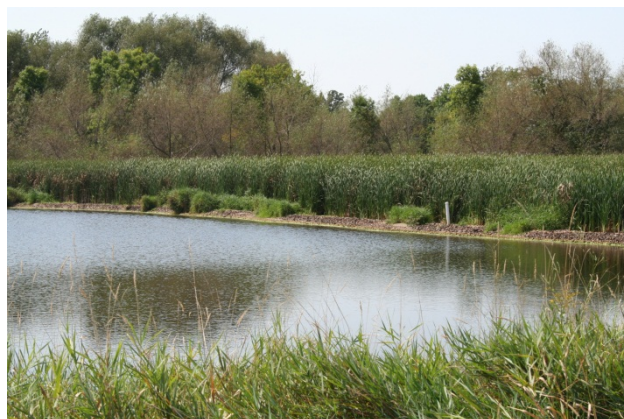
Segner Pond Limestone Berm Following Repairs

Activities conducted in 2013 included ongoing maintenance of fish barriers, Segner Pond limestone berm repair, and rough fish removal..
