### **2019-2021 The Project Inspection and Maintenance Summary**

The mission of the Clearwater River Watershed District is to promote, preserve, and protect water and natural resources within the boundaries of the district in order to maintain property values and quality of life as authorized by MS 103D.

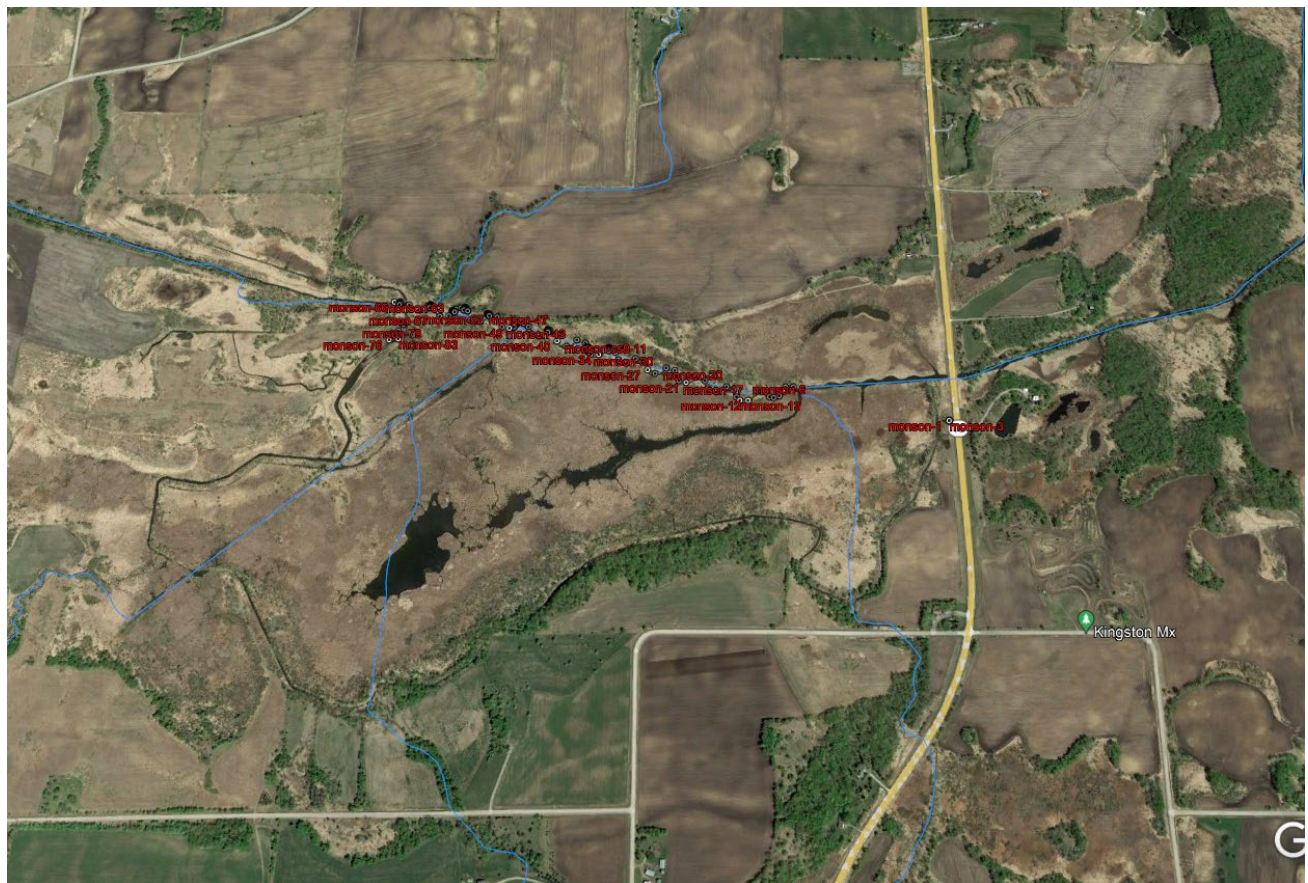
2021 Survey Locations

October 2021. R10 survey unit with canoe. Beaver dam at diversion structure with observed with head differential between upstream and downstream. Downstream of beaver dam water level was ~0.5 ft. Upstream water depth was ~2ft. Sediment basin requires cleanout. Channel in mostly good shape with well established vegetation. Reed canary grass buffer the stream banks dominant with some noticeable undercutting further upstream. Water was present along

entire stream reach, about 1.8 feet deep for the survey even during dry conditions of 2021. Staff collected cross sections above and below beaver dam. Also cross sectioned the centerline of the beaver dam.

*2021 survey photos*

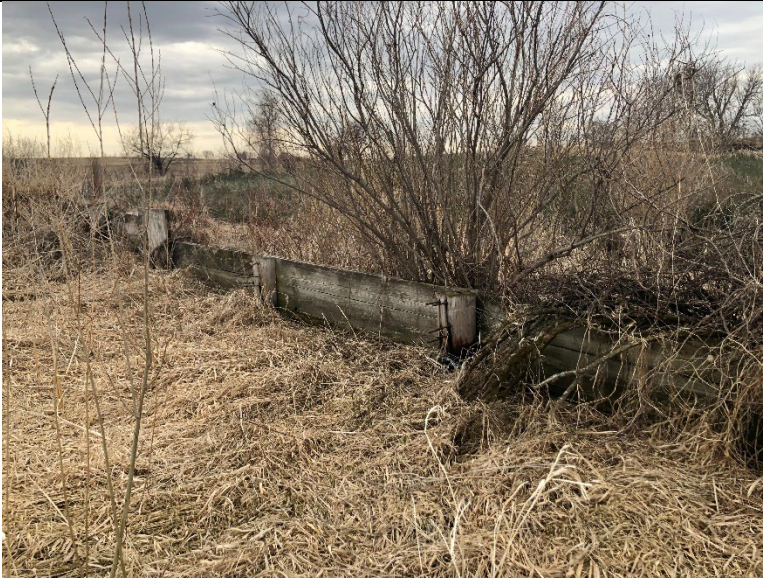
*2019 Site Photos*

The wooden weir diversion structures are in good condition. The berm and outlet structure do have woody brush growing that should be removed, and evidence of rodent tunneling which can undermine berm function.

*2019 site photo. On outlet berm, characteristic rodent tunneling (puppy for scale)*

- Conduct full survey in 2022 spring with drone and elevation.
- Survey the channel to determine if repair is needed.
- Flush cut brush on the berm and near the outlet structure.
- Investigate adding rat wire to areas of the berm/ outlet structure where rodents have burrowed and repair burrow damage.
- Consider repairing portions of broken fencing, or remove broken portions and replace with signage. The fencing work is a lower priority than other noted work items.
- Prior to any work, the District may wish to contact easement holders to inform them of work to be undertaken in order to avoid any potential confusion.

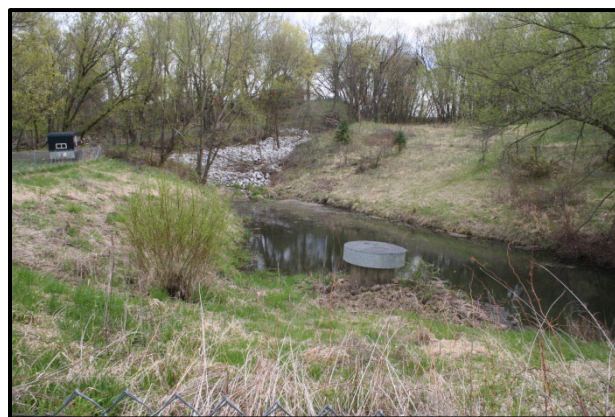
In the area of the basin, several trees need to be cut down within the basin fence in order to protect underground culverts from damage. The southern and western inlets are in good working order in 2017.

Portions of the fence around the basin are bent due to woody vegetation growth.

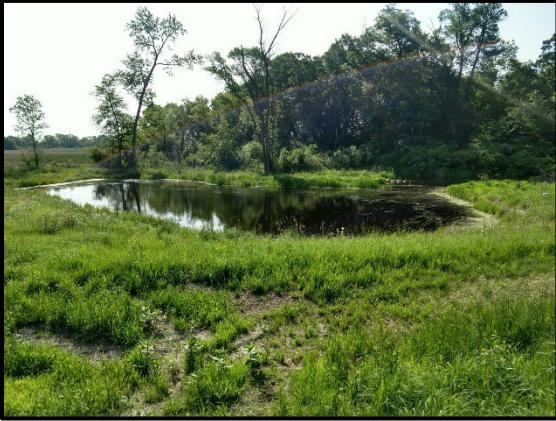
East Swartout Sand-Iron Filter

- Both stream and filter sheet-pile weirs were in good working order. Fish barrier is working well. Wings will be installed now that additional sheet piling work has been completed.
- Complete installation of fish barrier wings.
