2002 Project Inspection Report

Prepared for
**Clearwater River
Watershed
District**

June 2002

Table 1
Clearwater River Watershed District
Annual Project Inspection
May 2002

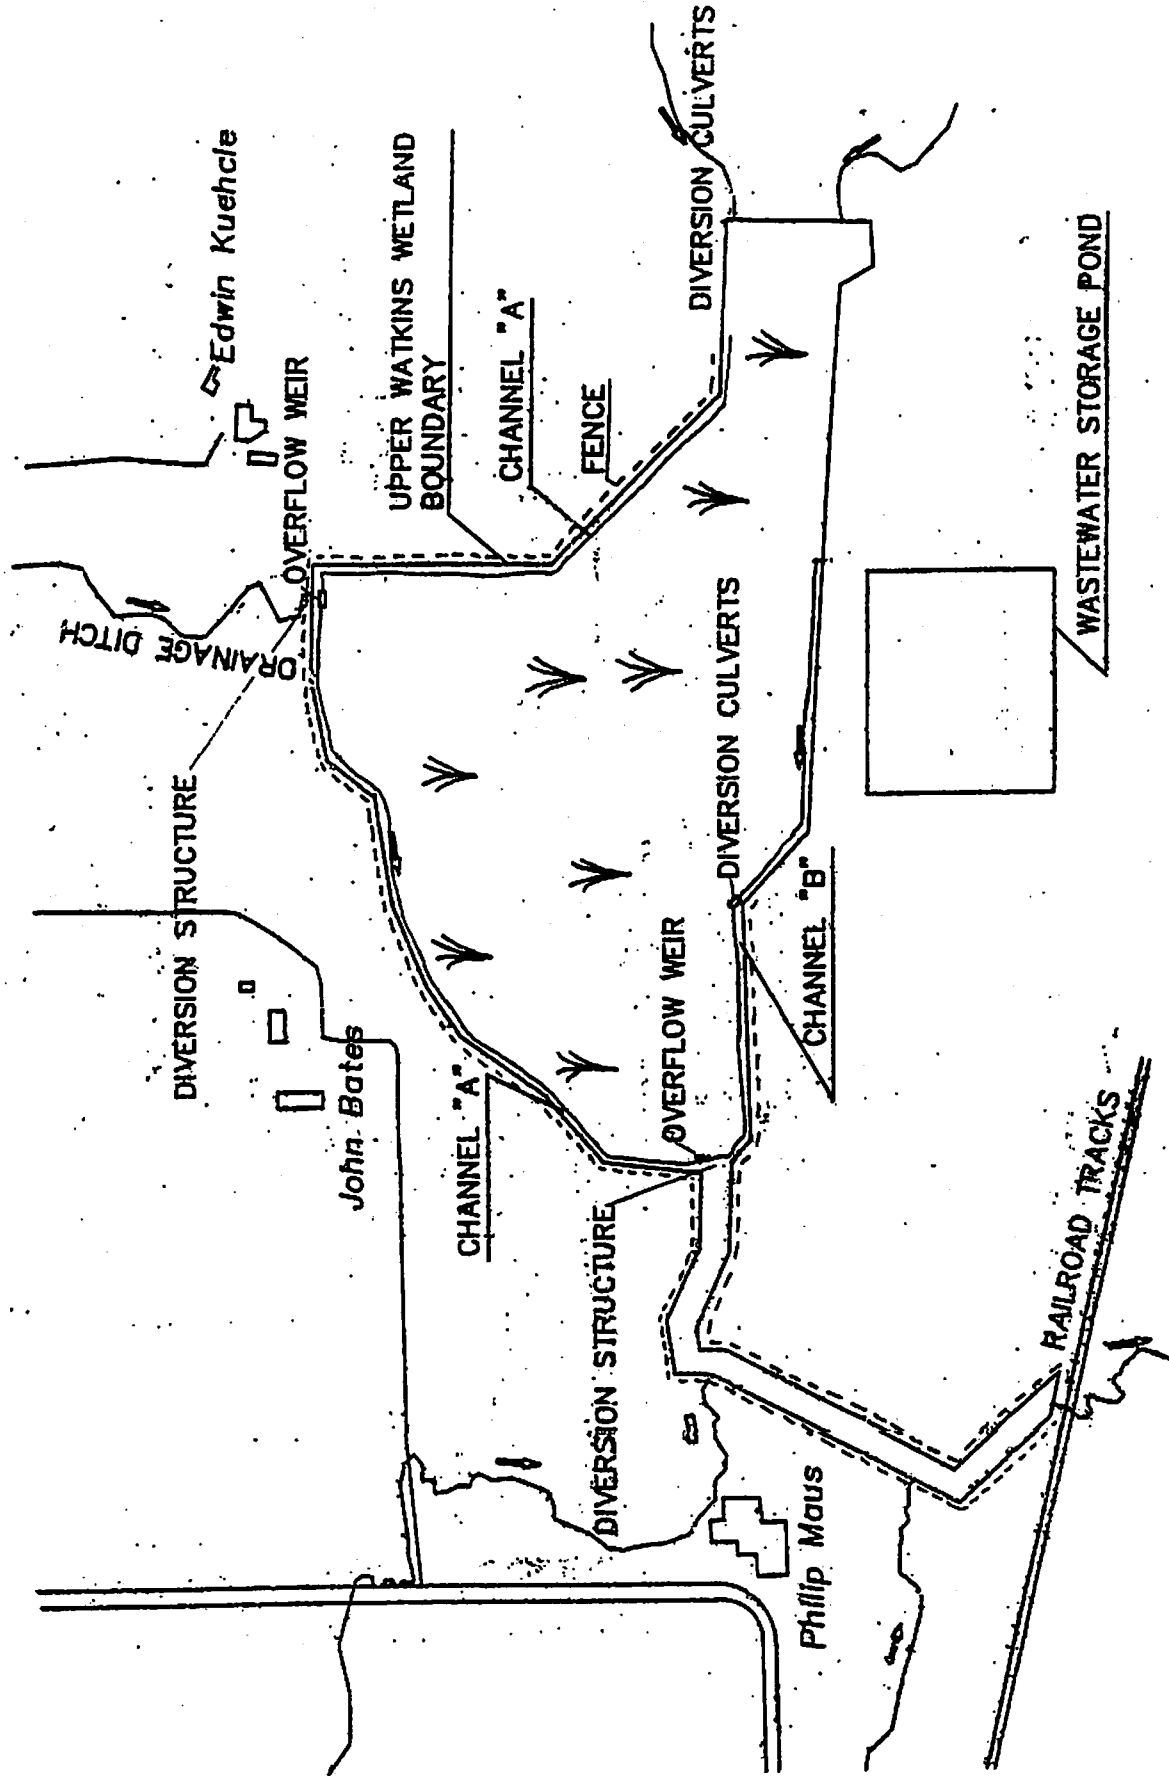
FIGURE 2

2. East side (Channel B) flowing normal, channel ports open.			✓	
3. Fence needs repair and tightening along east side.	✓			Kevin 8 hrs.
Upper Watkins Wetland Isolation Project (north) (see Figure 2 and photos 3 and 4).

1. Ditches and overflow structures in good condition.			✓	
2. Field erosion along north ditch (David Bates property). Have owner consider a buffer strip.		✓		Merle 4 hrs.

3. Fence needs repair and tightening.	✓			Kevin 8 hrs.
Annandale Wetland Treatment System (see Figure 3 and photos 5, 6, and 7).				
1. Ditch and overflow structure in good condition.			✓

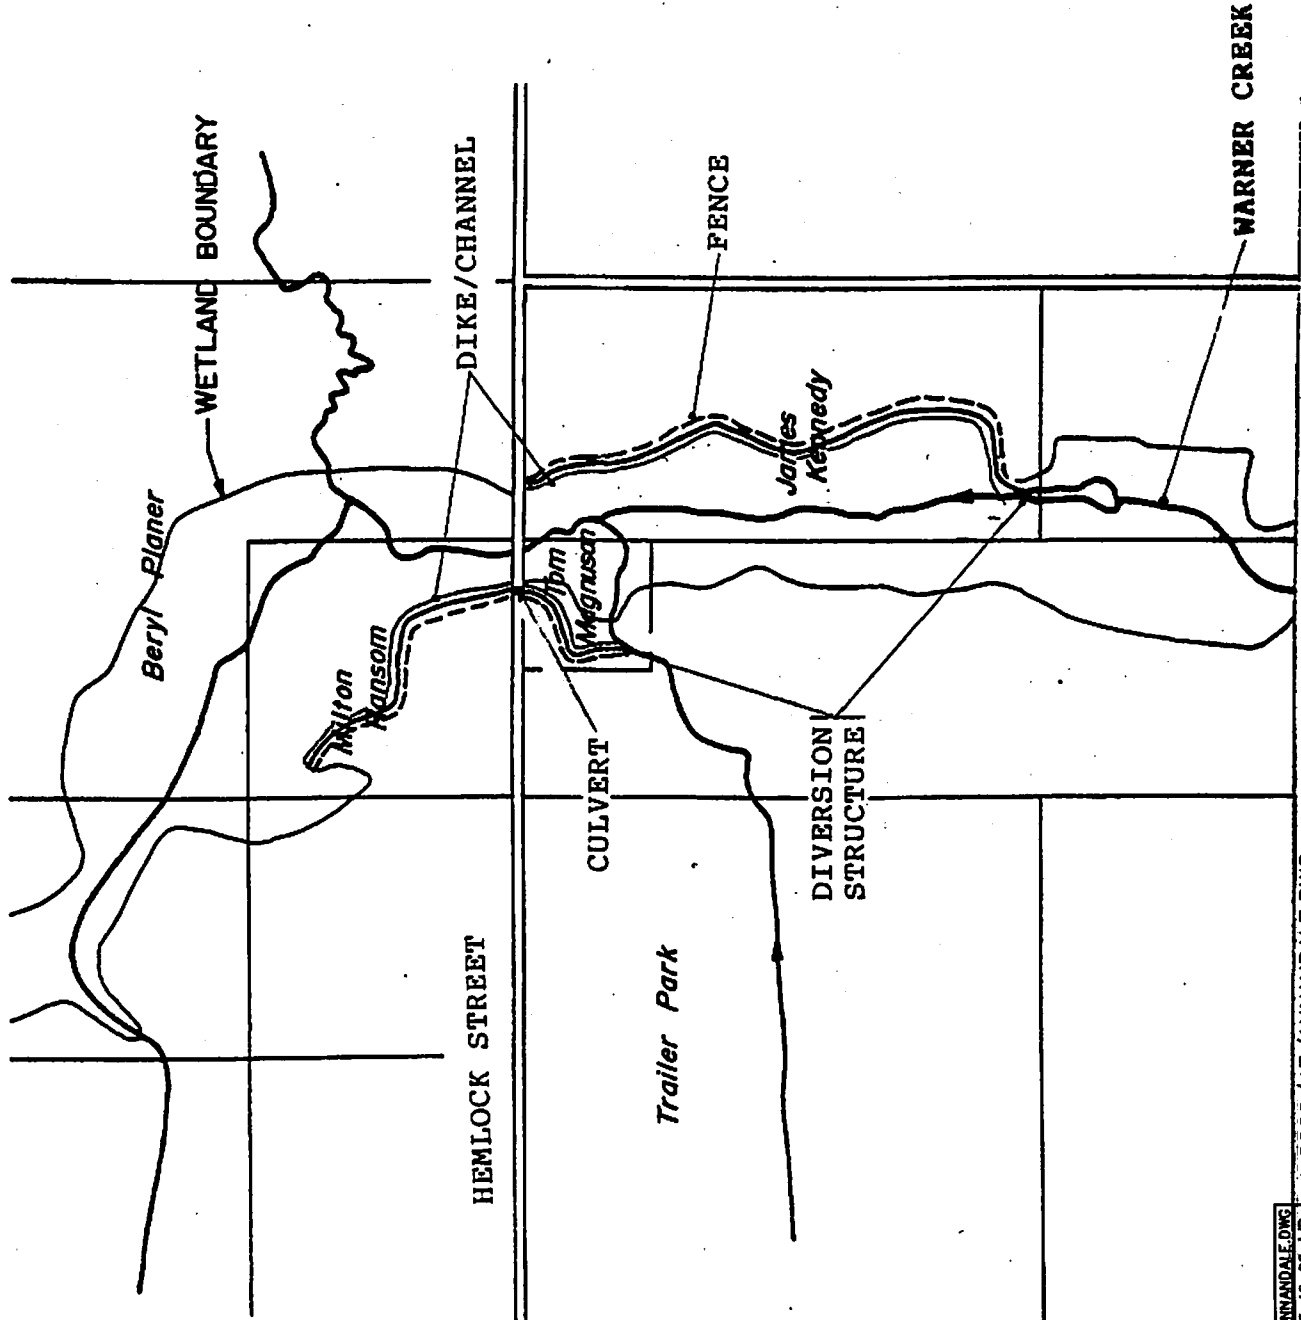
FIGURE 3

2. Large beaver dam on SW ditch. Remove dam, cut away brush and clean culverts.	✓			\$2,000
School Section Lake Outlet Project (see photo 8).				
1. Outlet structure and culverts in good condition.			✓
