2003 Project Inspection Report

Prepared for
**Clearwater River
Watershed
District**

June 2003

Table 1
Clearwater River Watershed District
Annual Project Inspection
May 2003

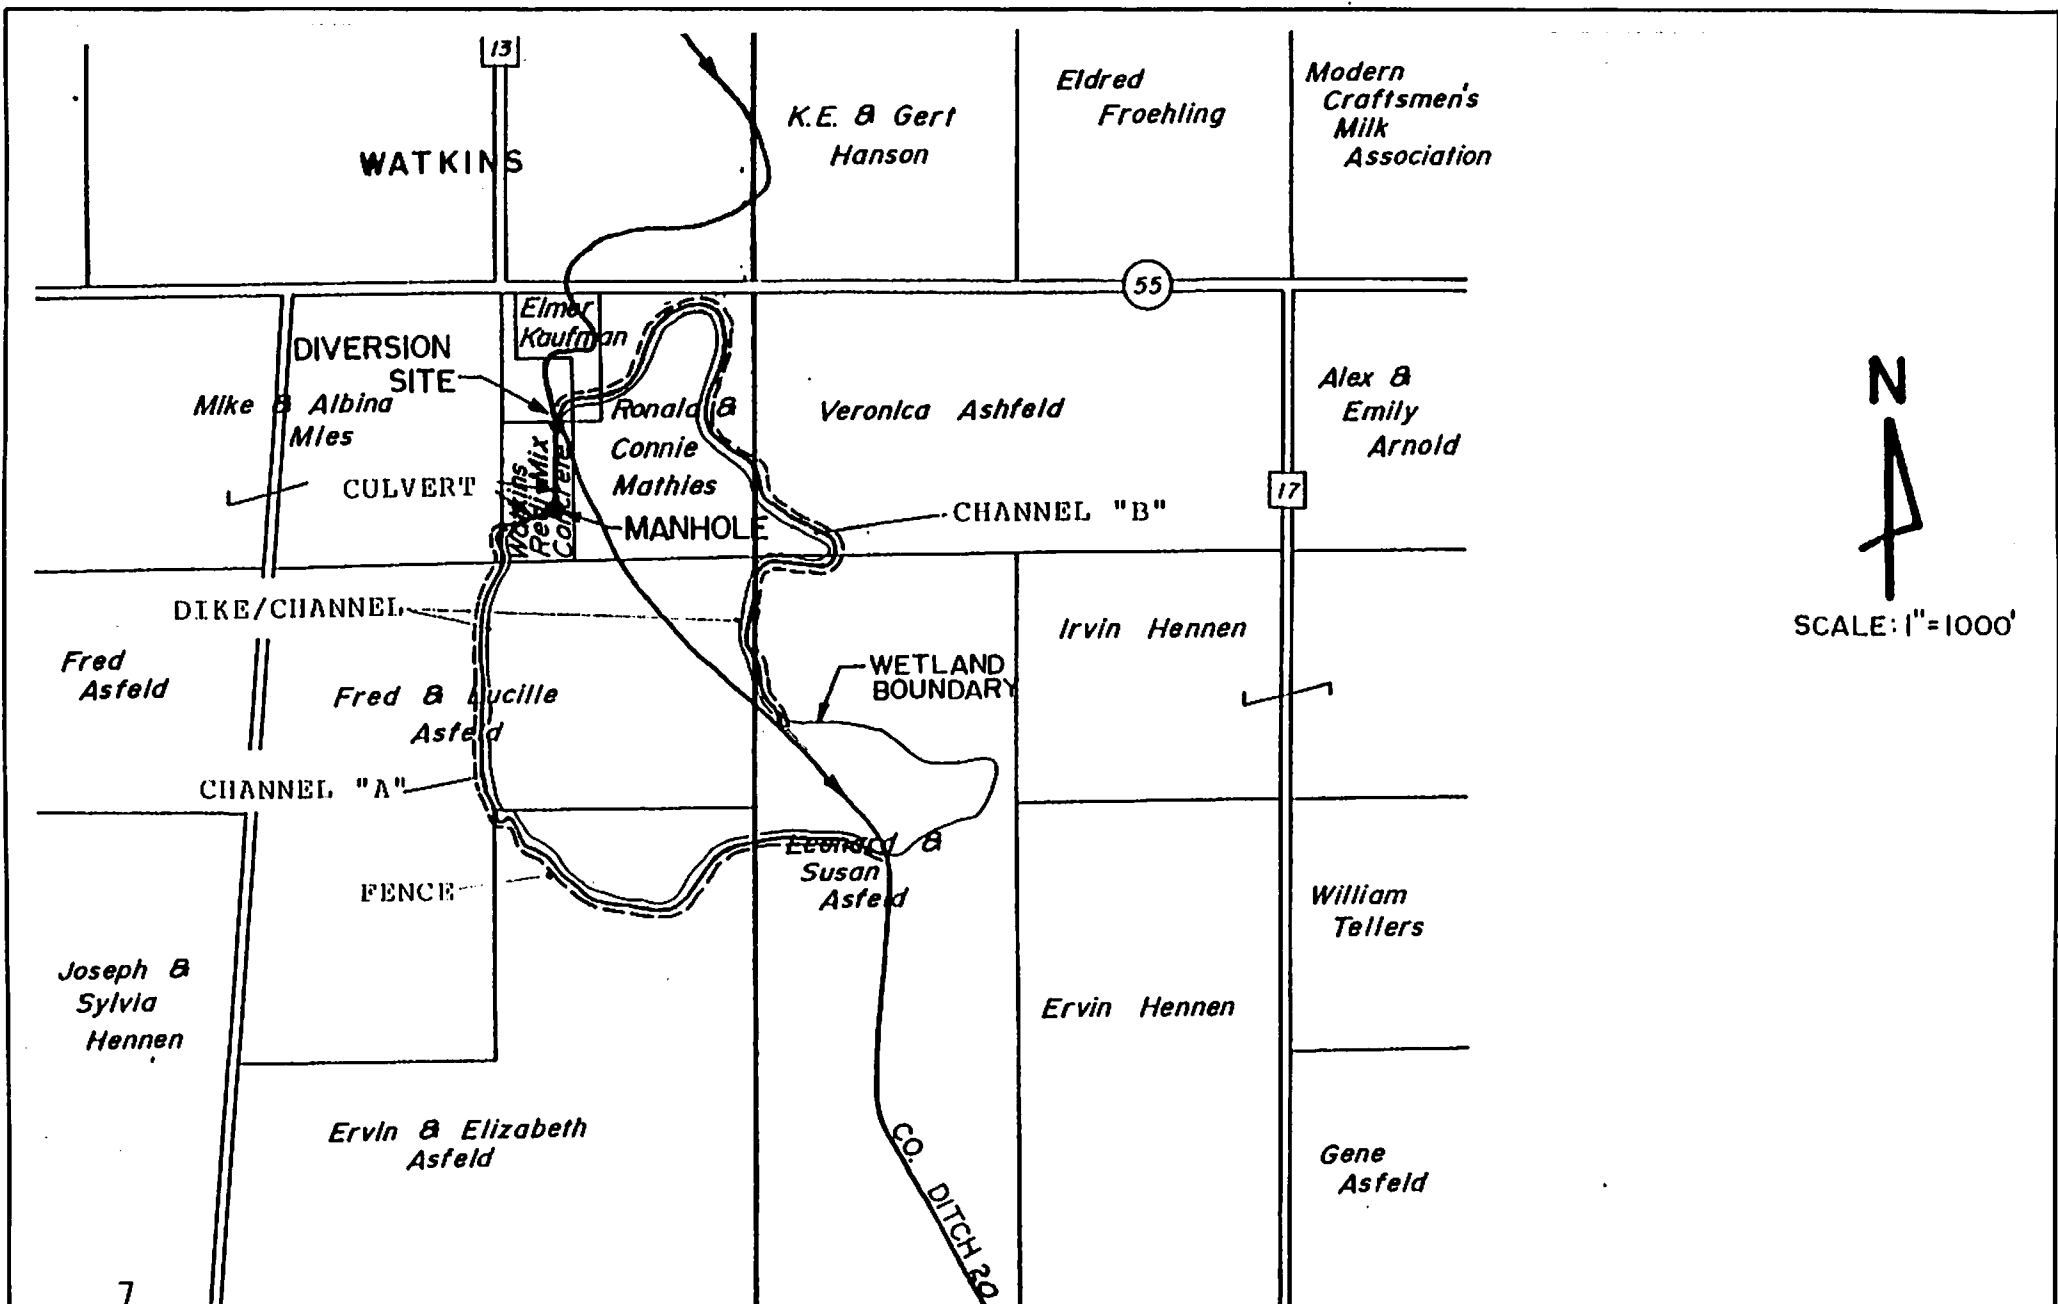
Project	Maintenance			Estimated Cost
	Required	Optional	No Action Now	
Watkins Wetland Treatment System (south) (see Figure 1 and photos 1 and 2).				
1. West side (Channel A) flowing normal, channel ports open.			✓

2. East side (Channel B) flowing normal, channel ports open.			✓	
Upper Watkins Wetland Isolation Project (north) (see Figure 2 and photo 3).				
1. Ditches and overflow structures in good condition.			✓

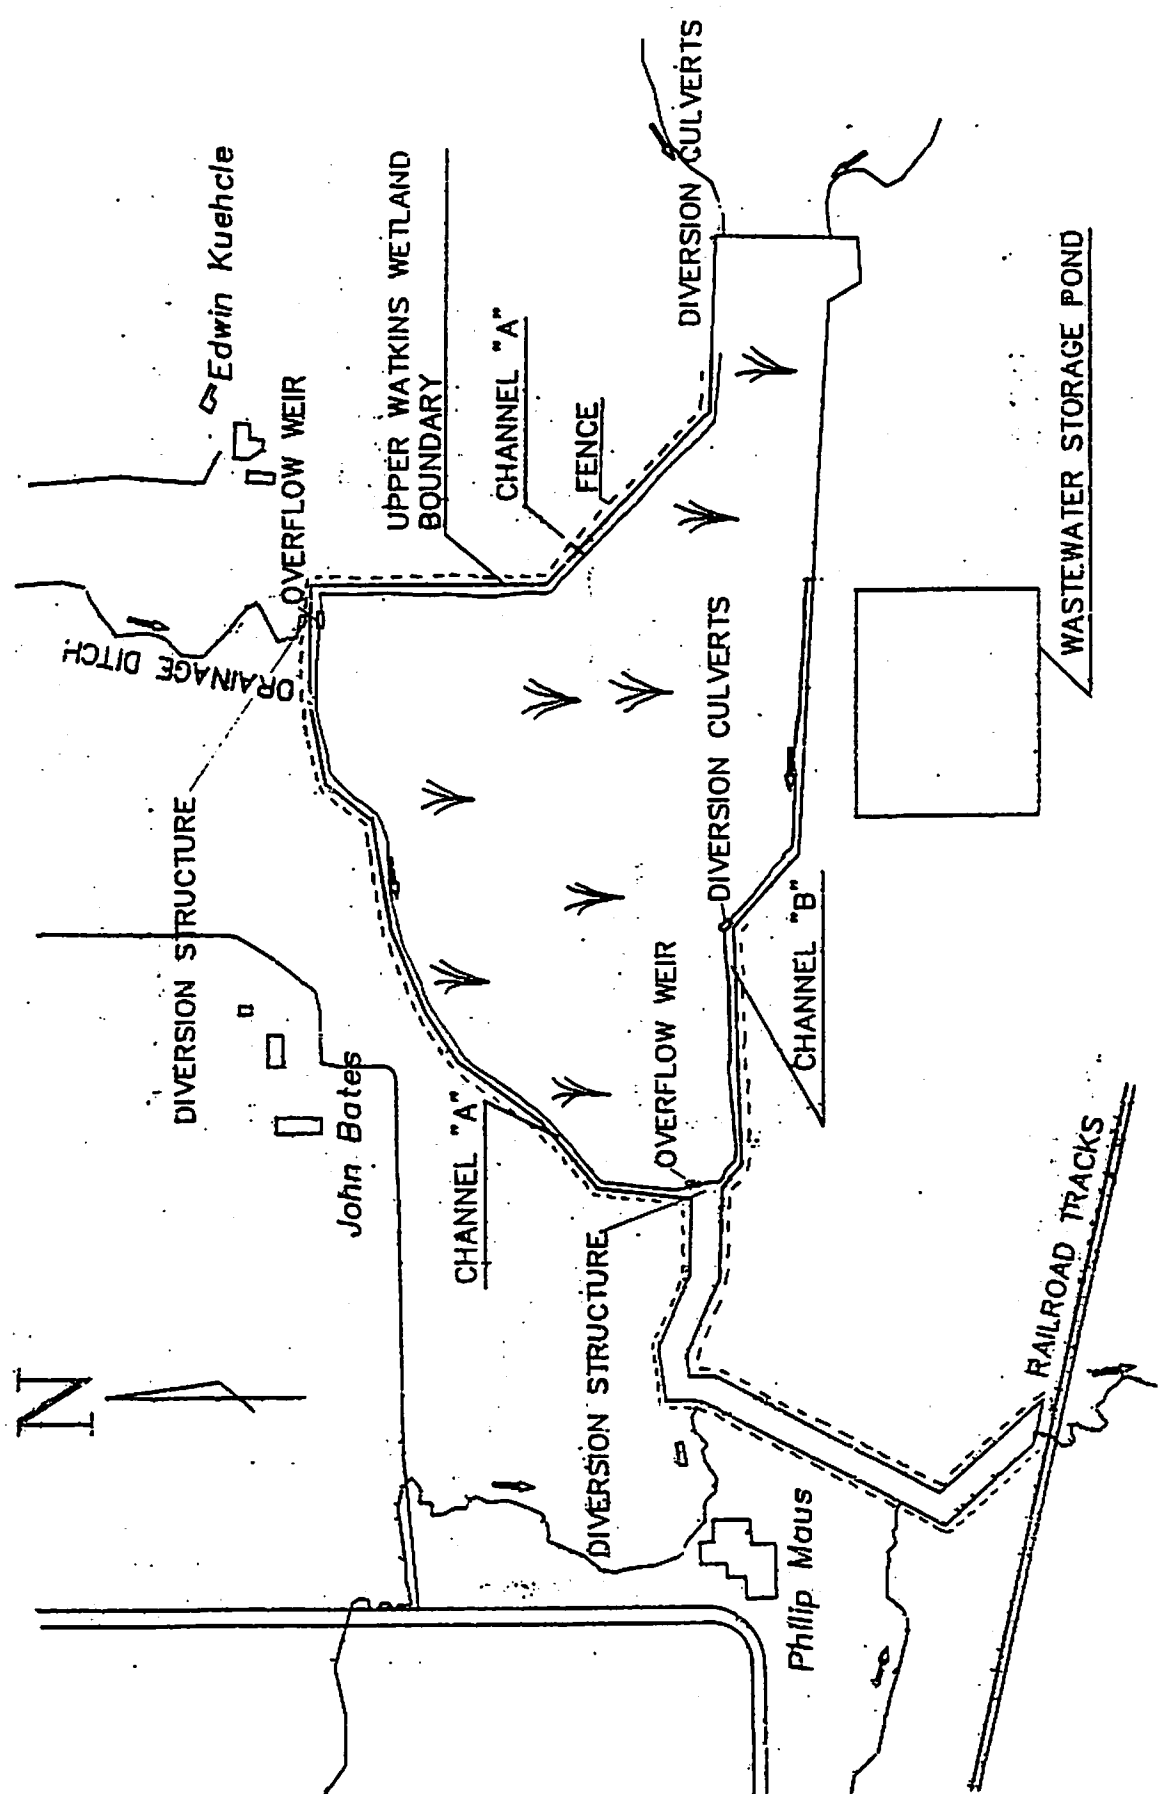
MAY 2003
 Figure 2

2. Fence needs repair and tightening.	✓			Kevin 8 hrs.
Annandale Wetland Treatment System (see Figure 3 and photos 4 and 5).				
1. Ditch and overflow structure in good condition.			✓	
School Section Lake Outlet Project (see photo 6).
