2007 Project Inspection Report

Prepared for
**Clearwater River
Watershed
District**

Re: 2007 Project Inspection Report
Wenck File #0002-101

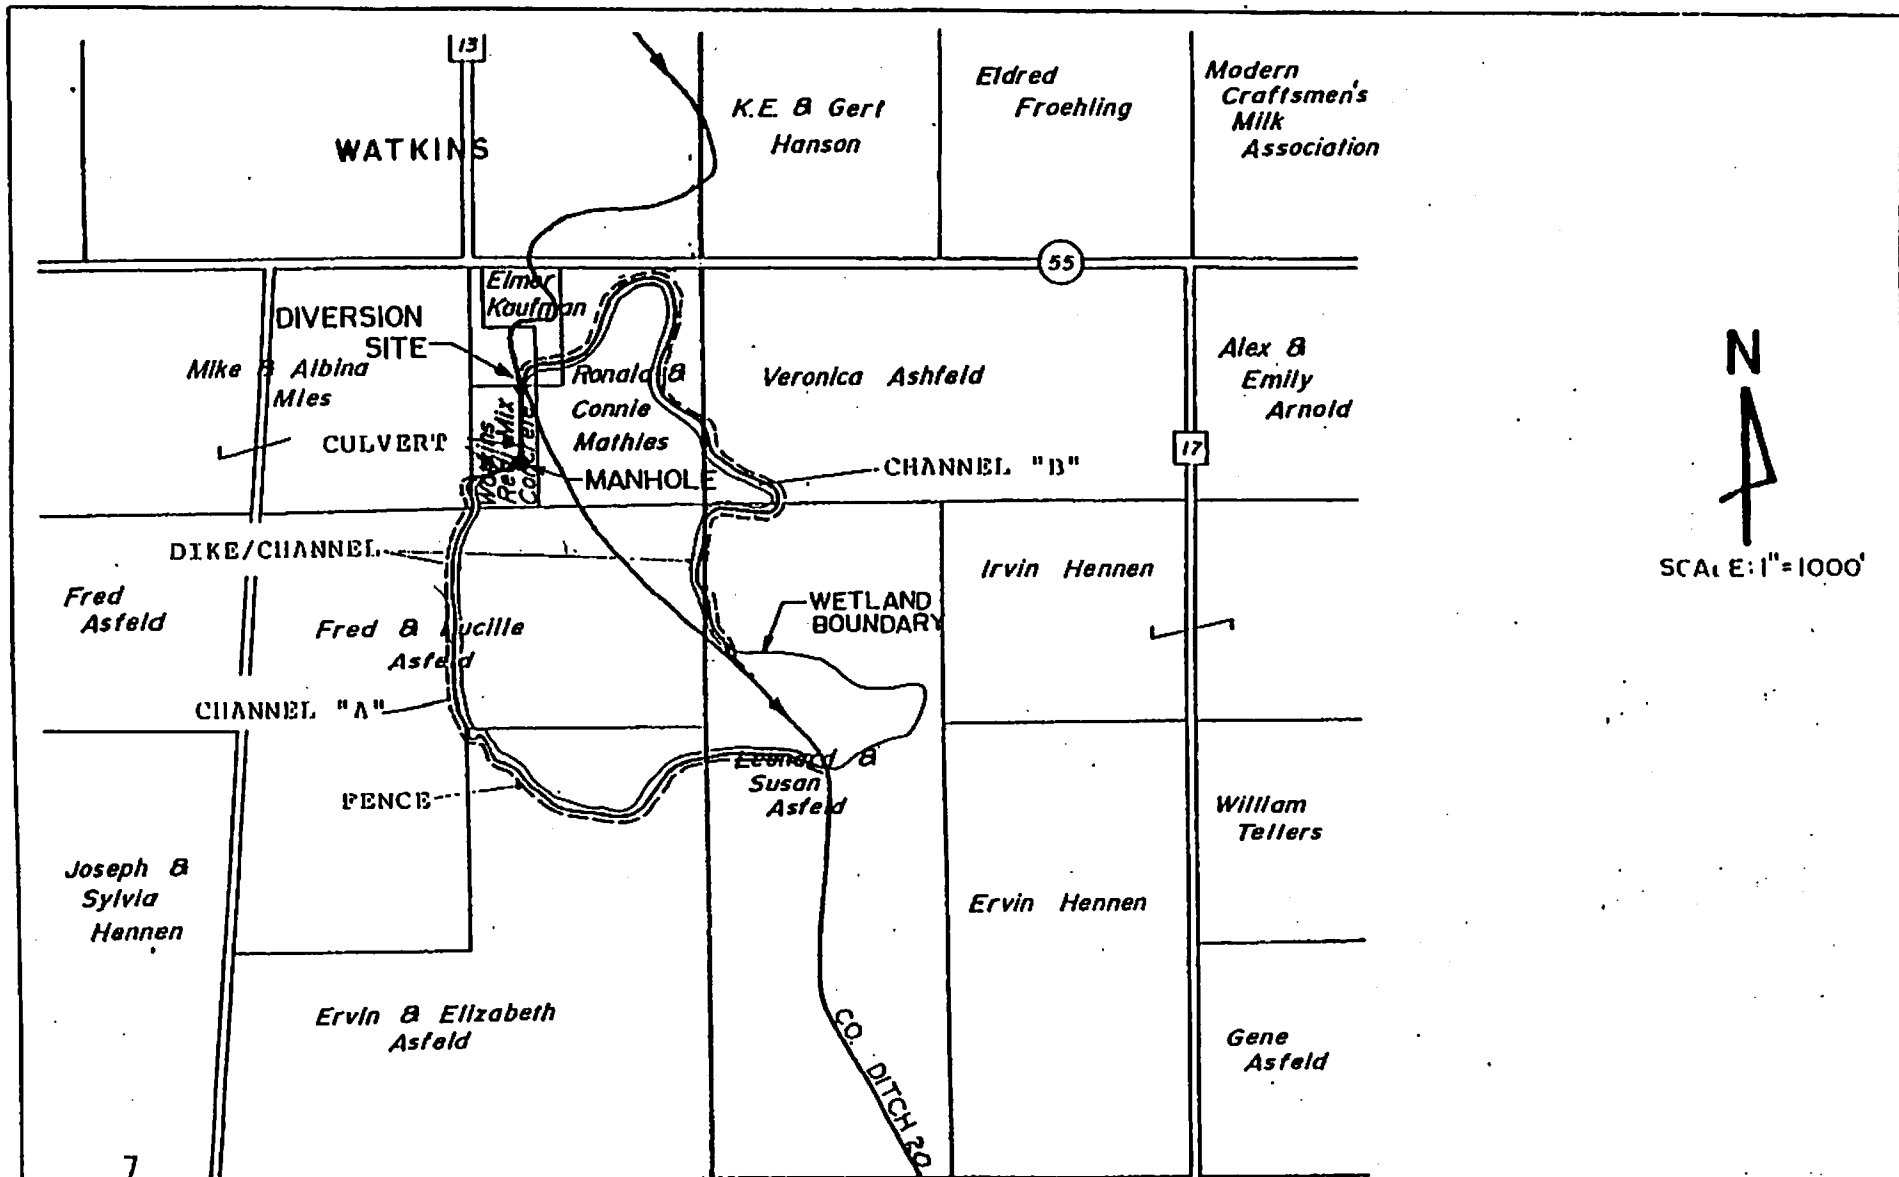
Figure 2

1. East side (Channel B) in good condition			✓	
2. Overflows vegetated.			✓	
3. Tile inlet and outlet in good condition.			✓	
4. Ports in good condition.			✓	
Clear Lake Inlet V-Notch (North) (see Photo 3)

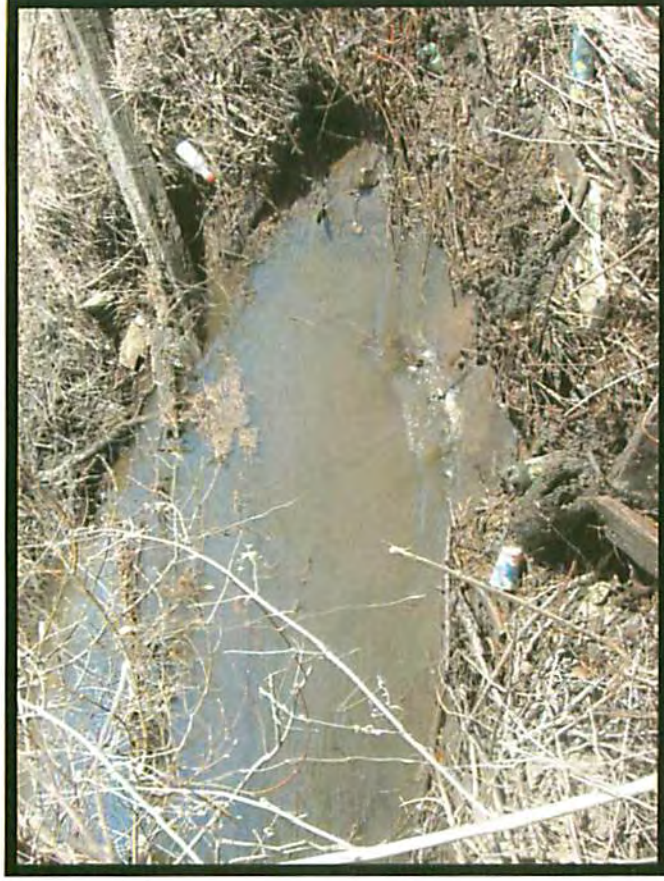
Photo 2-Watkins Wetland Treatment System
(South)

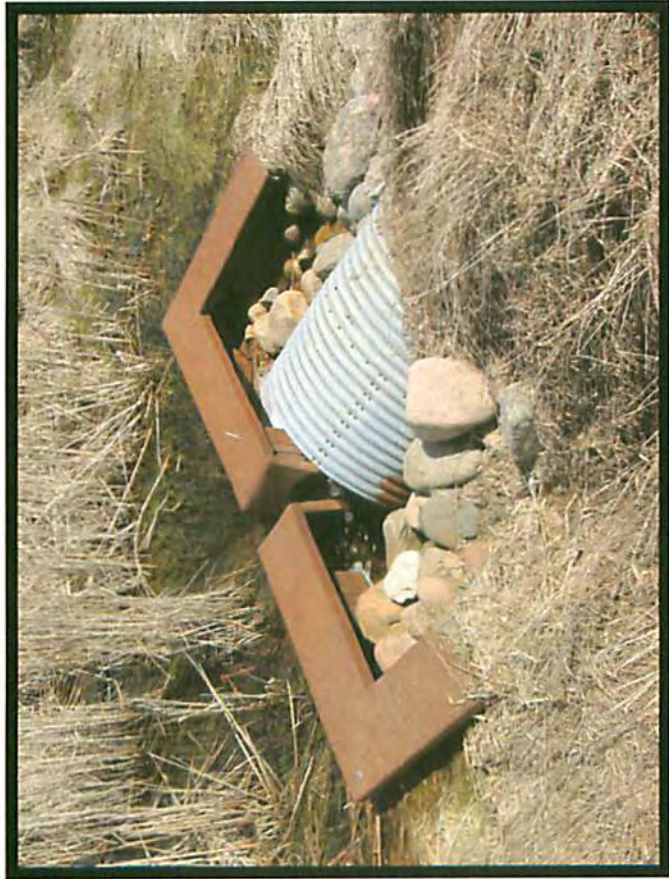
1. Outlet structure in good condition.			✓	
Nistler Sedimentation Basin (South) (see Photos 4,5, & 6).				
1. Sedimentation basin in good condition.			✓	
Kingston Wetland Treatment System (see Figures 3 & 4 and Photos 7 & 8)

Photo 3-Clear Lake Inlet V-Notch (North)

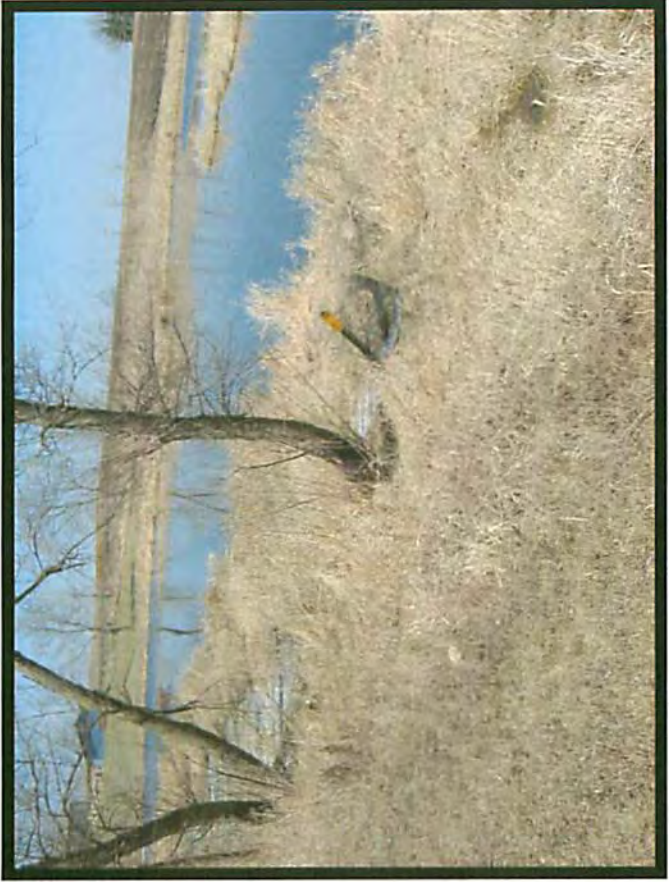
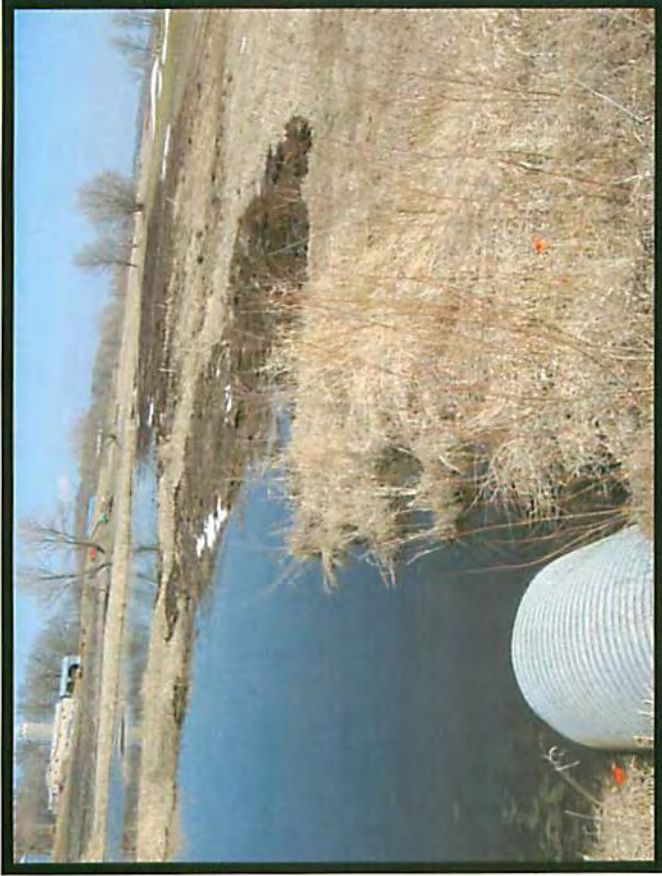
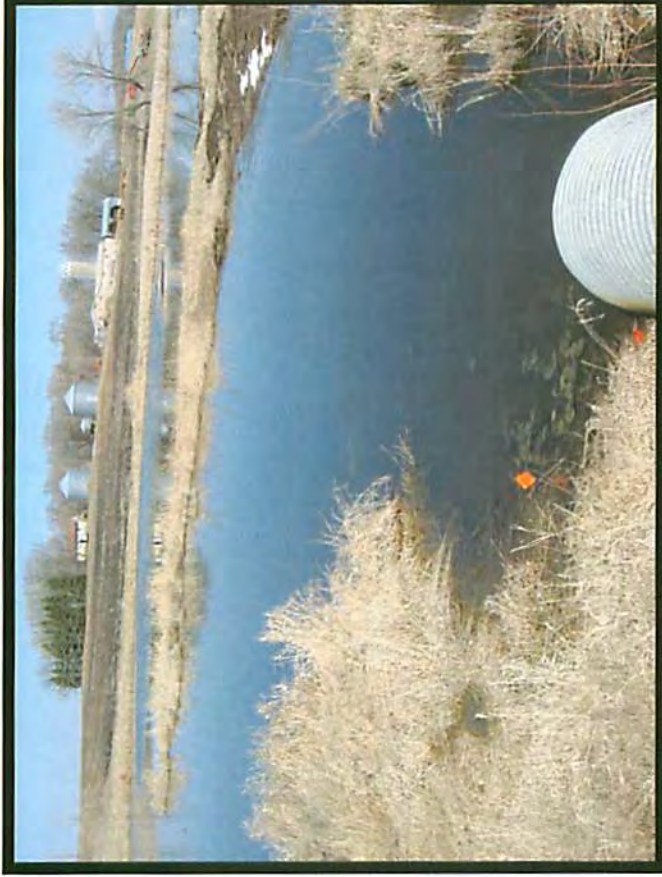
Photo 4-Nistler Sedimentation Basin

Photo 5-Nistler Sedimentation Basin

Photo 6-Nistler Sedimentation Basin

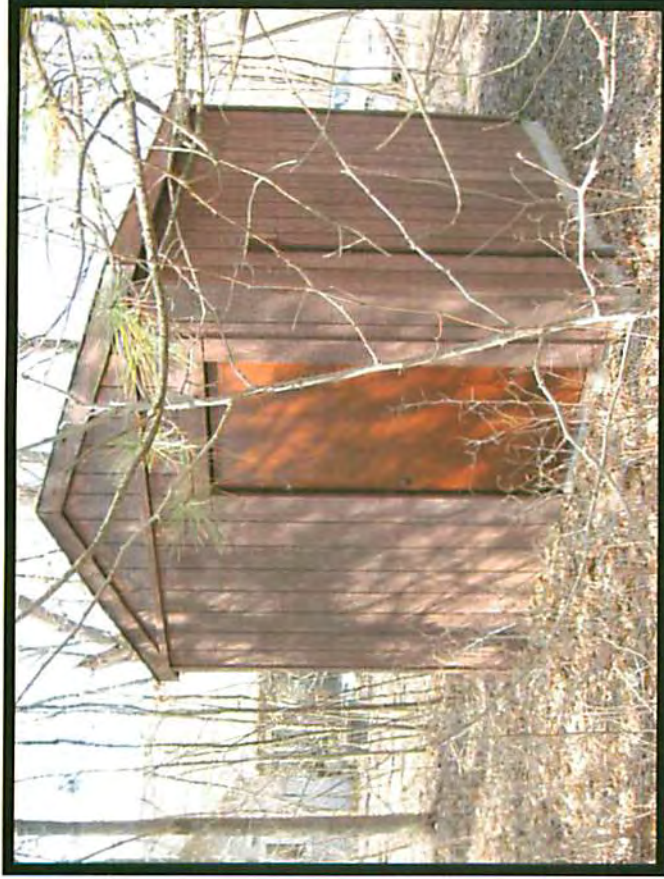
2. Lake Marie- Good condition, no maintenance needed.			✓

Photo 9-Lake Marie Aerator Building

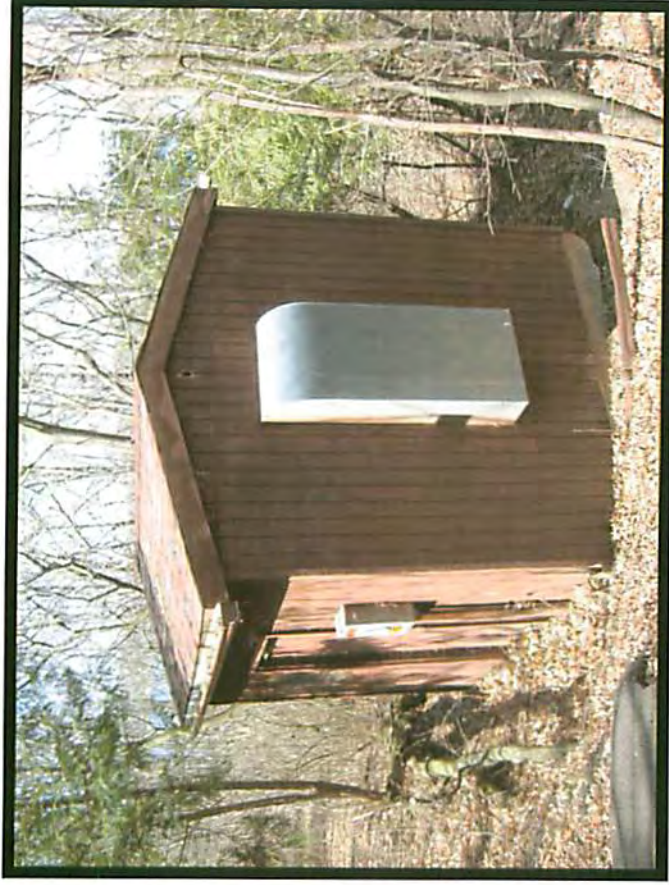
3. Reshape channel and reinforce dike to alleviate further problems with dike washouts.		✓		\$6,000
Aerator Buildings (see Photo 9 & 10)				
1. Lake Augusta-Good condition, no maintenance needed.			✓

Photo 10-Lake Augusta Aerator Building

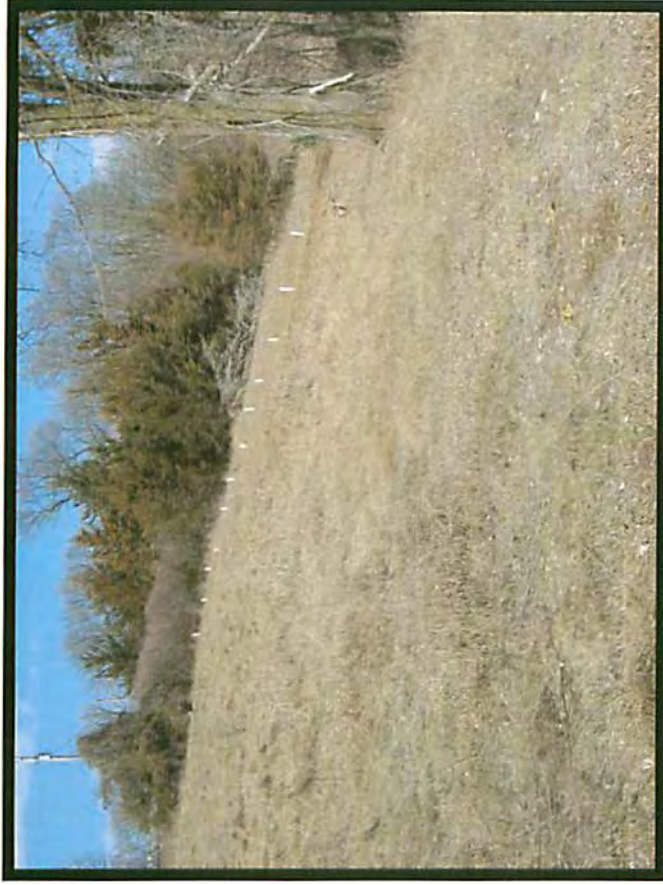
1. System in good condition.			✓	
2. Sedimentation basin in good condition.			✓	
Hidden River Wastewater Treatment System (see Photos 15 & 16).				
1. Summer weed control	✓			Kevin- 12 hrs

Photo 12-Rest-a-while Drainfield

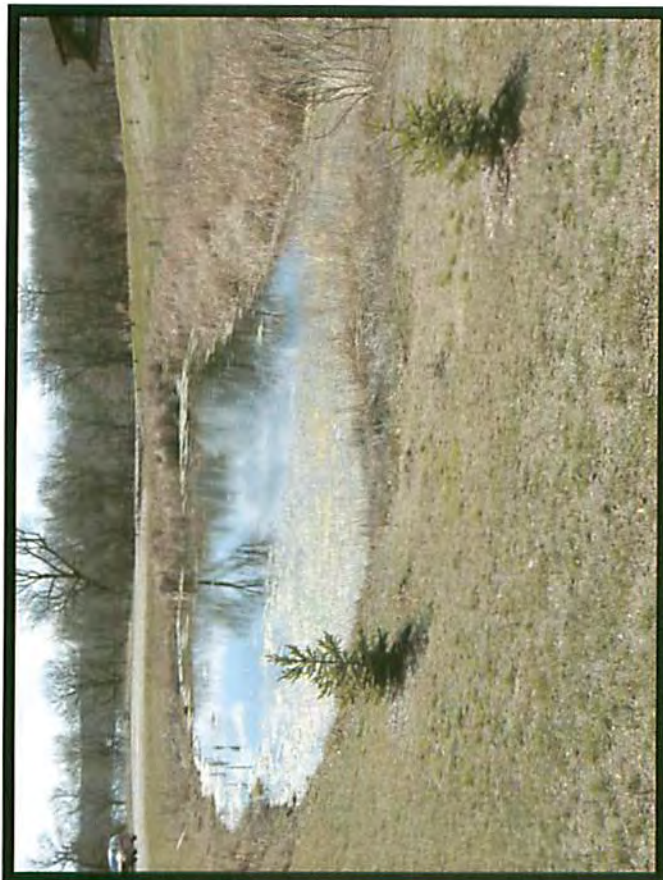
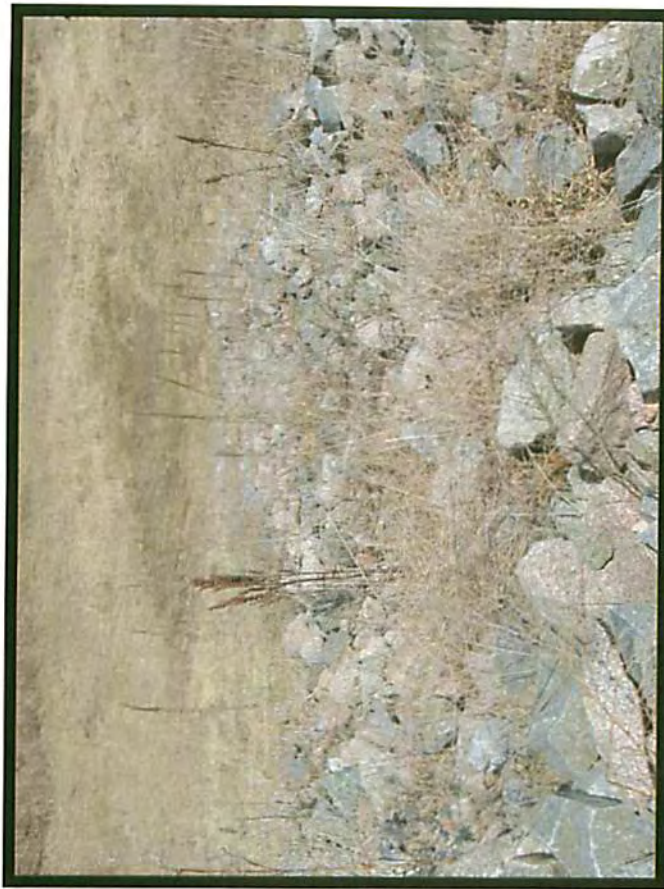
Photo 13-Rest-a-while Sedimentation Basin
(West)

Photo 14-Rest-a-while Sedimentation Basin
(East)

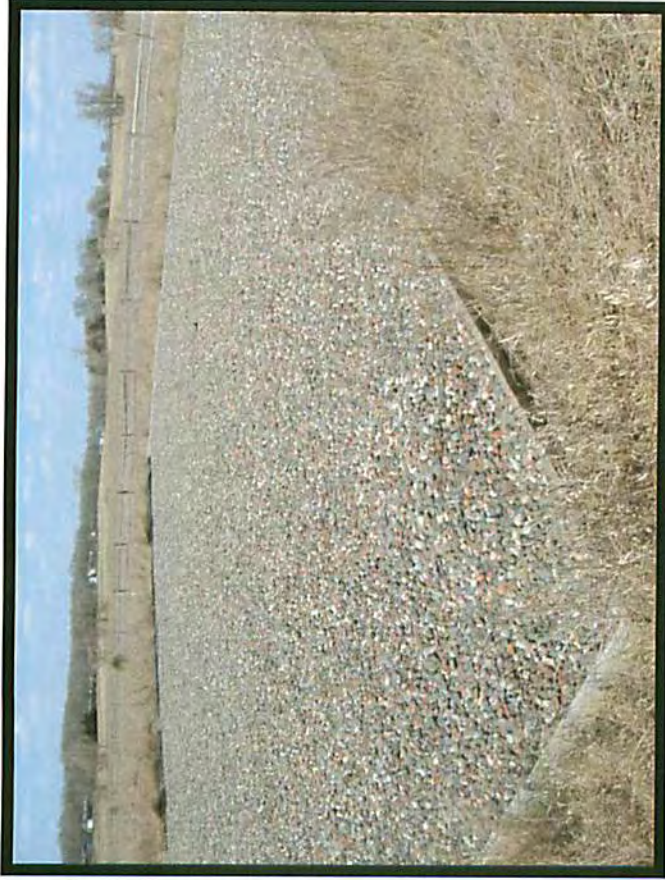
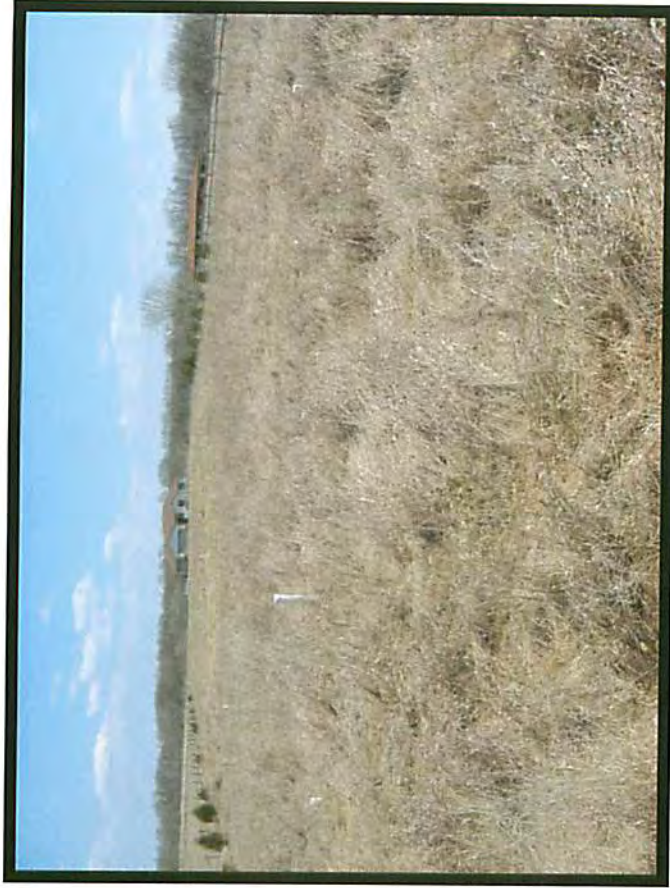
2. Sand filter and drain field in good condition.			✓	
3. Pump 8 septic tanks as required per schedule.	✓			Contract Pumper: \$2,000
Clearwater Harbor Wastewater Treatment System (See Photos 17 & 18)

Photo 15-Hidden River Wastewater Treatment
System Sand Filter

Photo 16-Hidden River Wastewater Treatment
System Drainfield

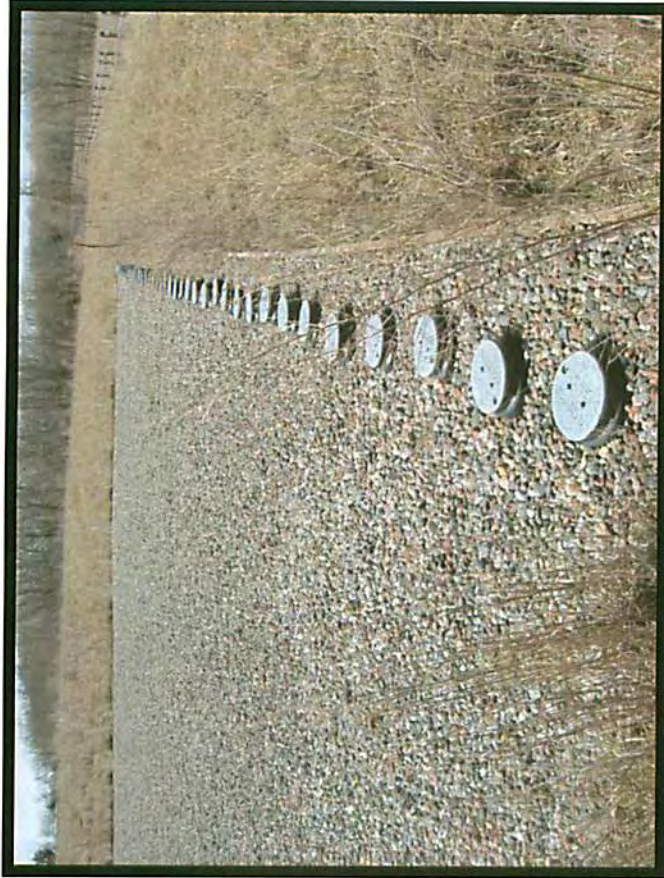
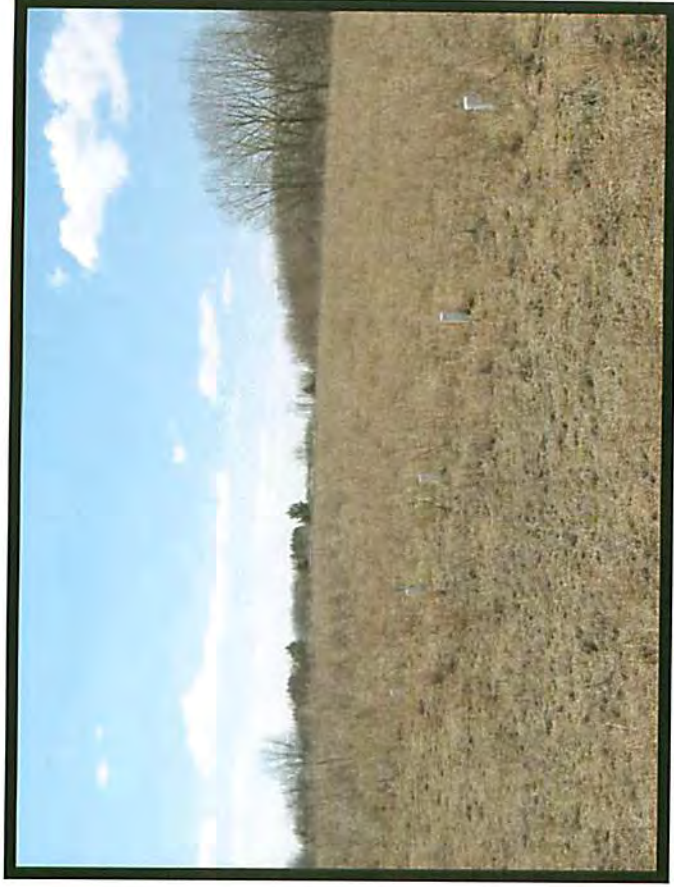
1. Summer weed control	✓			Kevin- 12 hrs
2. Drain field and sand filter in good condition.			✓	
Annandale Wetland Treatment System (see Figure 5 and Photos 19,20, 21 & 22).

Photo 17-Clearwater Harbor Wastewater
Treatment System Sand Filter

Photo 18-Clearwater Harbor Wastewater
Treatment System Drainfield

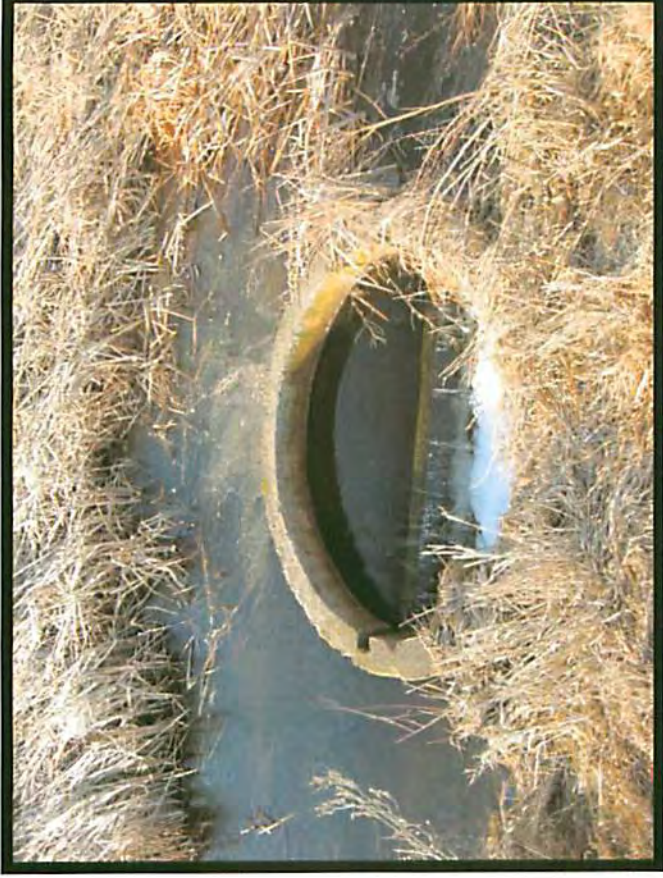
1. Vegetation needs to be removed from channel near diversion structure and two ports.	✓			Kevin - 16 hrs + \$300 for equipment
2. Beaver dam that is blocking south channel needs to be removed.	✓			Kevin - 16 hrs + \$300 for equipment
Pleasant Lake Outlet Project (see Photo 23).

Photo 21-Annandale Wetland Treatment System
Dry Channel Downstream of Beaver Dam

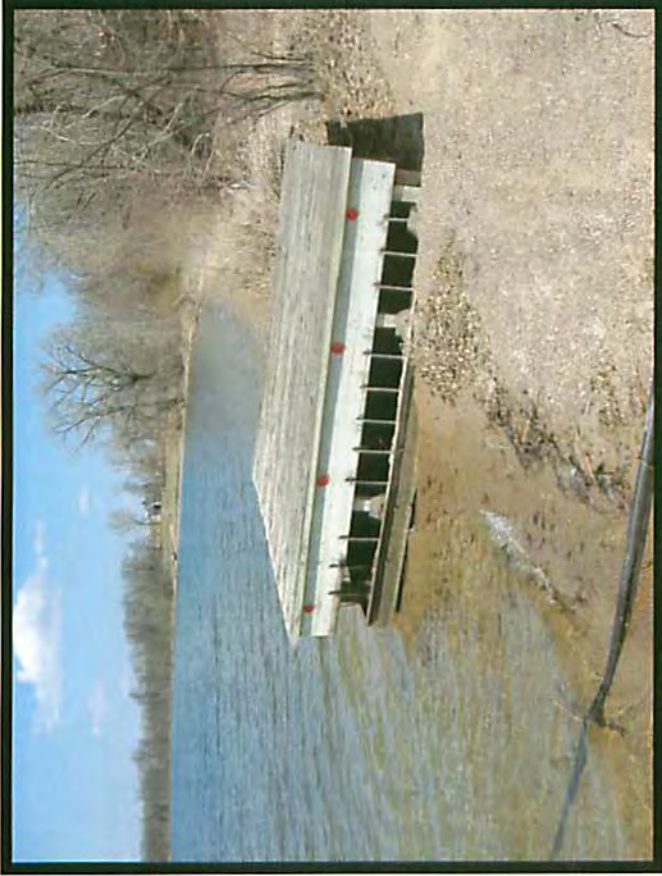
Photo 22-Annandale Wetland Treatment System
Outlet Structure

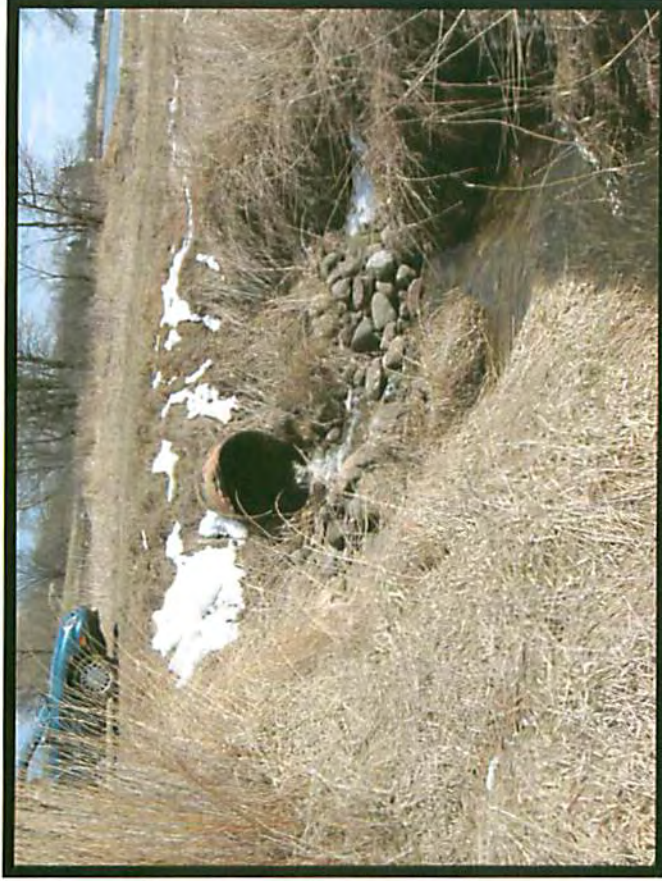
Project	Maintenance			Estimated Cost
	Required	Optional	No Action Now	
Henshaw Lake Outlet (see Photo 24).				
1. Outlet in good condition.			✓	
Swartout Lake Fish Barrier (see Photo 25 & 26).				
1. Fish barrier installed at lake outlet.			✓	
Illsley Ave Fish Barrier (see Photos 27 & 28).				
1. Fish barrier installed in stream near Illsley Ave and Hwy 55.			✓	
Lake Augusta Erosion Control Project (see Figure 6 and Photos 29, 30, 31, & 32).				
1. Sedimentation boxes in good shape.			✓	
2. Riser has crack in bottom of concrete, needs repair.	✓			Repair crack in concrete base: \$4,000
3. Structure outlet in good condition.			✓

Photo 23-Pleasant Lake Outlet Structure

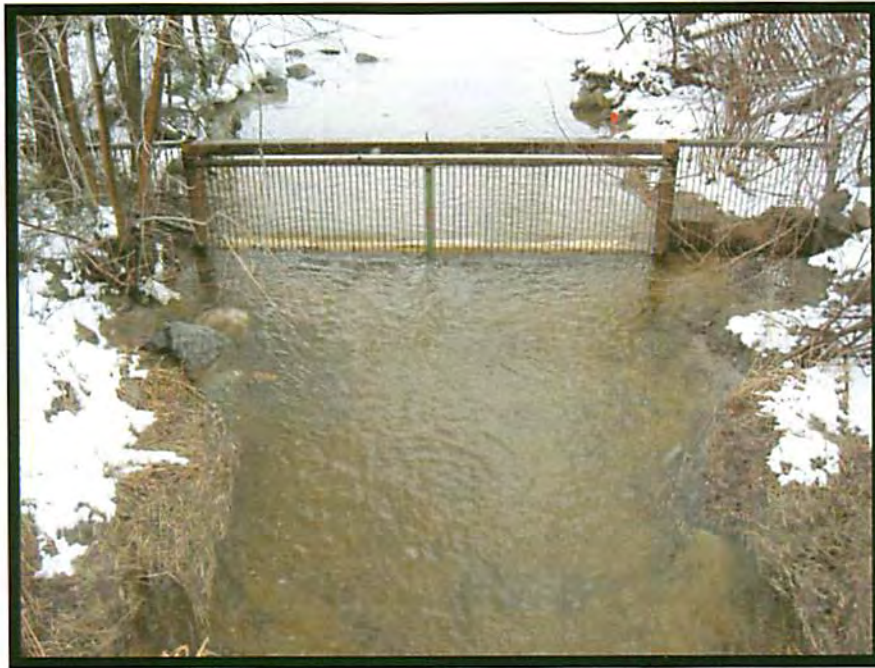
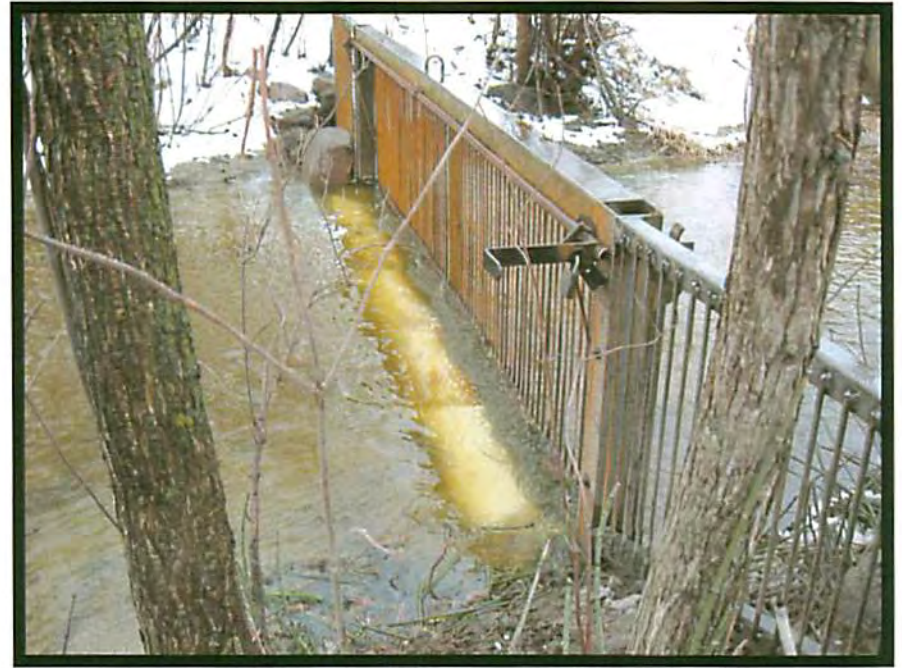
Photo 24-Henshaw Lake Outlet

Photo 25-Swartout Lake Fish Barrier

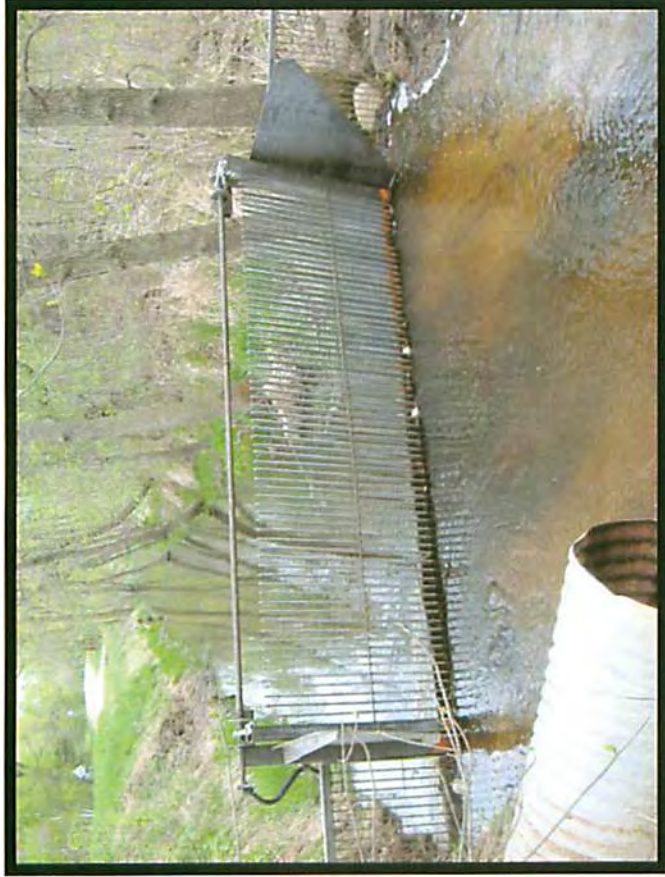
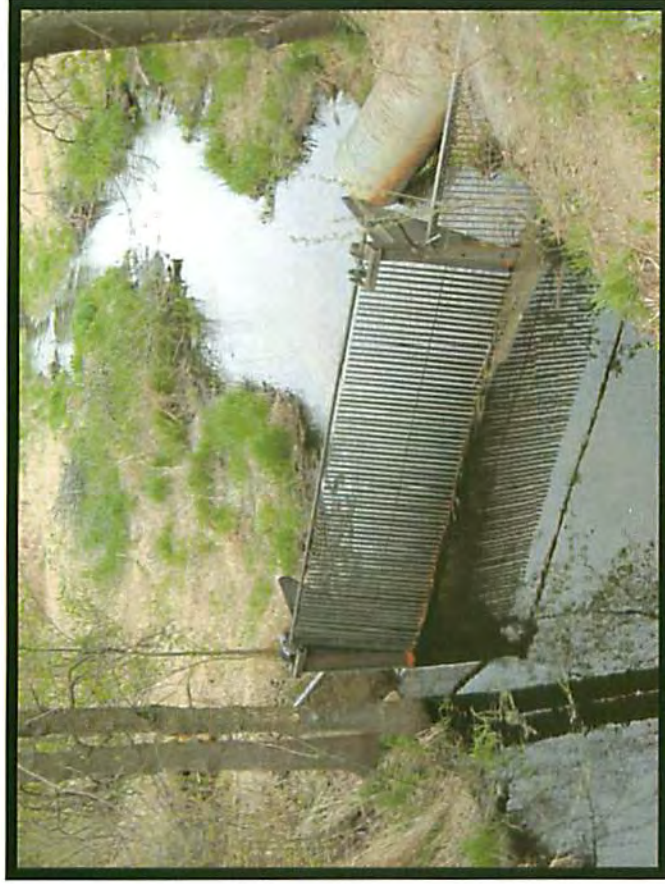
Photo 26-Swartout Lake Fish Barrier

Photo 27-Illsley Ave Fish Barrier

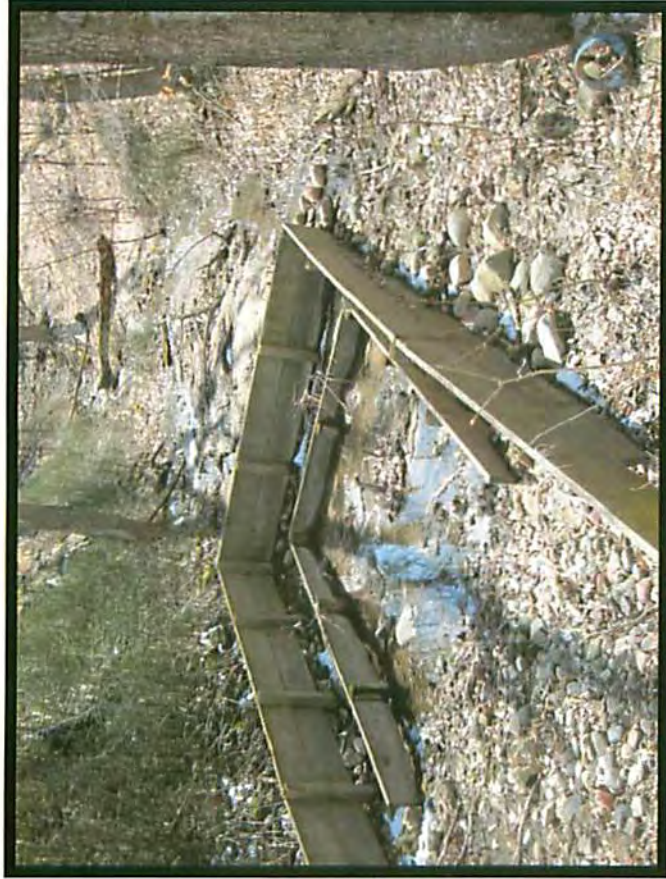
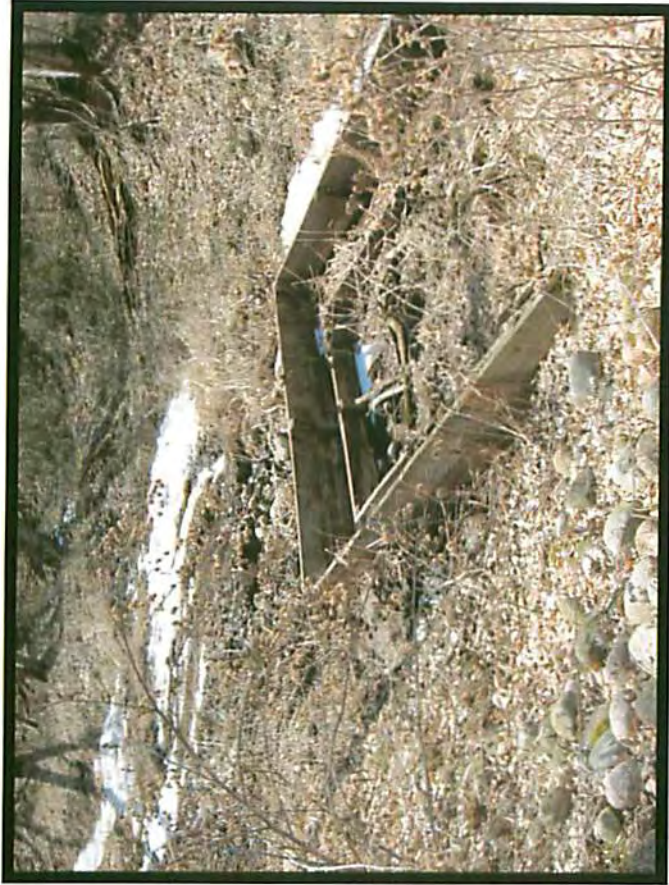
Photo 28-Illsley Ave Fish Barrier

Photo 29-Lake Augusta Erosion Control Project
Sedimentation Box (West)

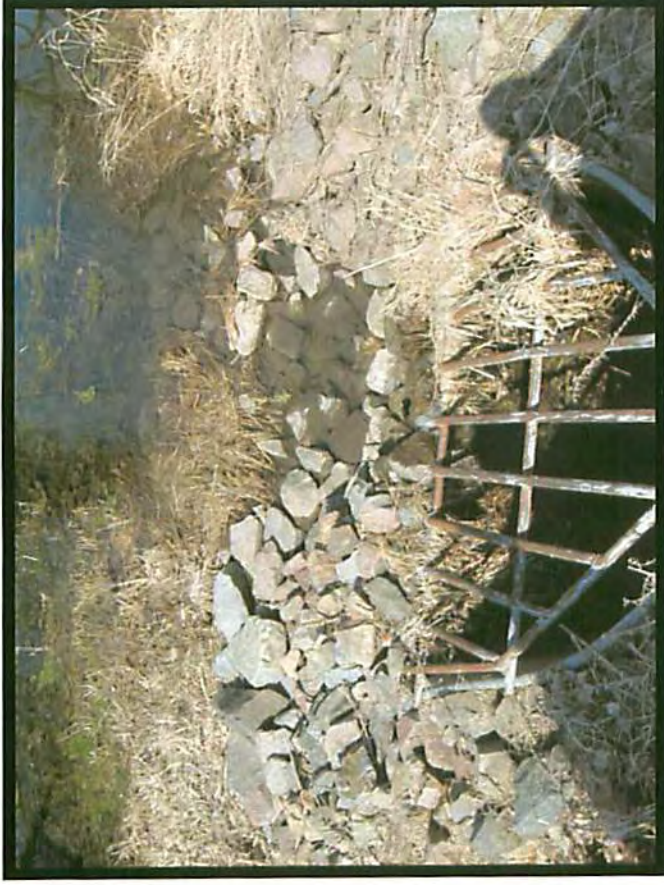
Photo 31-Lake Augusta Erosion Control System
Riser (Cracks in bottom of structure to be repaired
in 2007)
