# **2009 Project Inspection Report**

**Clearwater River  
Watershed  
District**

**Wenck File # 0002-132**

**May 2009**

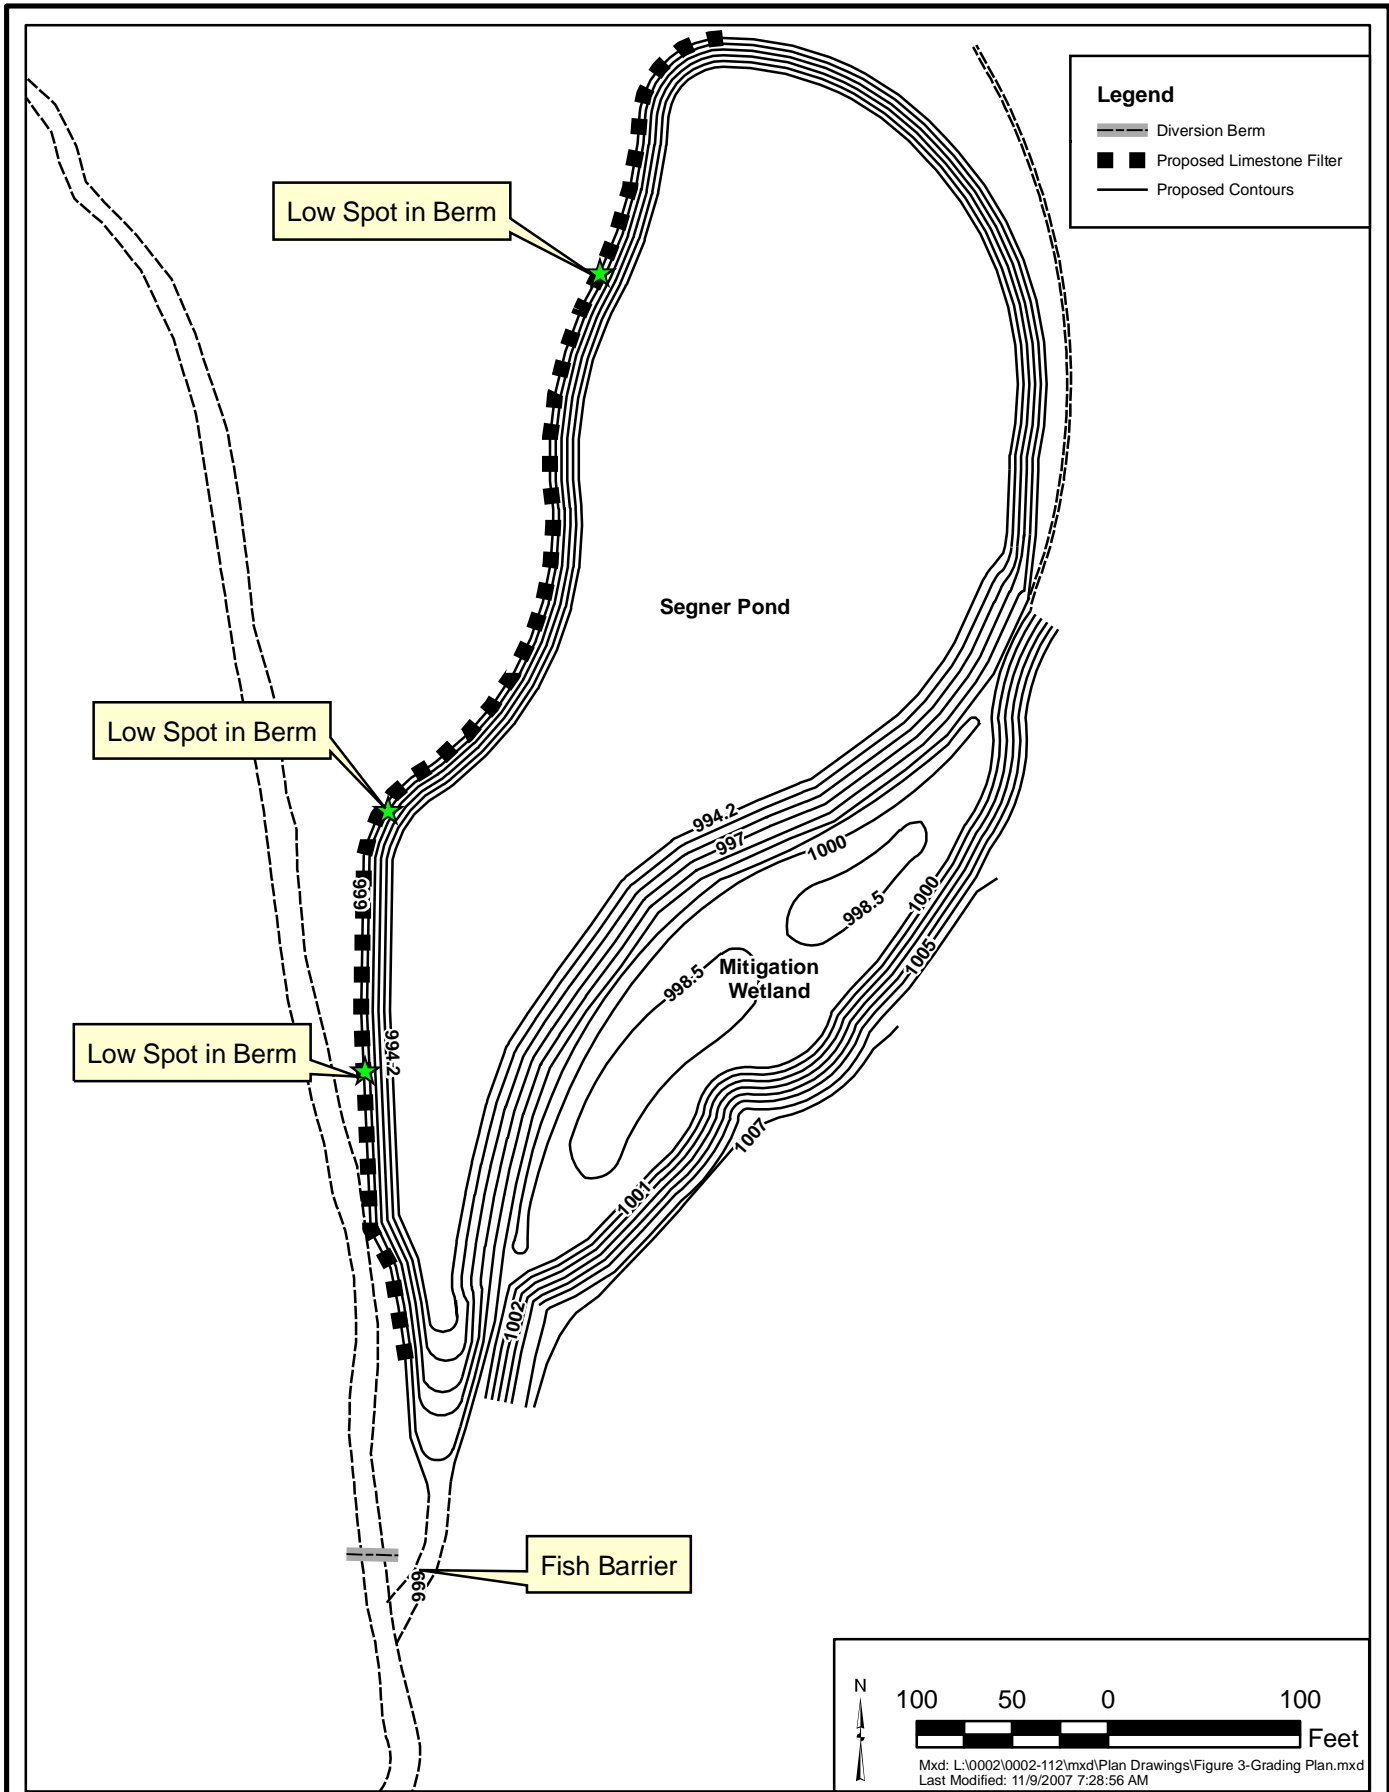
1. Fish barrier in good condition and operating properly.			✓	
Segner Pond (See Figure 3 and Photos 18-20)				
1. Diversion structure operating properly.			✓

2. Add limestone to three low spots in limestone berm.	✓			\$2,000
3. Riprap to repair washout on bank along sides of fish barrier.	✓			\$1,500
