2017

2017 PROJECT INSPECTION REPORT

The mission of the Clearwater River Watershed District is to promote, preserve, and protect water resources within the boundaries of the district in order to maintain property values and quality of life as authorized by MS 103D.

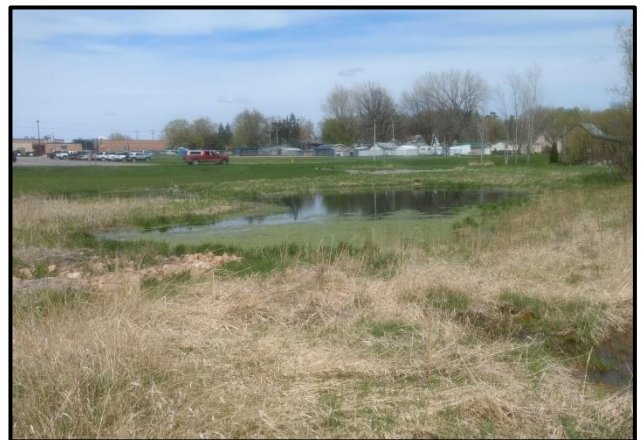
Hendricks Emergency Overflow: Noted that due to expansion of lot at Hendricks' Sand and Gravel Inc. that a significant portion of the overflow has been altered. The alteration will have a constricting effect on flow. However, the CRWD does not hold an easement over this area, as it is in railroad right-of-way.
