2005 Project Inspection Report

**Clearwater River
Watershed
District**

Re: 2005 Project Inspection Report
Wenck File #0002-72

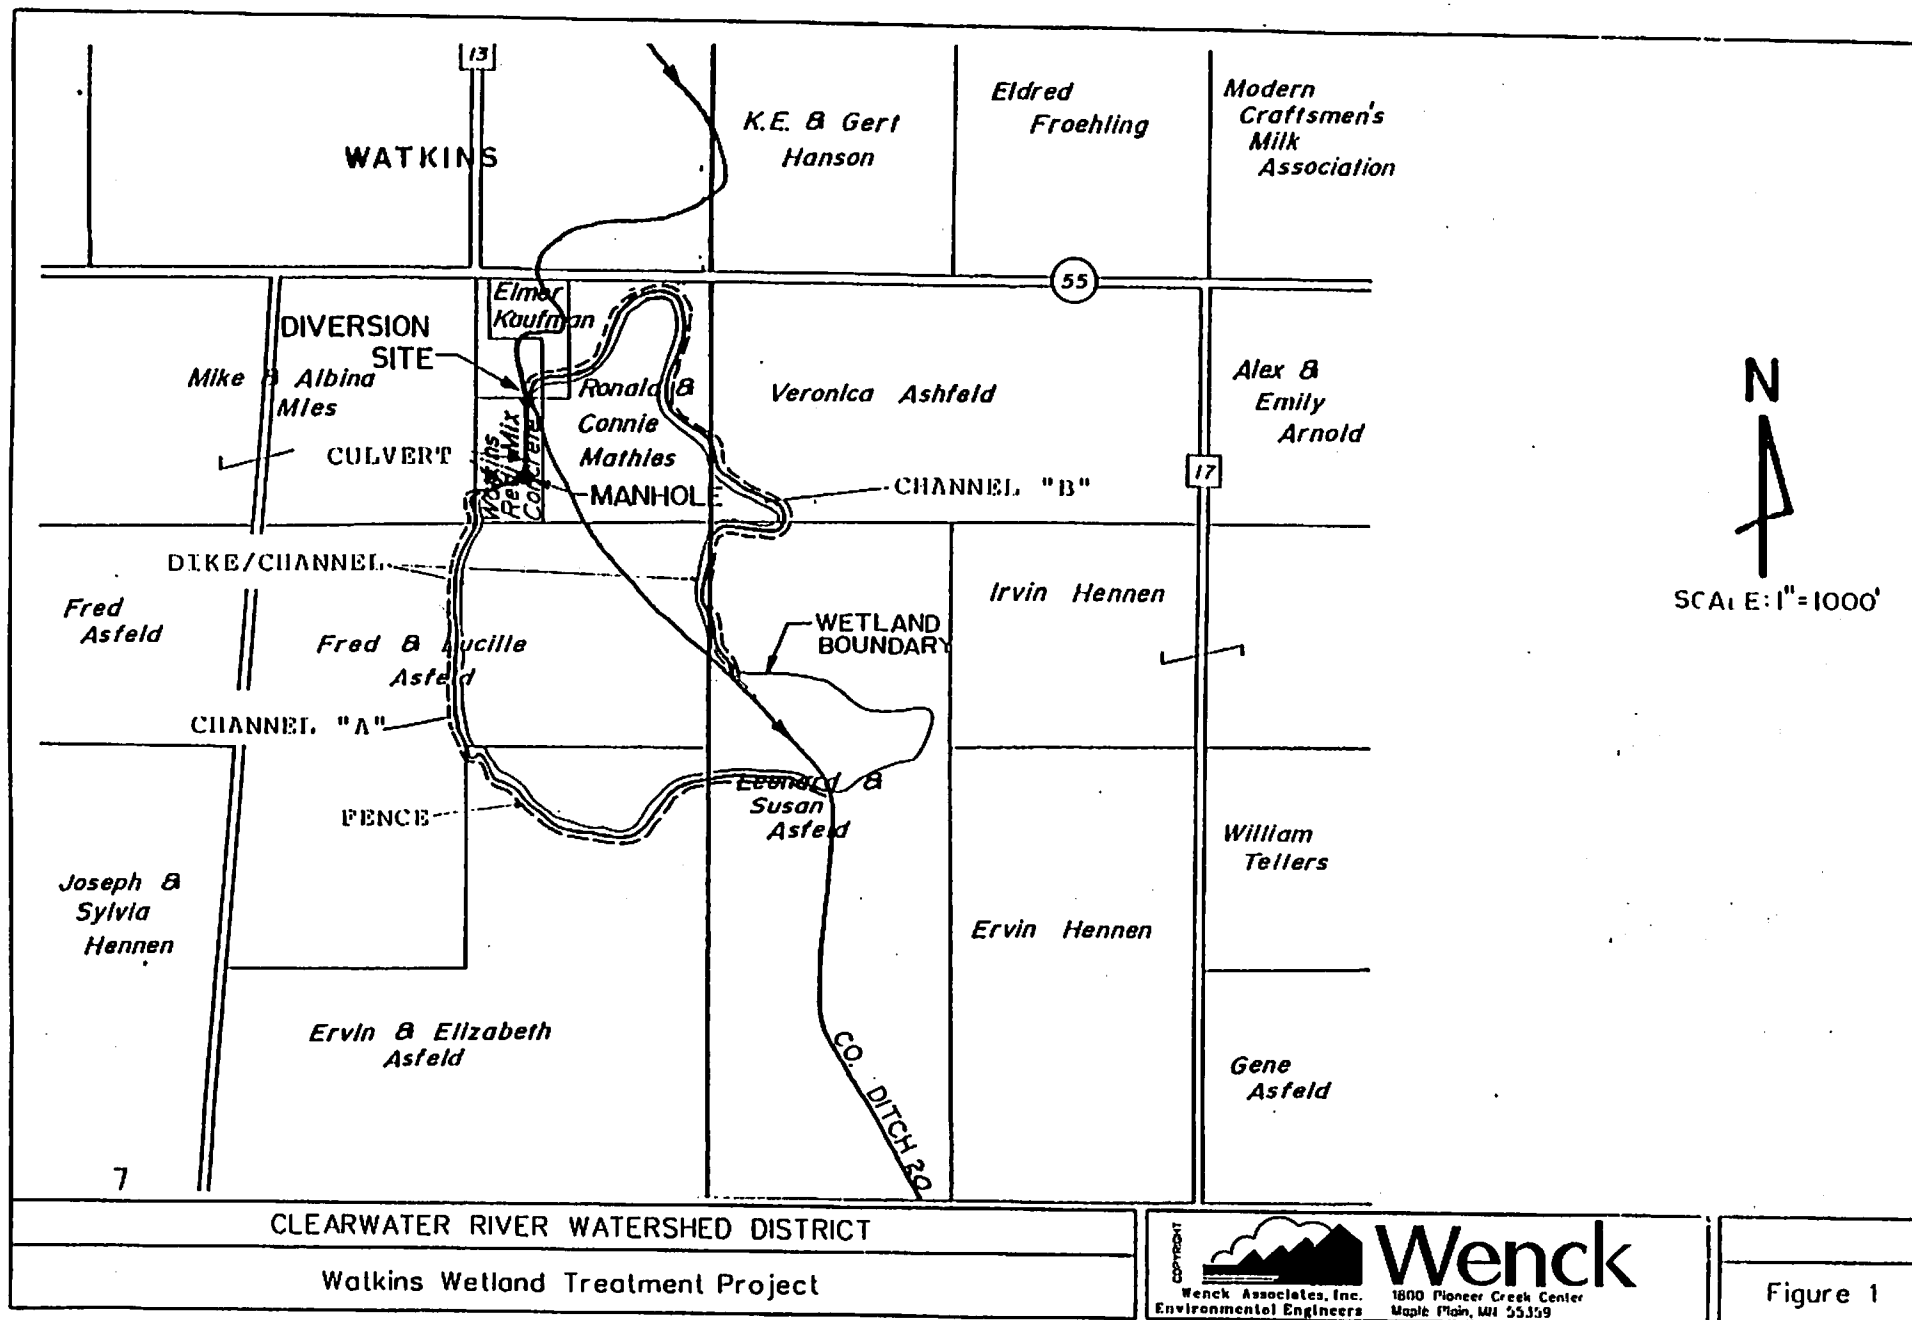
Project	Maintenance			Estimated Cost
	Required	Optional	No Action Now	
Watkins Wetland Treatment System (south) (see Figure 1 and Photos 1 and 2).				
1. West side (Channel A) washout south of pipe outlet	✓			\$3500
