September 2015

## KINGSTON WETLAND RESTORATION LEADS TO HEALTHIER ENVIRONMENT

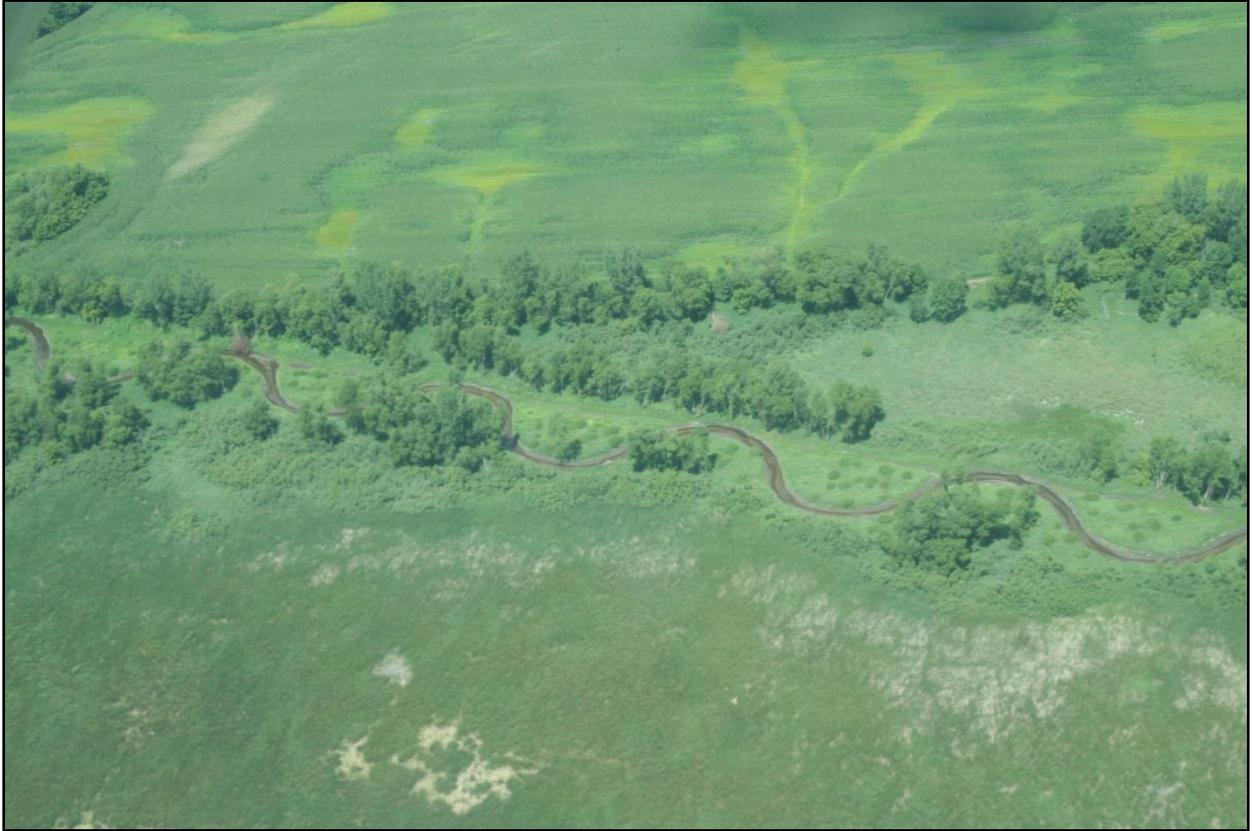
Figure 1: Aerial of restored low flow river channel

The restored wetland and river channel comes close to pre-agrarian hydrology by re-meandering the low flow channel through the wetland. This addressed the DO impairment while lowering the frequency of times the wetland was exporting soluble phosphorus downstream. It also preserved access to the floodplain during high flows, which maintains the particulate phosphorus trapping capabilities of the wetland. In addition, a limestone filter berm was installed across the outlet of the wetland as it reenters the river to provide soluble phosphorus removal during low flow conditions.
