# 2016

## 2016 PROJECT INSPECTION REPORT

The mission of the Clearwater River Watershed District is to promote, preserve, and protect water resources within the boundaries of the district in order to maintain property values and quality of life as authorized by MS 103D.

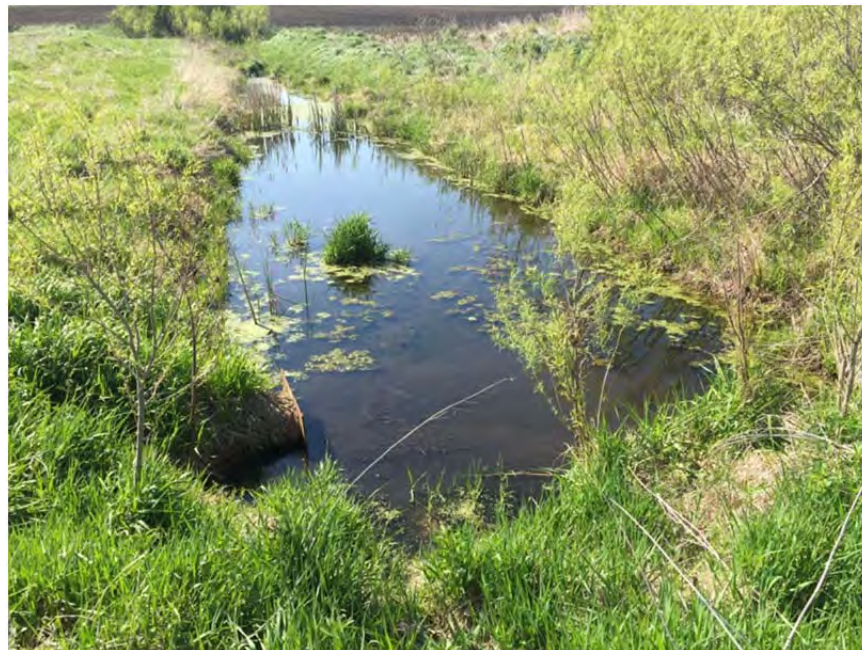
Outflow from wetland in Channel B (Station 1100)

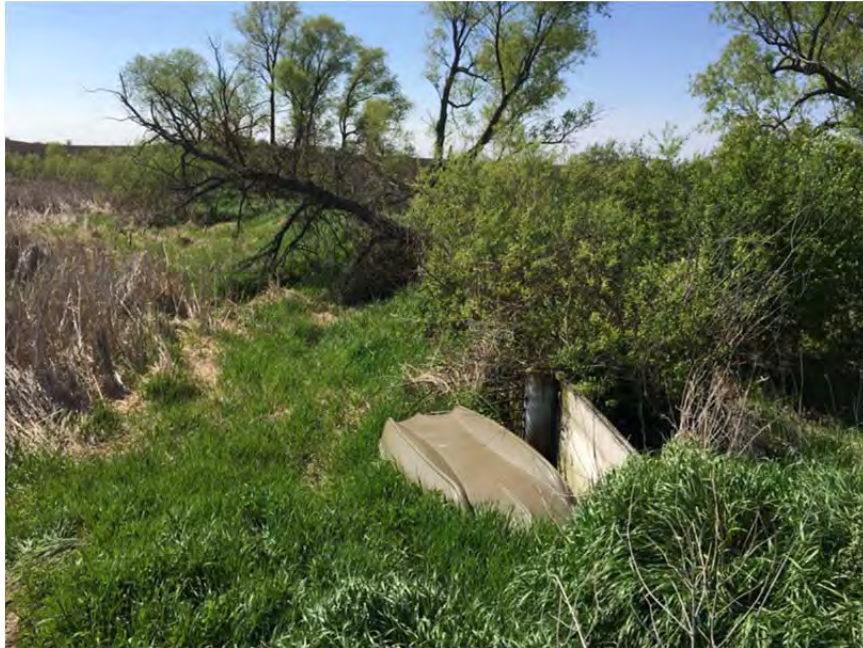
Diversion Structure (Station Point 2400)

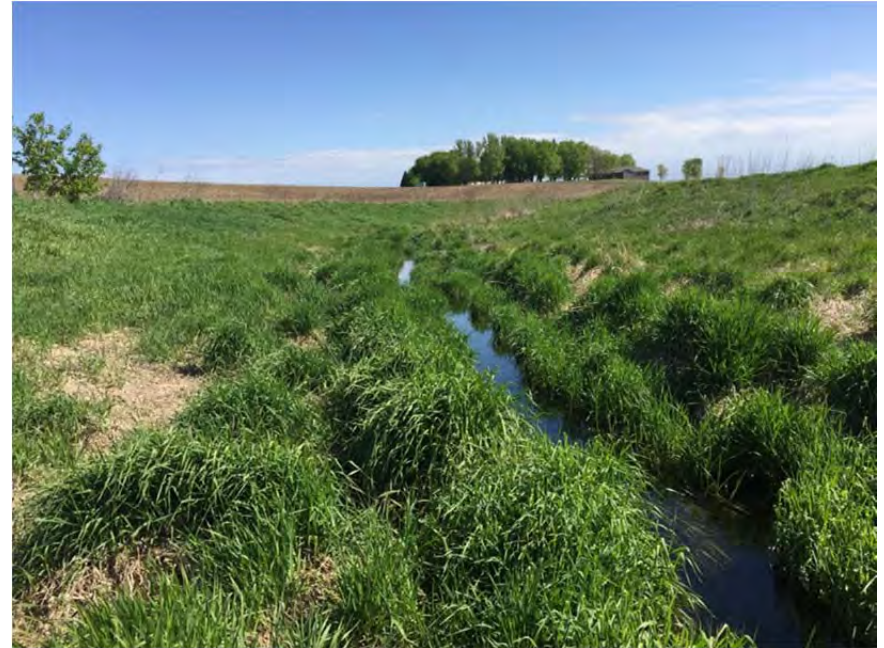
Channel A (Station Point 2300)

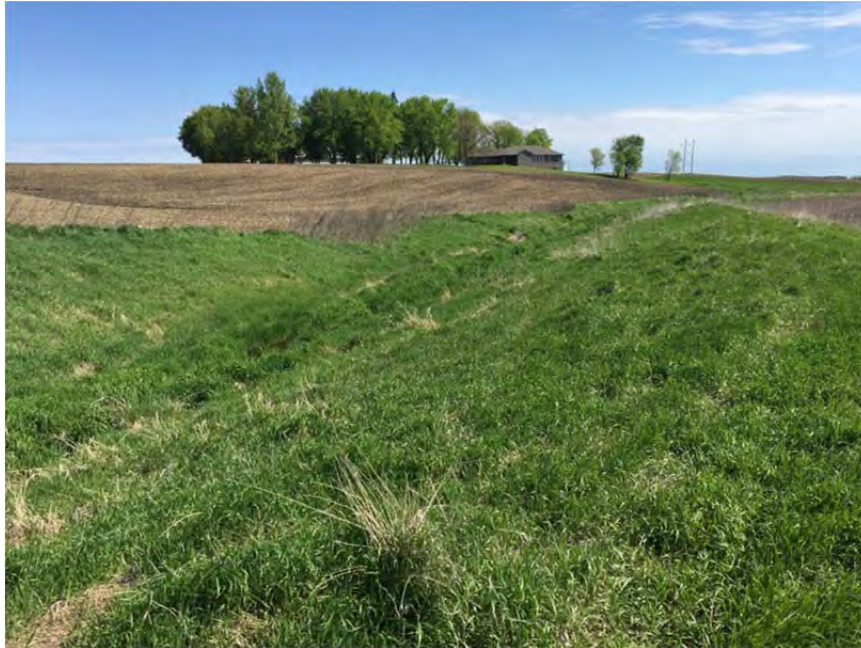
Channel A (Station Point 3300)

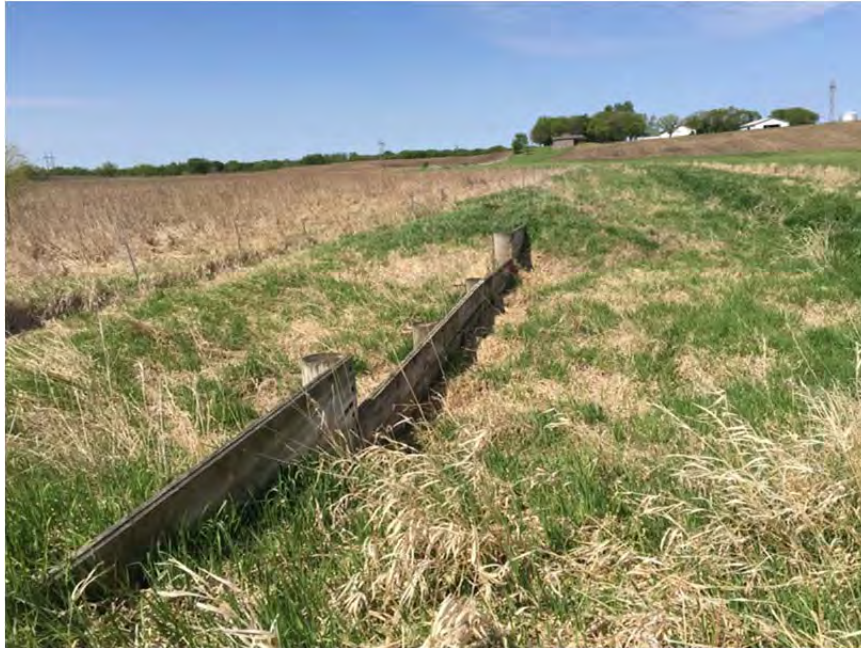
Diversion Structure (Station Point 5100)

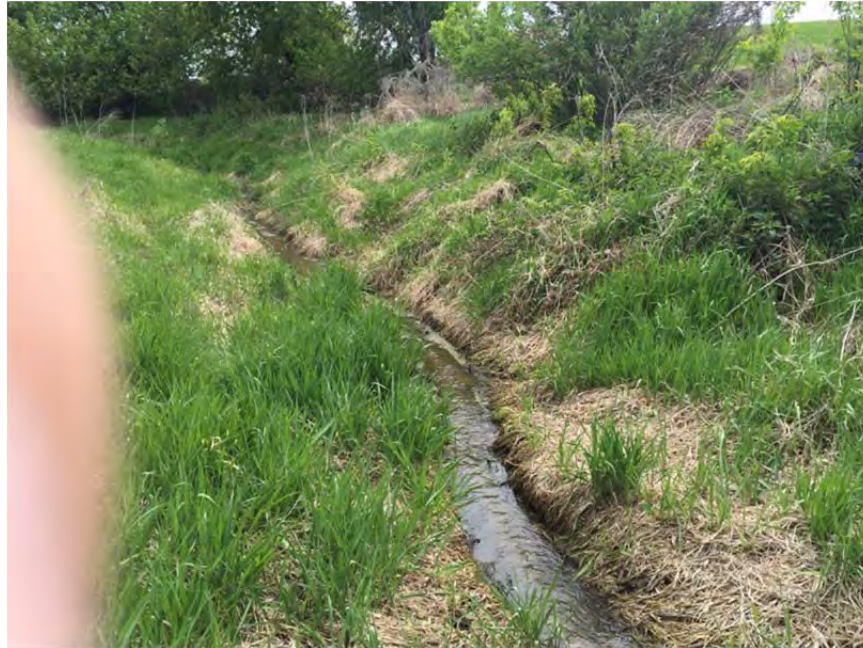
Channel A (Station Point 8000)

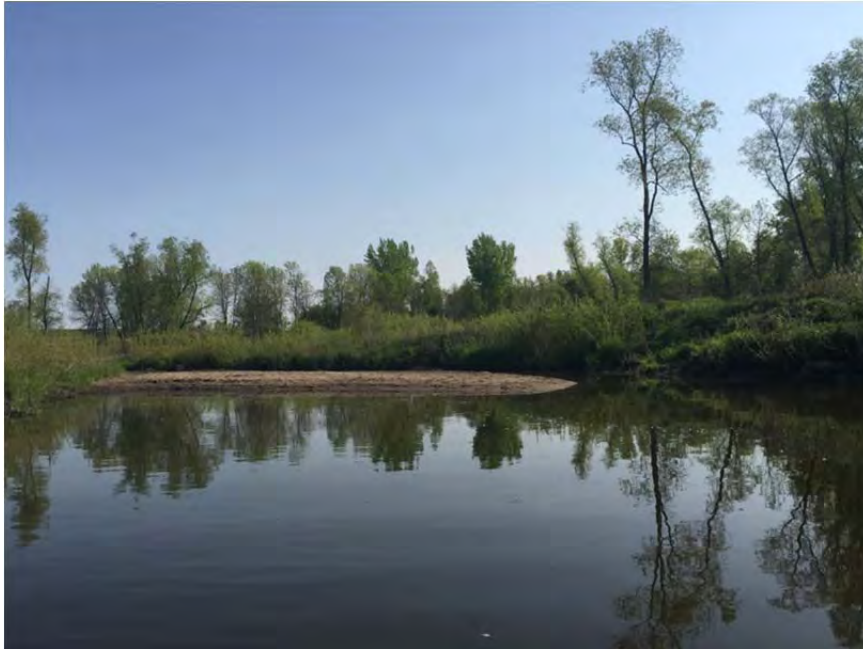
Sedimentation basin looking north towards  
sediment deposit

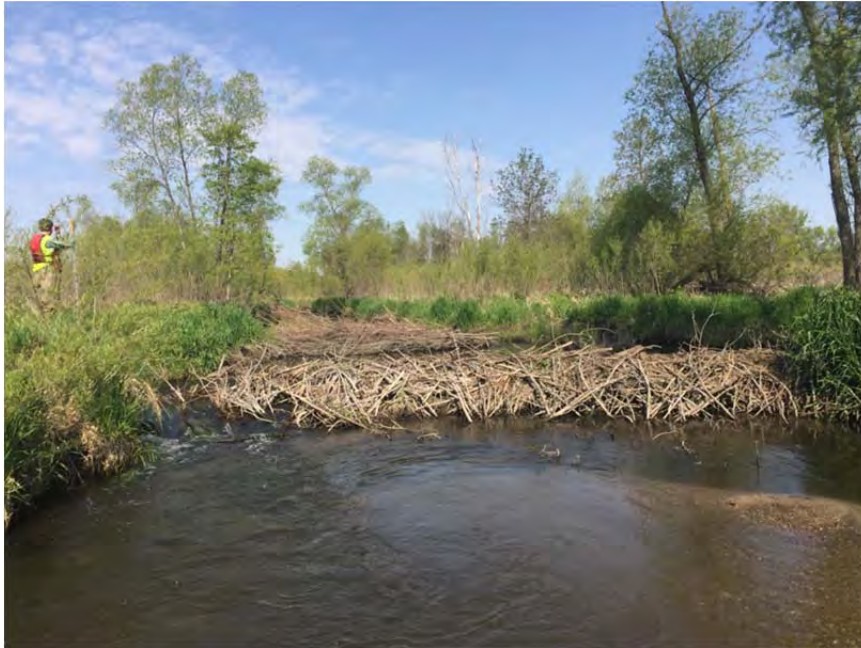
Beaver dam blocking main channel

- ▲ The effectiveness of removing beaver dams and/or stabilizing the channel near the beaver dams to reduce further bank erosion and potential impacts on the channel downstream should be evaluated to determine the feasibility of such work.
- ▲ The feasibility of removing accumulated sediment from the sediment forebay and sediment basin, as well as in the plunge pool, should be evaluated to determine if it is feasible and cost effective.
- ▲ Continue to monitor the constructed stream channel at established cross-sections to determine how the channel is functioning over time.

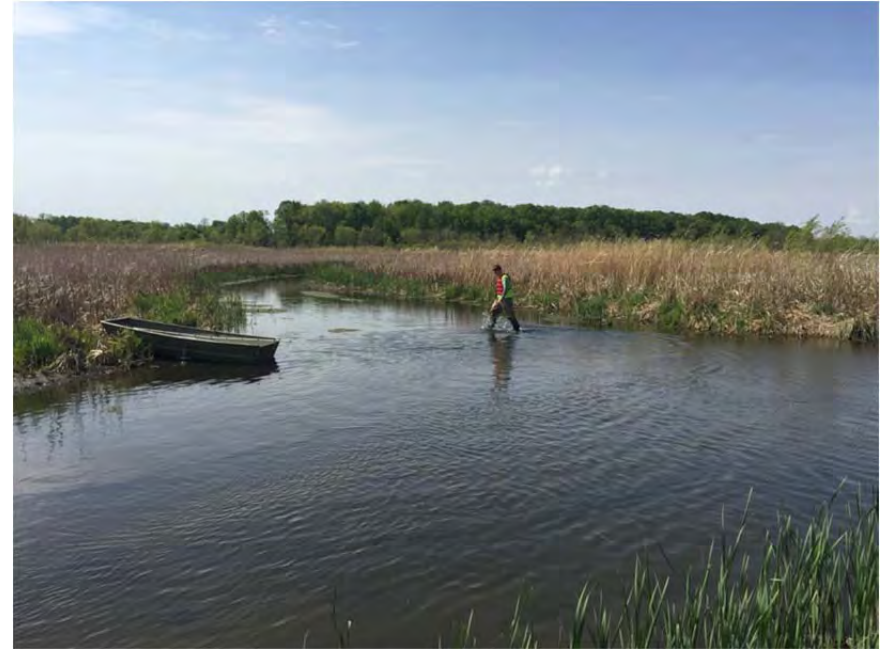
The survey of the top of the constructed limestone berm found that the top of the limestone was at an elevation of 1034.7 feet, which is slightly lower than the design elevation of 1035 feet.

Limestone berm

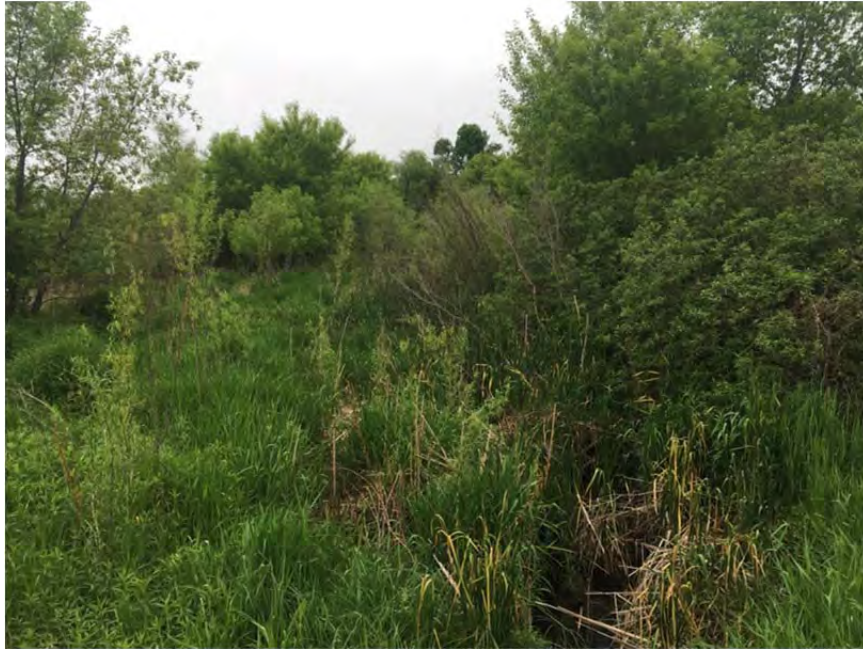
Channel Upstream of Hemlock Street

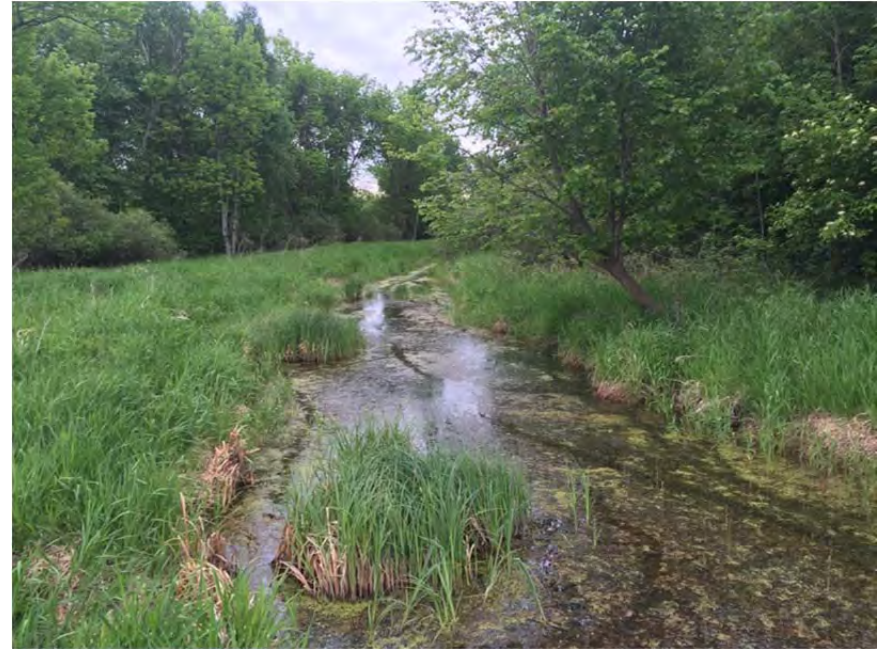
Channel (Station Point 1400)

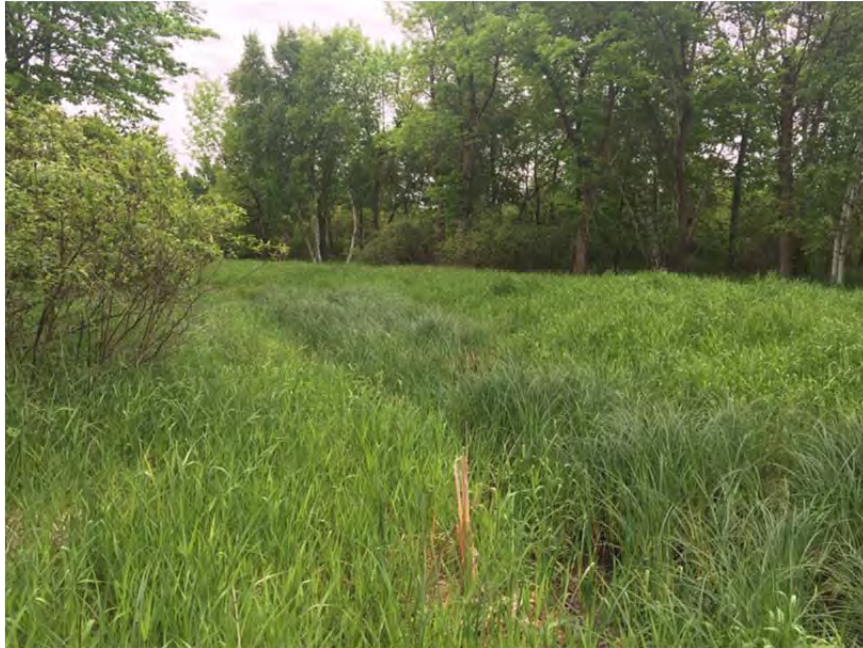
Native vegetation in channel (Station Point 1200)

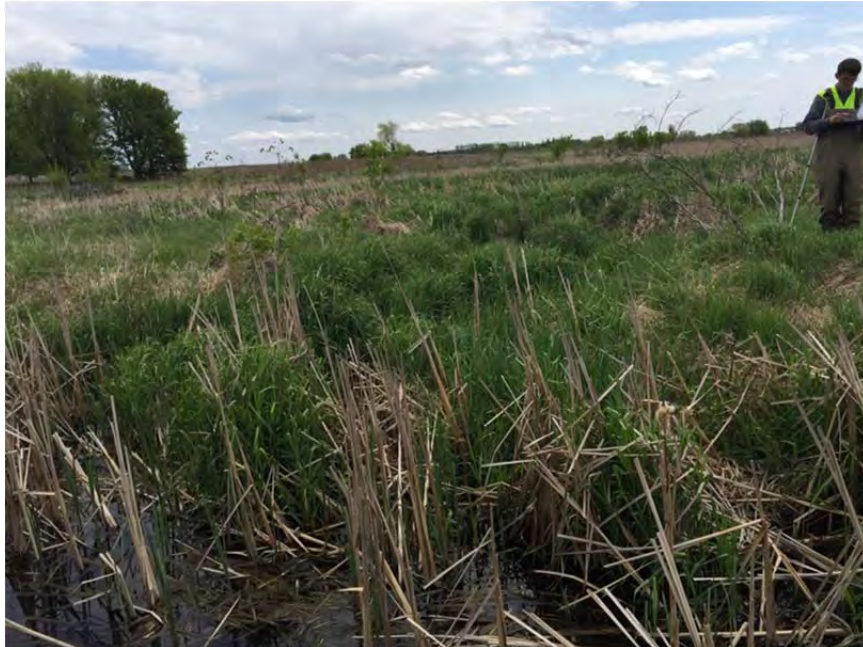
Constructed RipRap Overflow Structure in Berm  
(Station 1100)

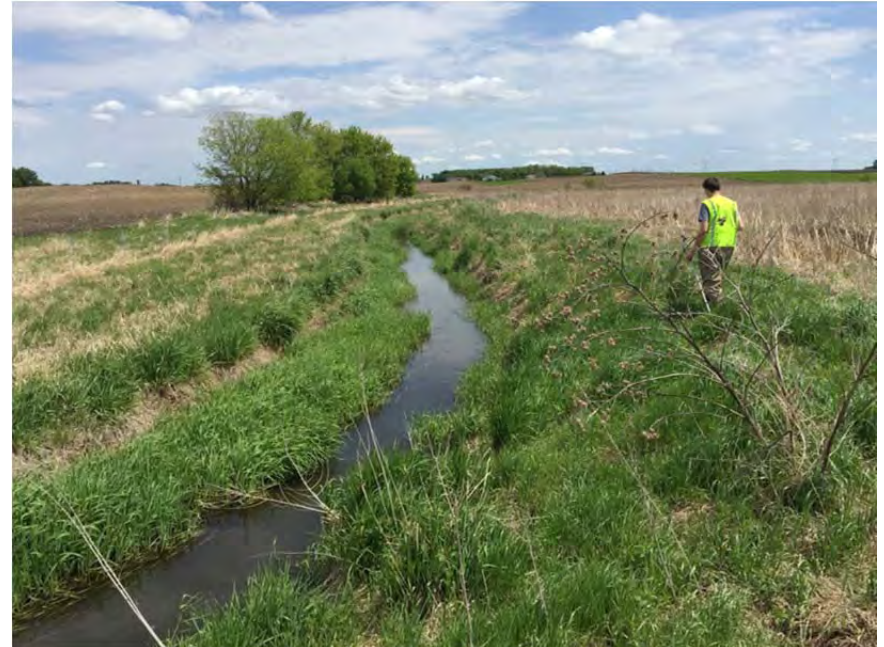
Channel B (Station 2200)

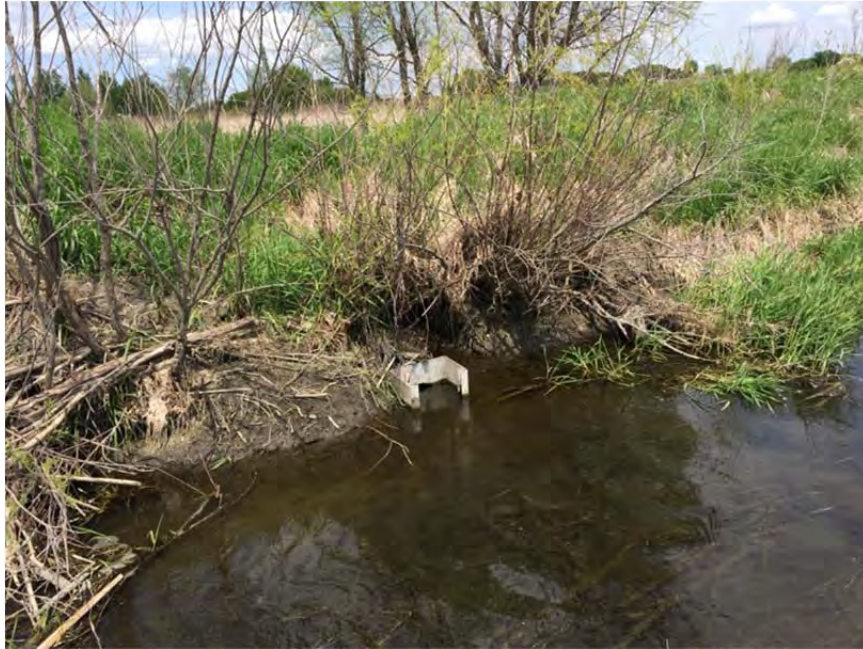
Port

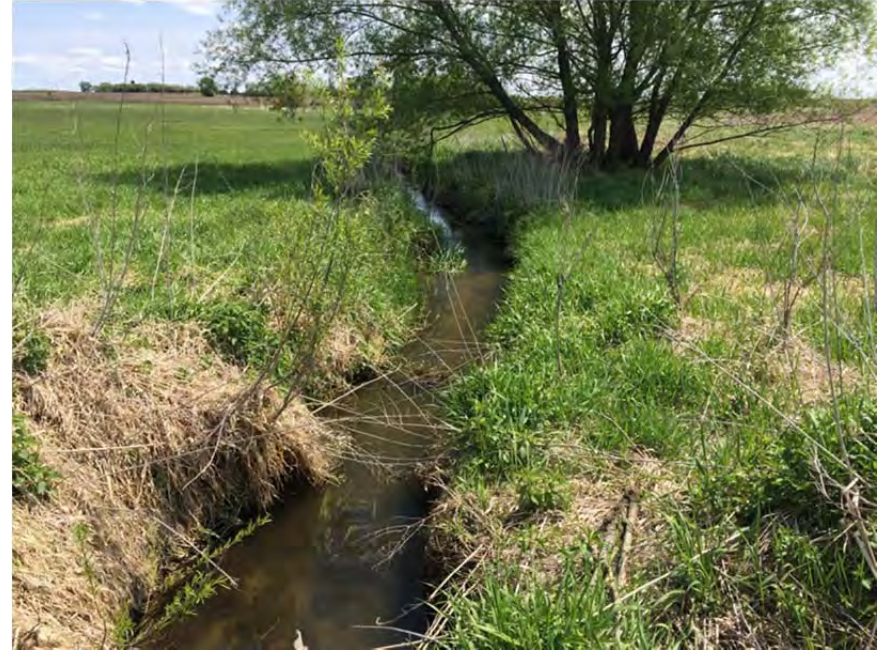
Flow channel downstream of berm cut  
(Station 300)

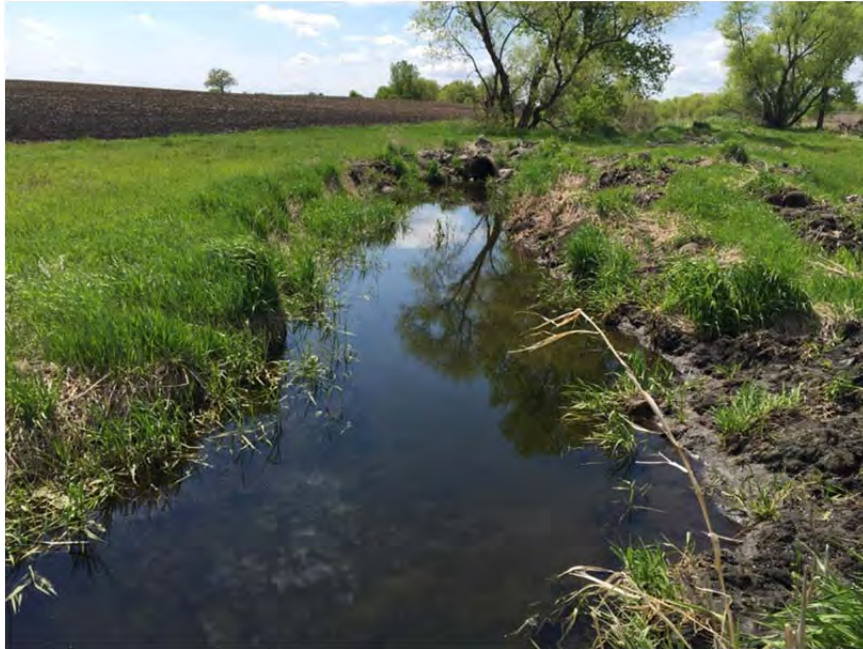
End of Channel A (at junction with County Ditch 20)

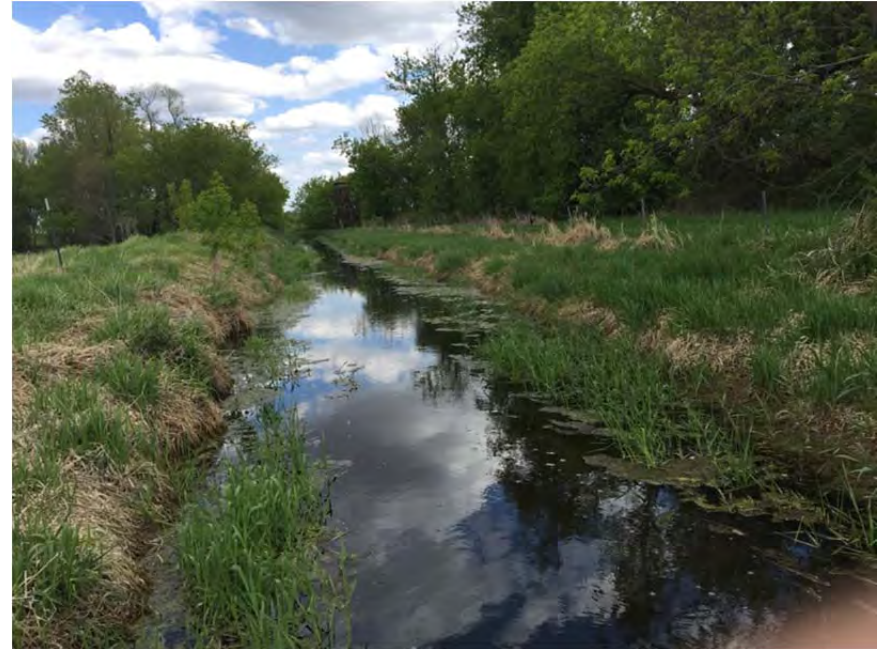
Typical Channel A Conditions

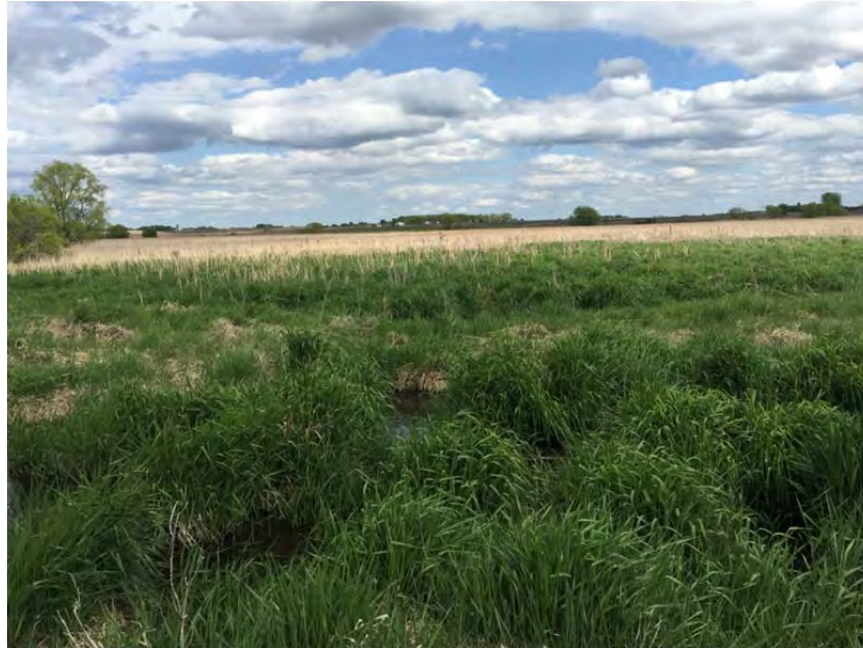
Beginning of Channel A

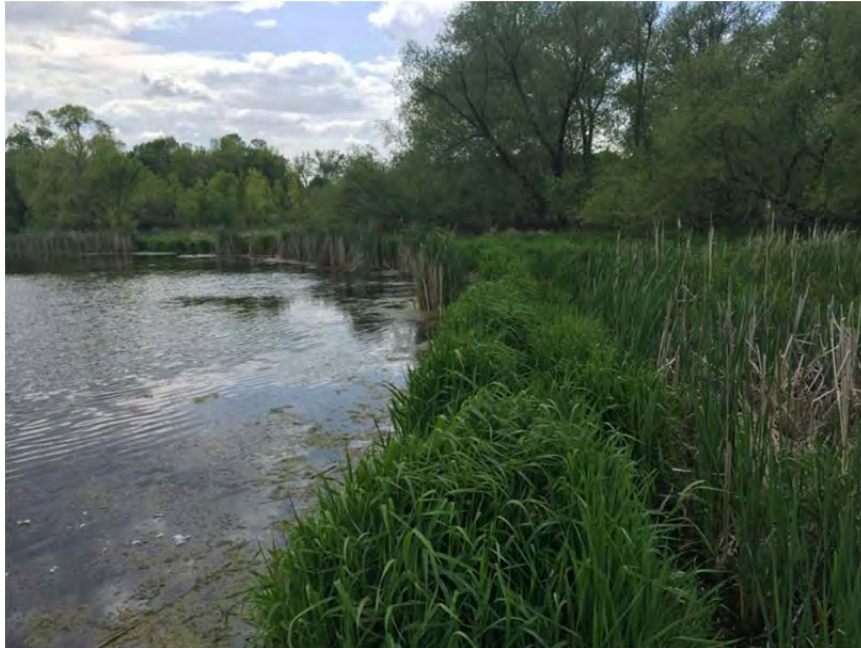
Limestone Filter Berm

- ▲ Continue to monitor areas of lower elevation on treatment filter berm to determine if additional maintenance is needed in future years.

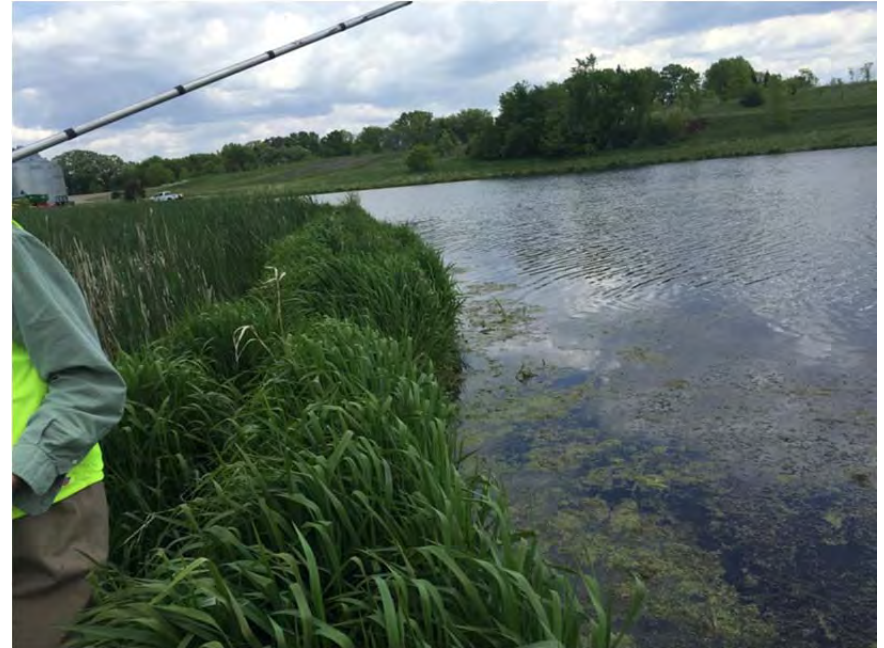
Limestone Filter Berm and Pond Edge

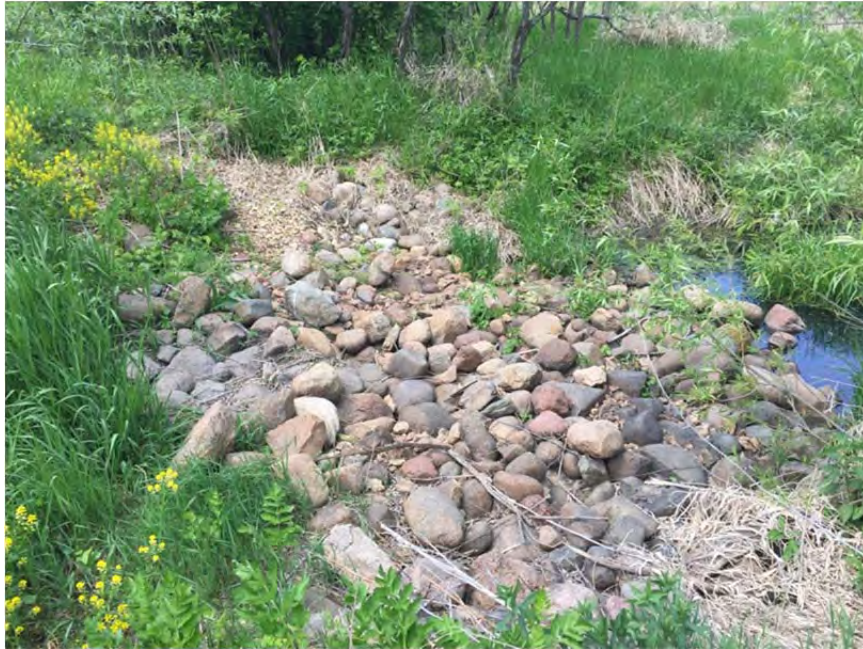
Diversion Structure

- ▲ Determine and evaluate if slightly higher runout elevation of limestone diversion structure needs to be addressed.

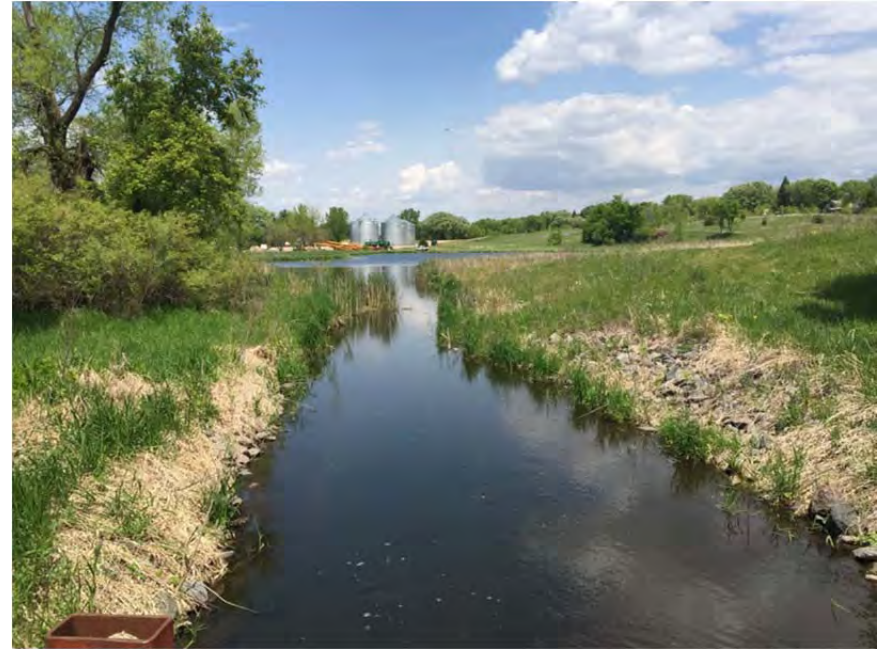
Channel upstream of treatment basin

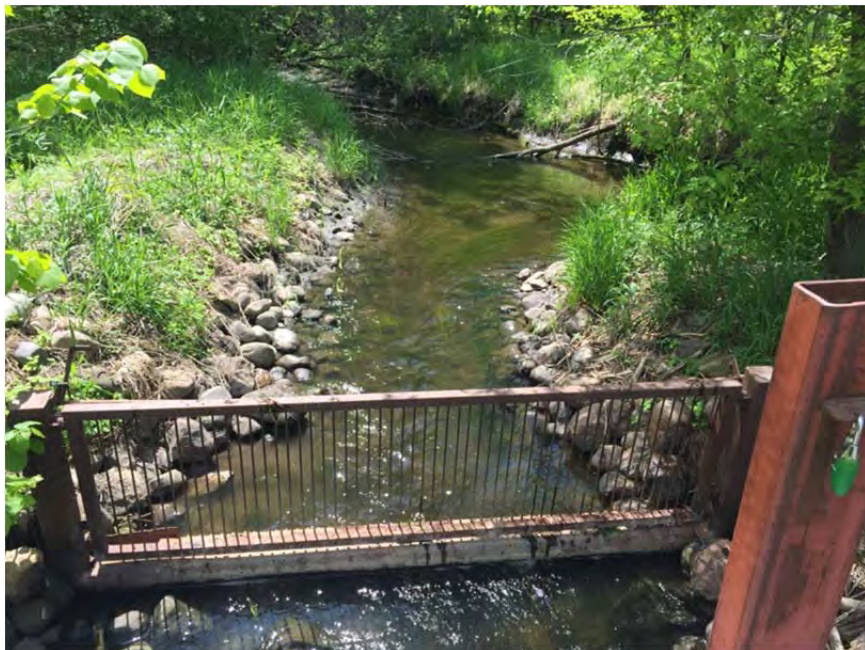
Fish barrier

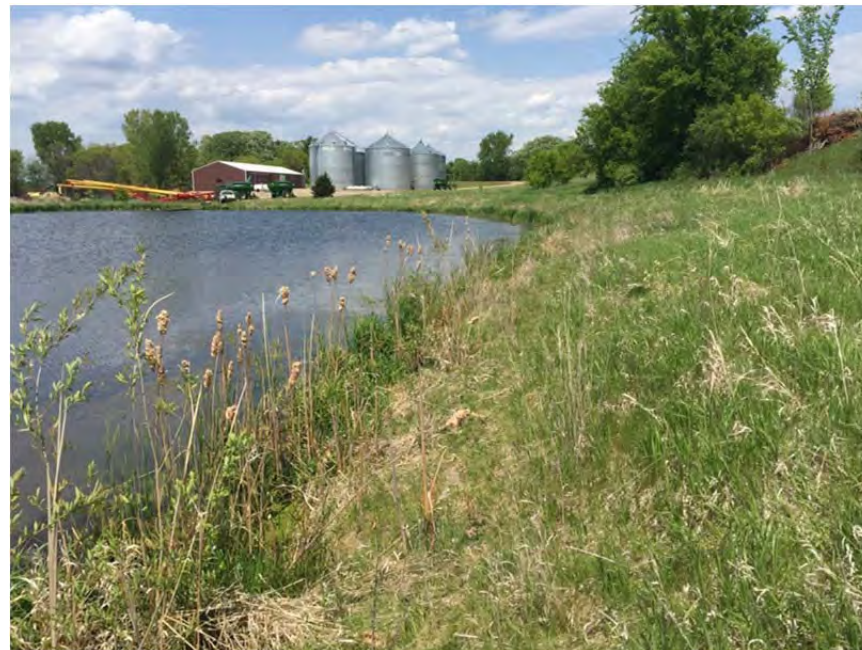
Eastern slope of treatment basin

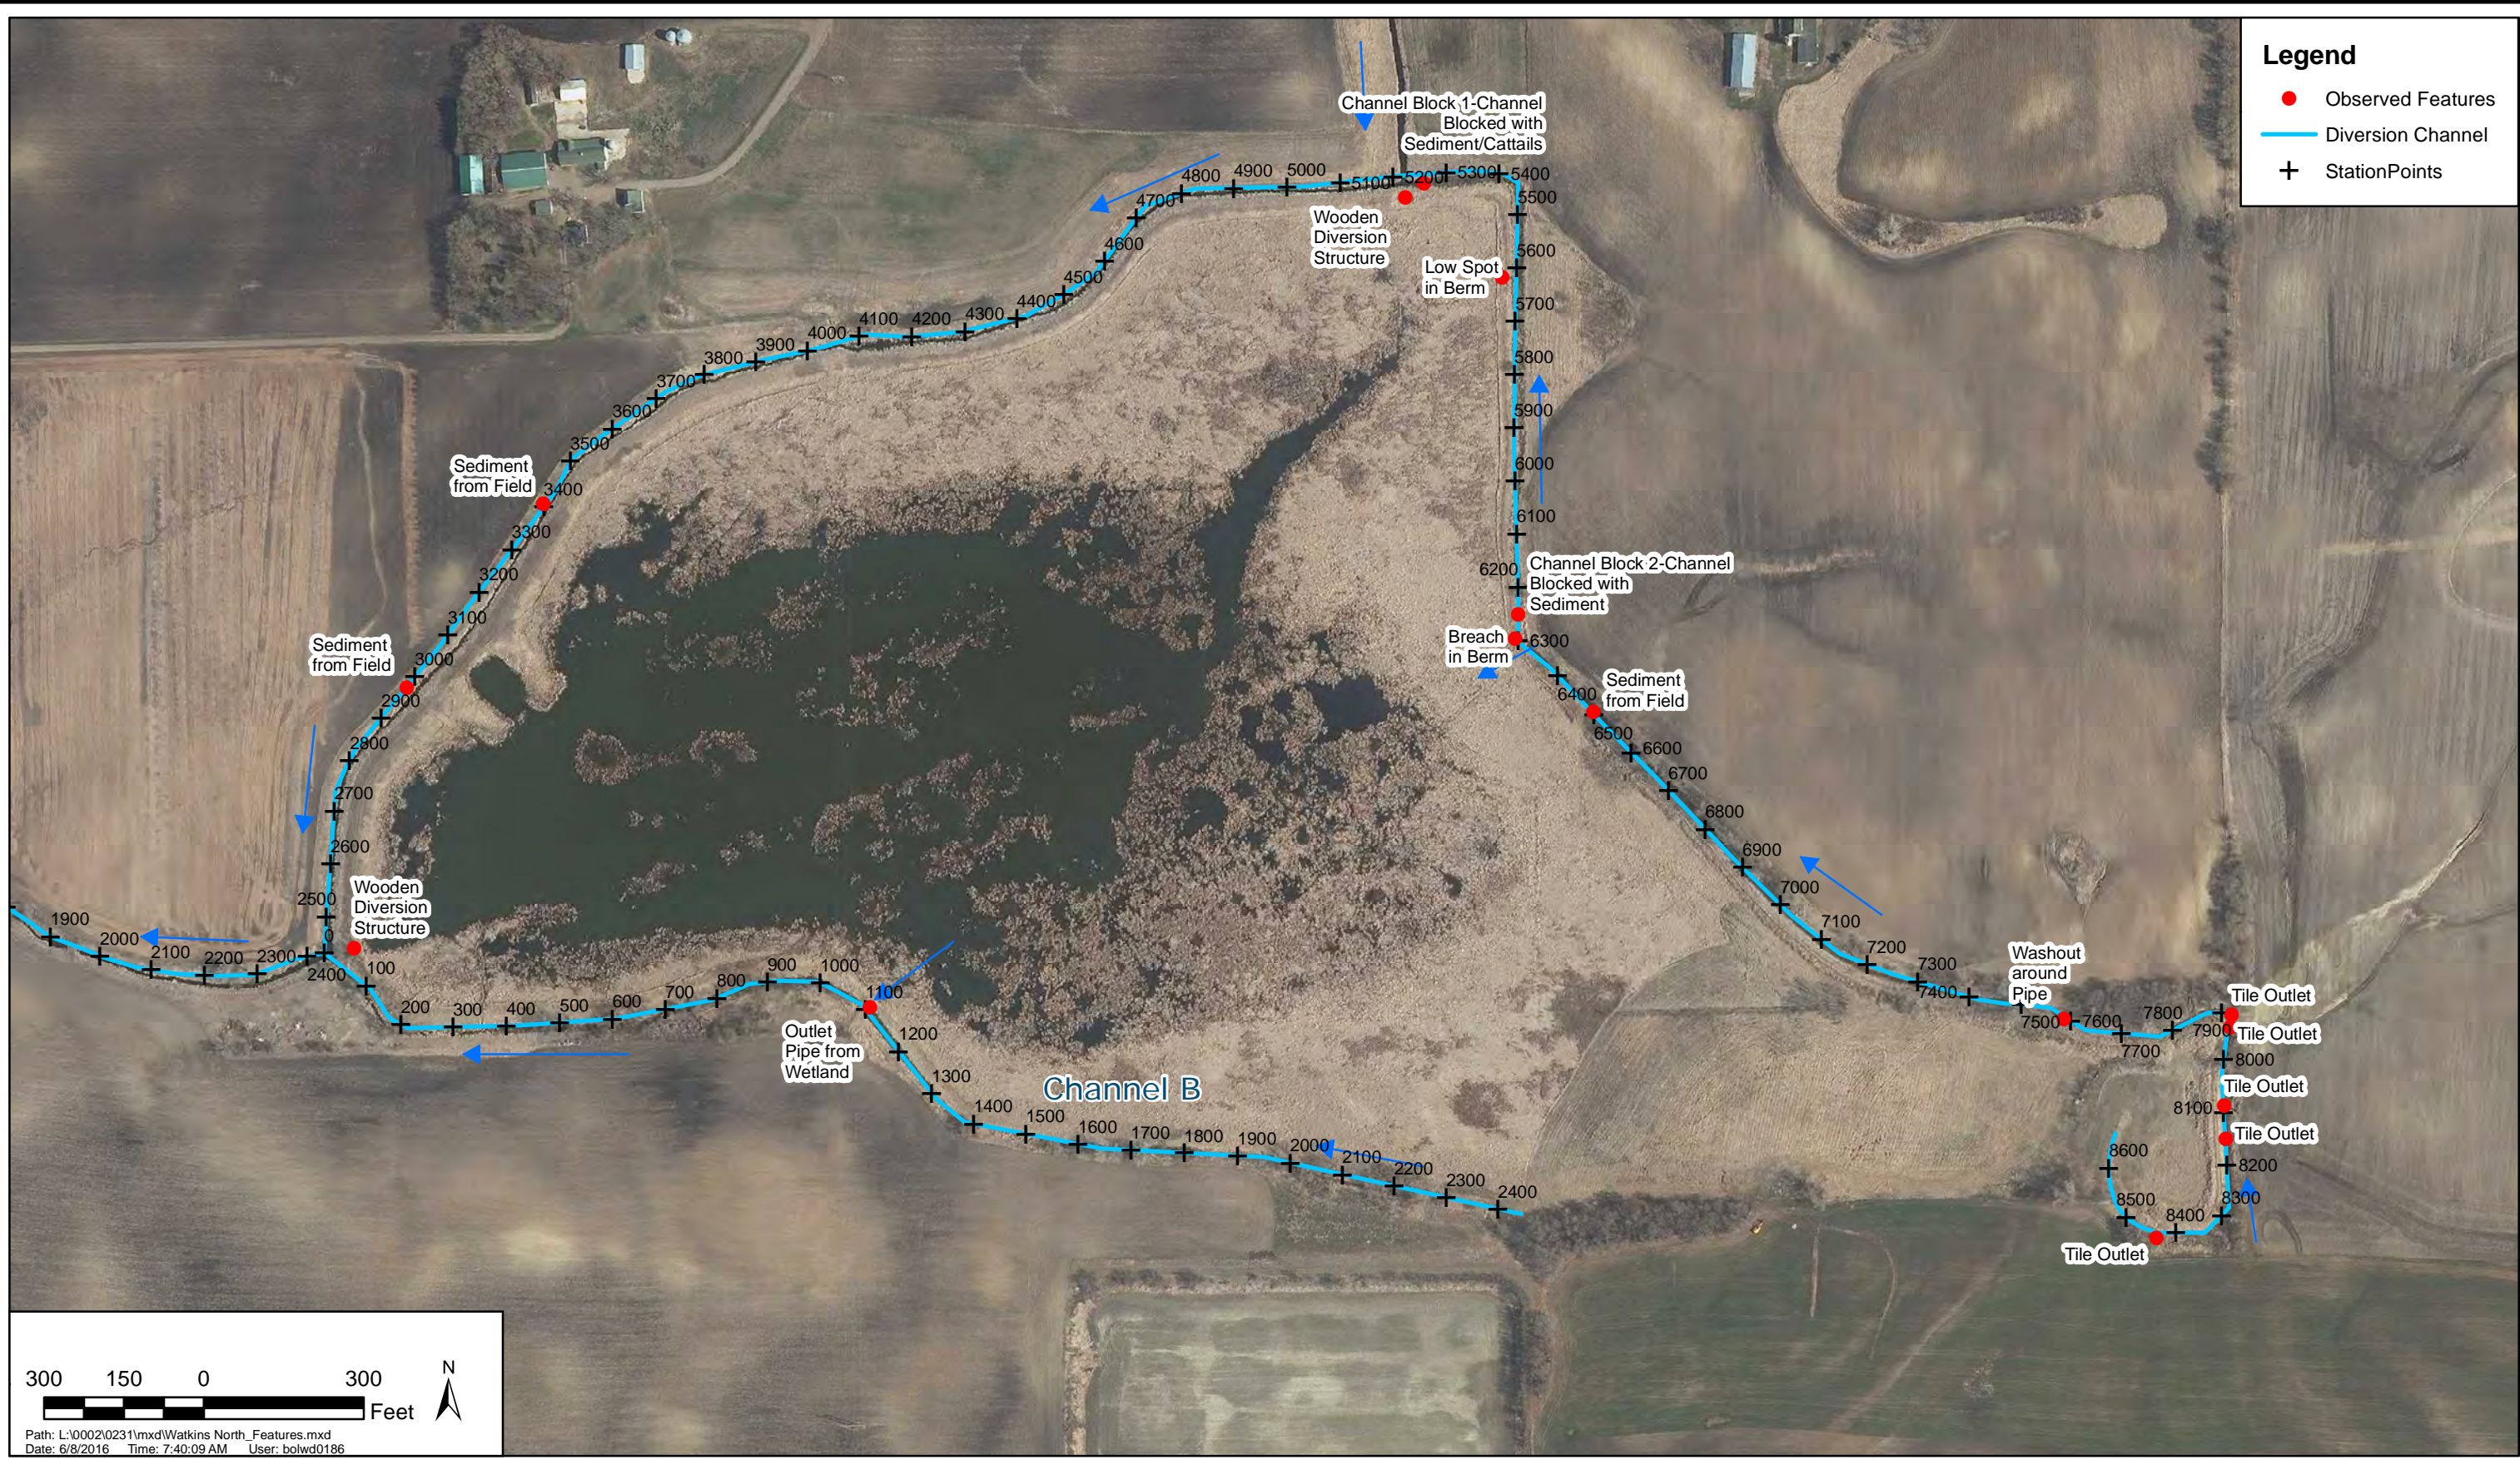
Wenck and CRWD staff investigation of the Watkins Wetland Isolation Unit focused on determining the extent of accumulated sediment in the diversion channel, the integrity of the berm isolating the channel from the wetland, and overall system functionality. Observations of each of these project components are discussed below. Figure 2 shows overall project components and areas of interest noted during the investigation.

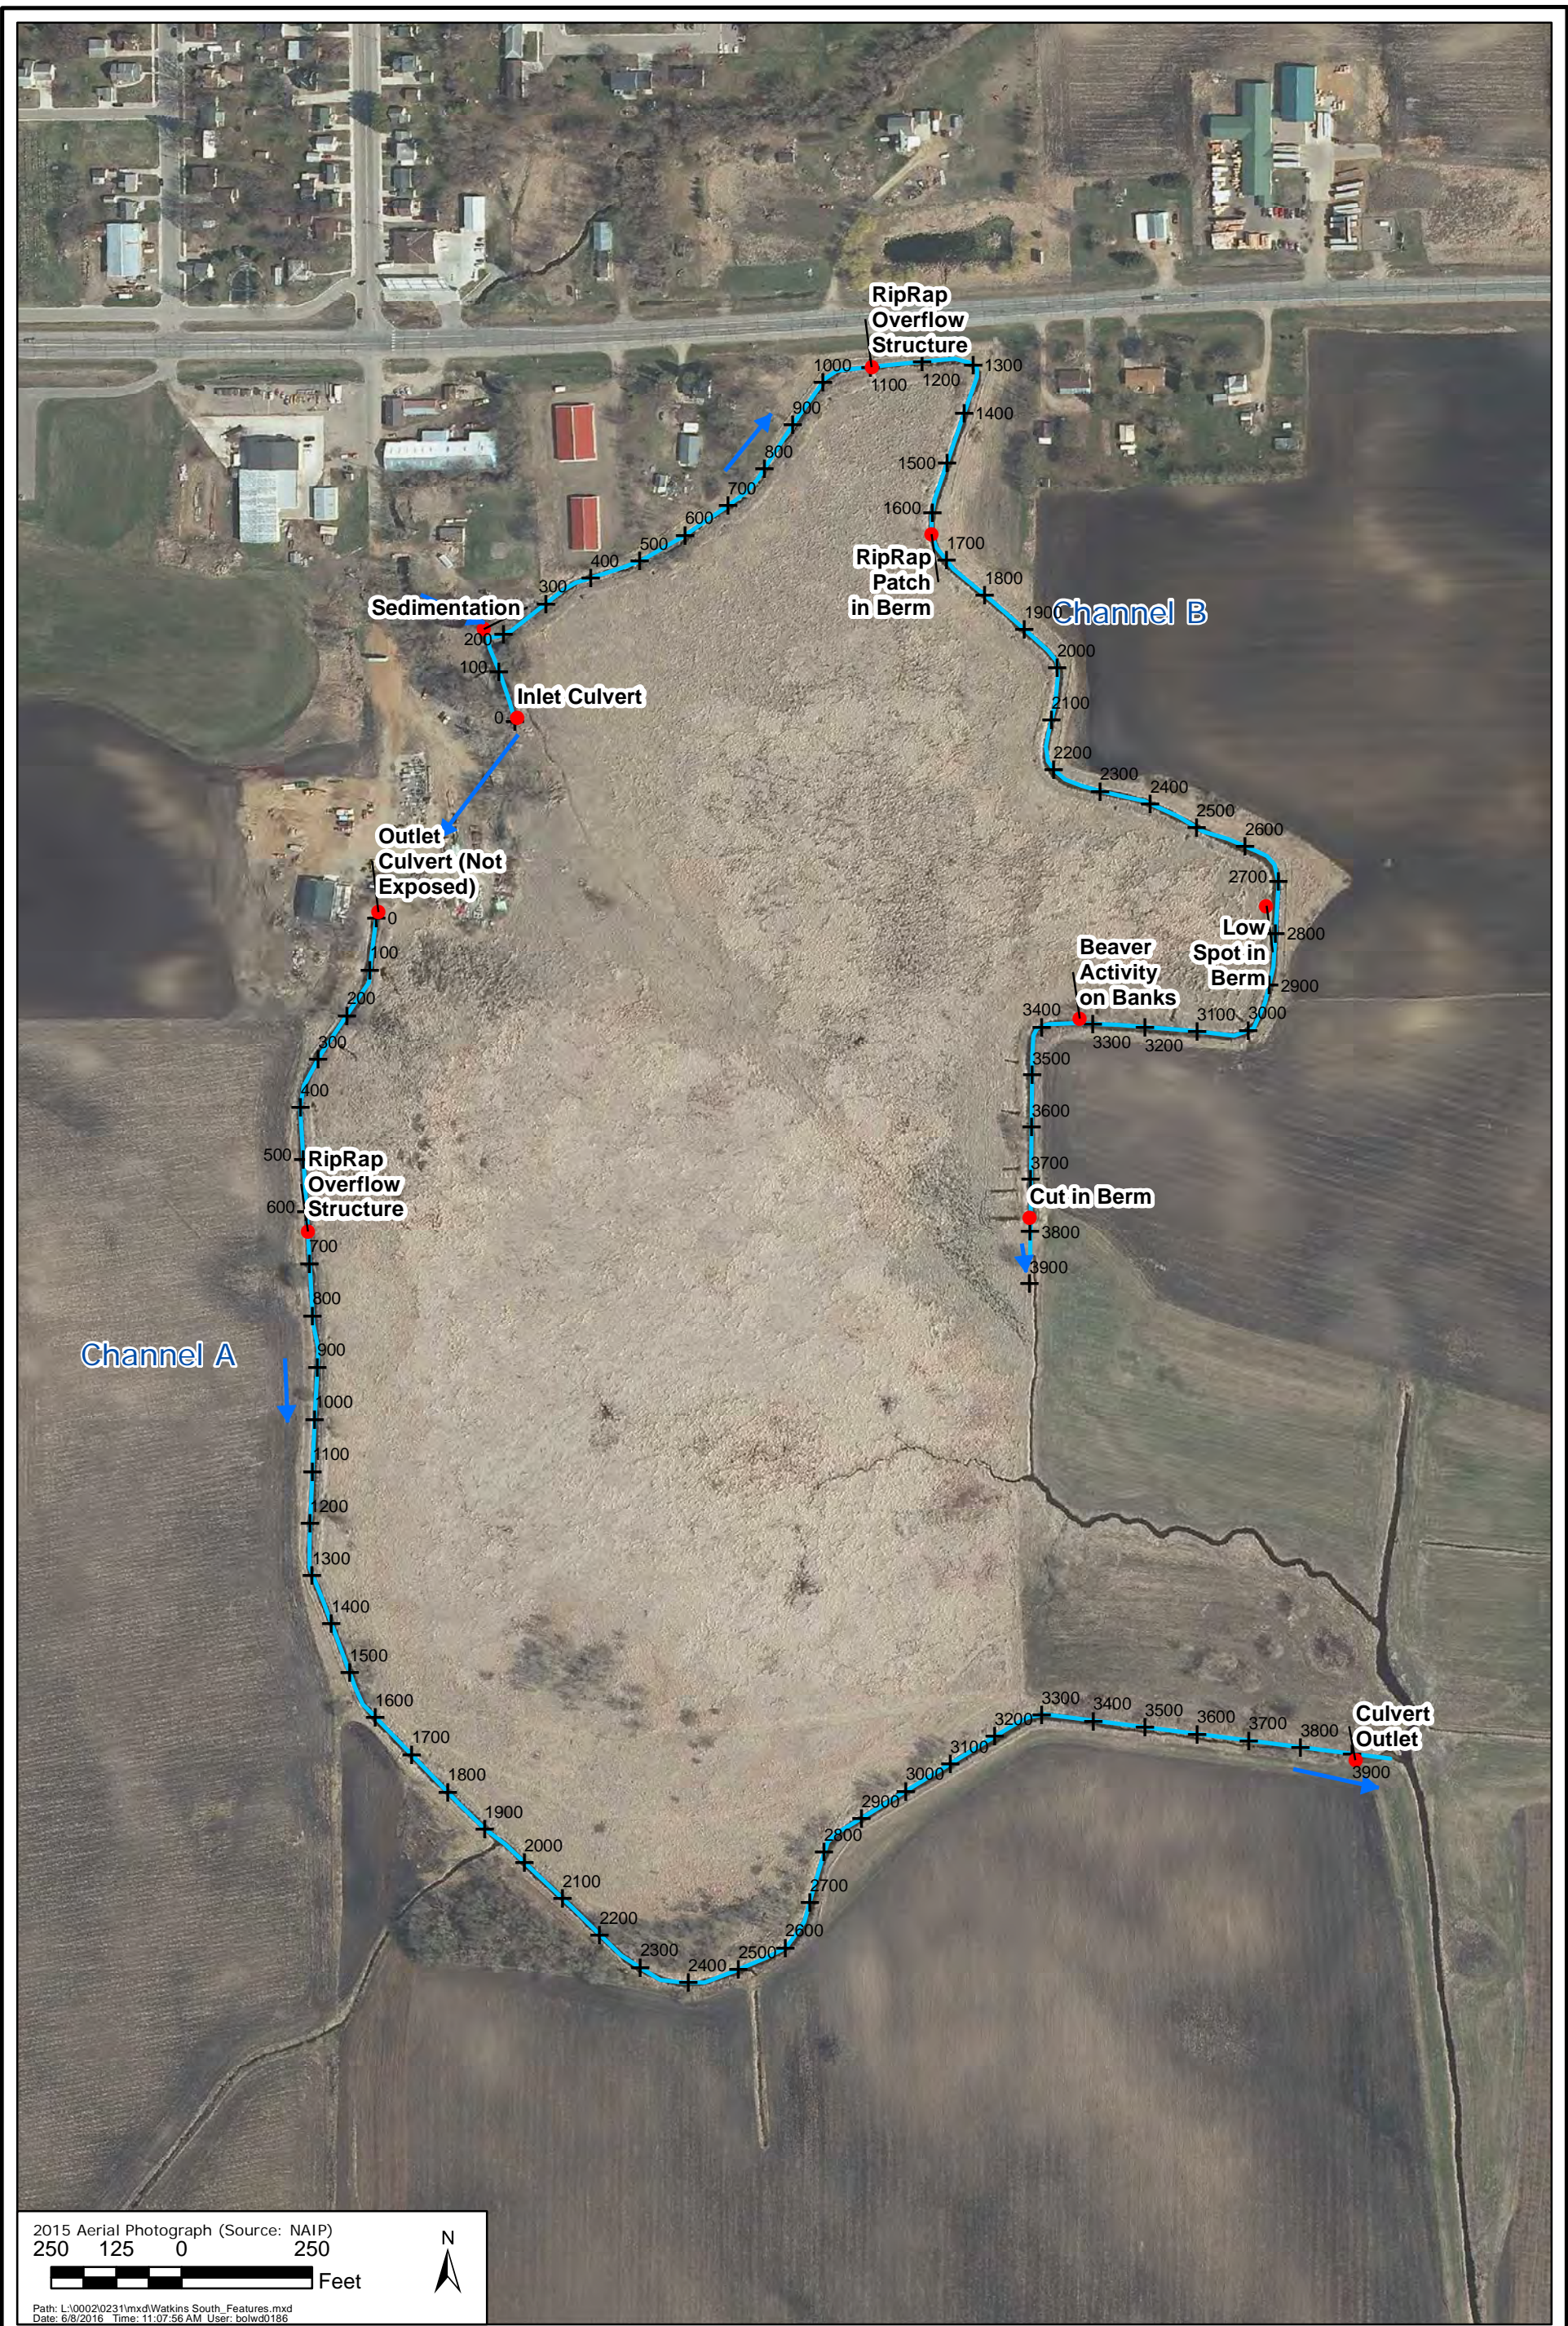
Figure 5

Wenck and CRWD staff investigation of the Watkins Wetland Treatment System South focused on determining the extent of sedimentation in the diversion channels (Channel A and Channel B) around the wetland, locating and observing the condition of ports, observing and documenting the integrity of the berm and investigation of a known cut that recently occurred in the berm, and general project functionality. Project components and observations of the investigation are shown in Figure 5.

Other low spots were observed at several other locations in Channel B as shown in Figure 5. Rip rap overflow structures were installed at cuts in the berm by CRWD in two locations in the late 2000s to alleviate drainage concerns from landowners adjacent to the project. These overflow cuts essentially lower the water levels in the diversion channel and allow water to flow back into the wetland at the determined elevations. These structures appeared to be functioning as designed.
